Customer Name : MERCEDES-BENZ MOBILITY  
(THAILAND) CO., LTD.

Inspection Date : 2024-07-24

Tel. :  
Lemon Inspection ID : LEMON24070403

Brand	MERCEDES BENZ	Model year	2022
Model	A200	Engine Code - No.	28291480820849
Sub-model	AMG Dynamic	Registration year	2022-12-19
Registration No.		Chassis No.	W1K1771876L005370
Current Mileage(km.)	63587	Engine Capacity(cc.)	1300

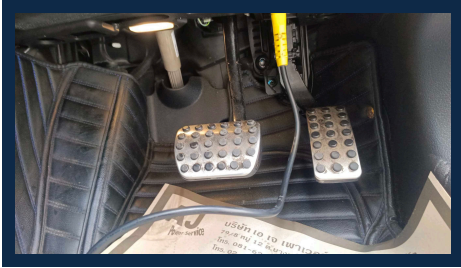
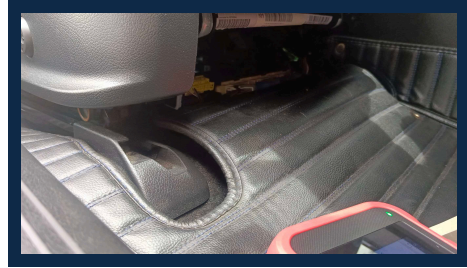
**Flood Report**

Evidence of Flood

No

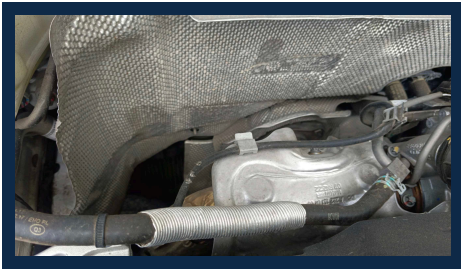
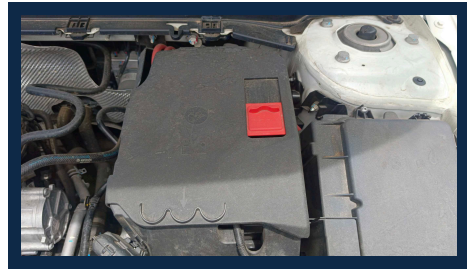
**Fire Report**

Evidence of Fire

No
