Vehicle : MERCEDES BENZ E300

Chassis number : W1K2130536L035745

Inspection date : 2024-07-24

Vehicle Certification : Pass the inspection standard of SCHIC INSPECTION BY LEMON-AIDE

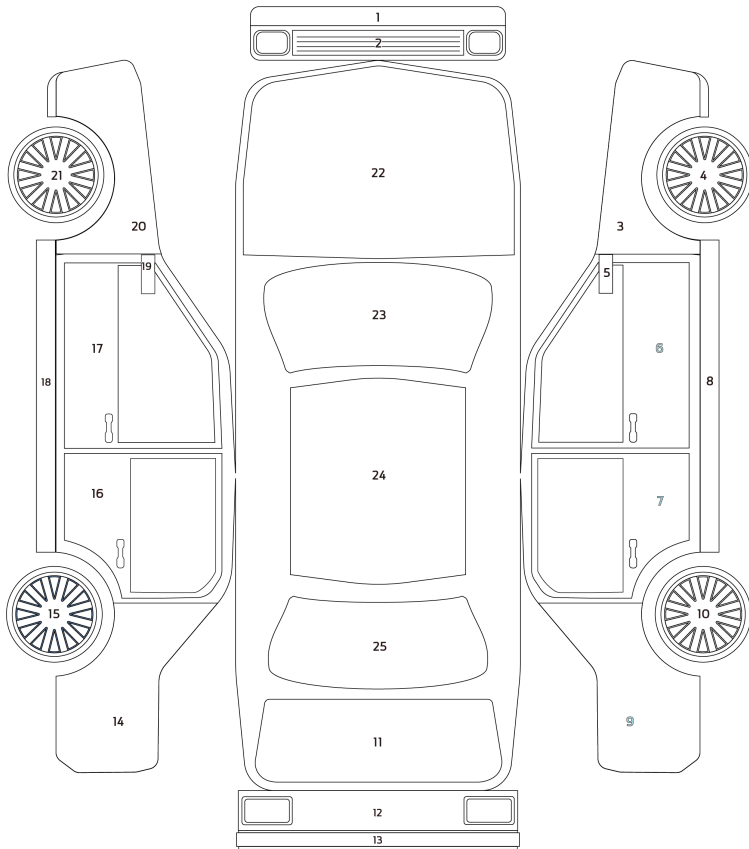
Exterior Inspection Points

1. Front Skirt	O	14. Left Skirt	O
2. Front Bumper	O	15. Left Wing Mirror	O
3. Front Right Fender	O	16. Front Windshield	O
4. Front Right Wheel	O	17. Roof	O
5. Front Left Fender	O	18. Rear Right Fender	O
6. Front Left Wheel	O	19. Rear Bonnet	O
7. Front Bonnet	O	20. Back Right Wheel	O
8. Right Wing Mirror	O	21. Rear Bumper	O
9. Front Right Door	O	22. Rear Skirt	O
10. Rear Right Door	O	23. Rear Left Fender	O
11. Right Skirt	O	24. Back Left Wheel	O
12. Rear Left Door	O	25. Back Windshield	O
13. Front Left Door	O

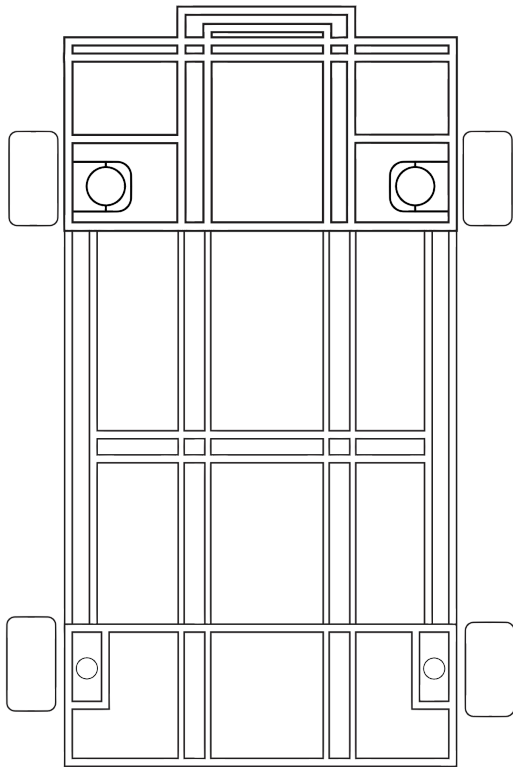
Chassis Report

No dent in the under carriage (th)	PASS
No deform chassis or chassis frame (th)	PASS
No visible corrosion on the chassis or chassis frame (th)	PASS
No missing part on the chassis frame (th)	PASS
Half cut Analysis (th)	PASS

Chassis Damage Level	No Damage
----------------------	-----------

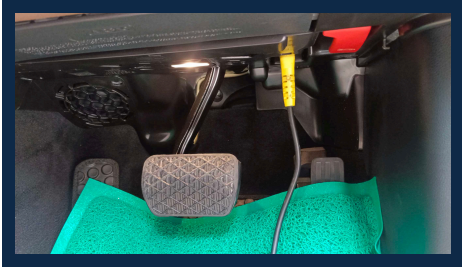
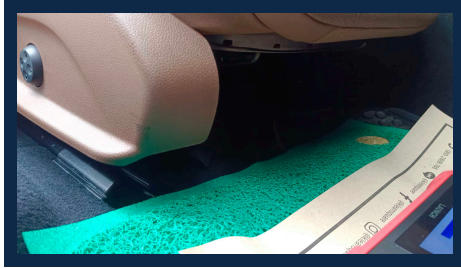
Flood Report

Evidence of Flood	No
-------------------	----

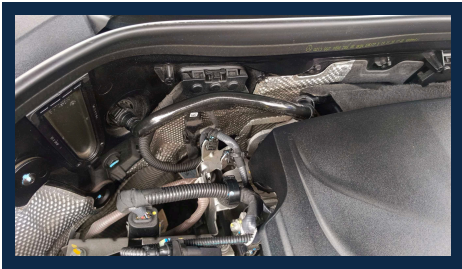
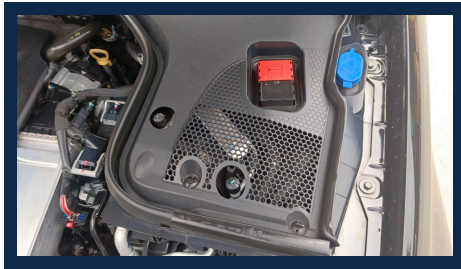
Fire Report

Evidence of Fire	No
------------------	----
