Preowned Vehicle Inspection Report

Premium Inspection Analysis

Vehicle : MERCEDES BENZ A200

Chassis number : W1K1771876L000817

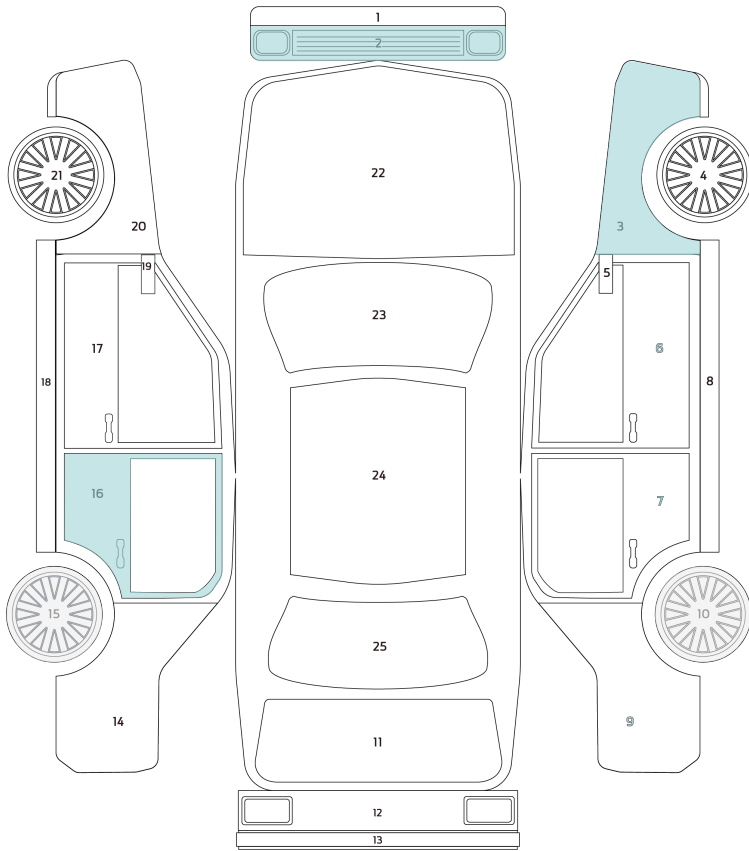
Exterior Inspection Points

1. Front Skirt	O	14. Left Skirt	O
2. Front Bumper	BP	15. Left Wing Mirror	O
3. Front Right Fender	BP	16. Front Windshield	O
4. Front Right Wheel	O	17. Roof	O
5. Front Left Fender	O	18. Rear Right Fender	O
6. Front Left Wheel	O	19. Rear Bonnet	O
7. Front Bonnet	O	20. Back right wheel	O (S1)
8. Right Wing Mirror	O	21. Rear Bumper	O
9. Front Right Door	O	22. Rear Skirt	O
10. Rear Right Door	O	23. Rear Left Fender	O
11. Right Skirt	O	24. Back left wheel	O (S1)
12. Rear Left door	BP	25. Back Windshield	O
13. Front Left Door	O

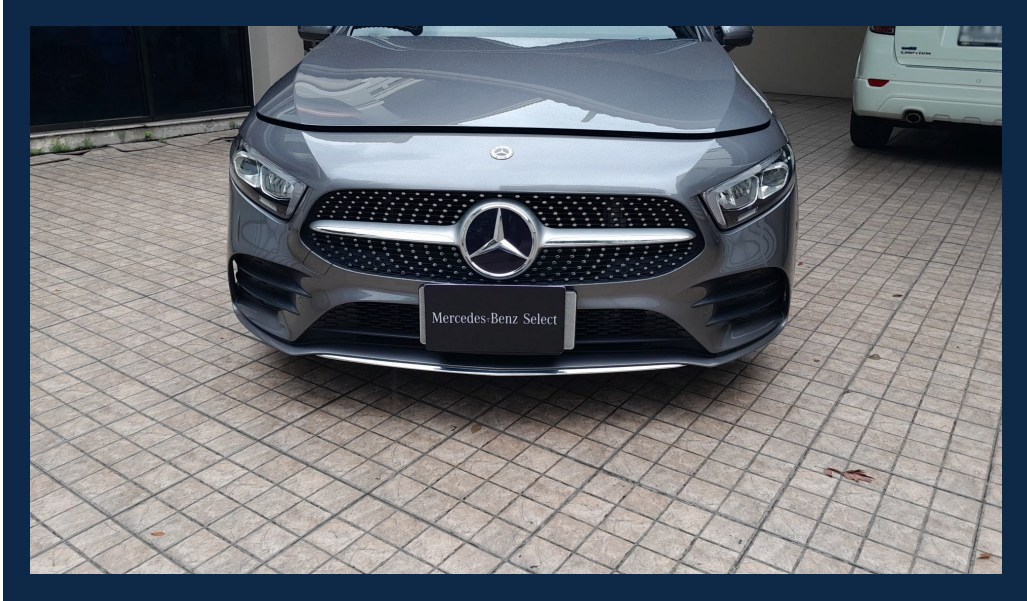
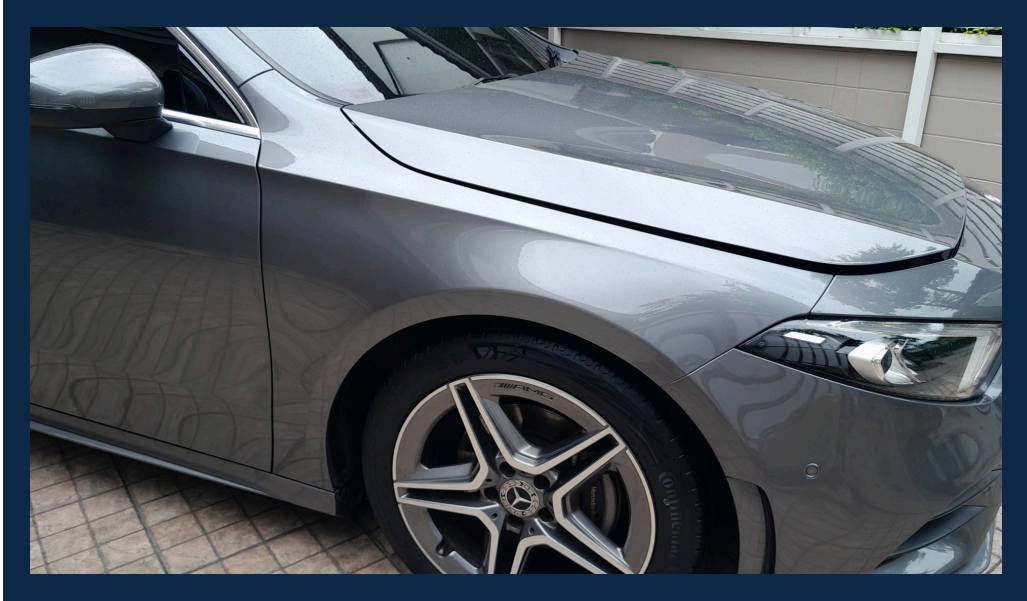
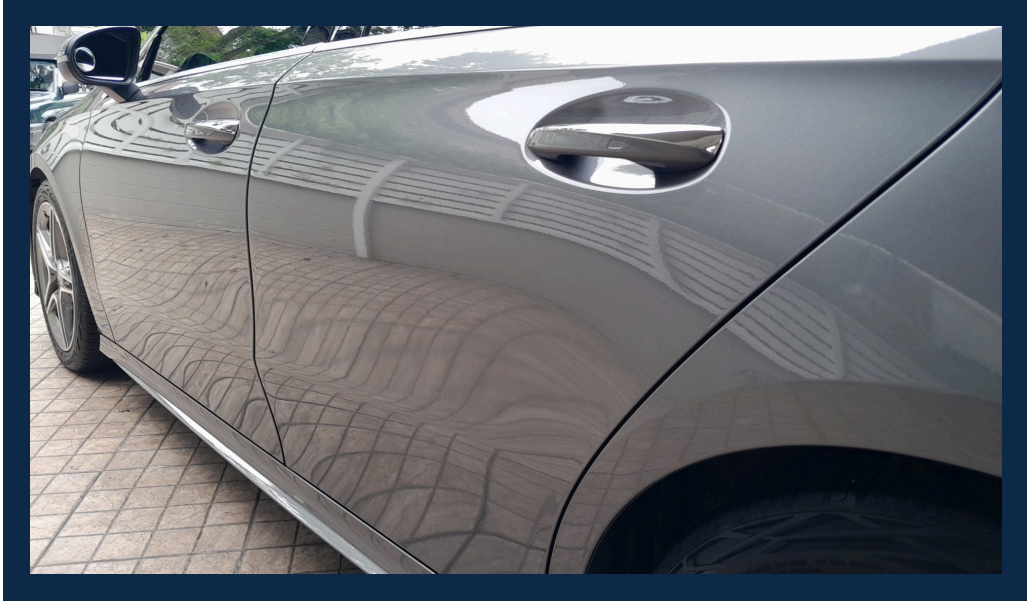
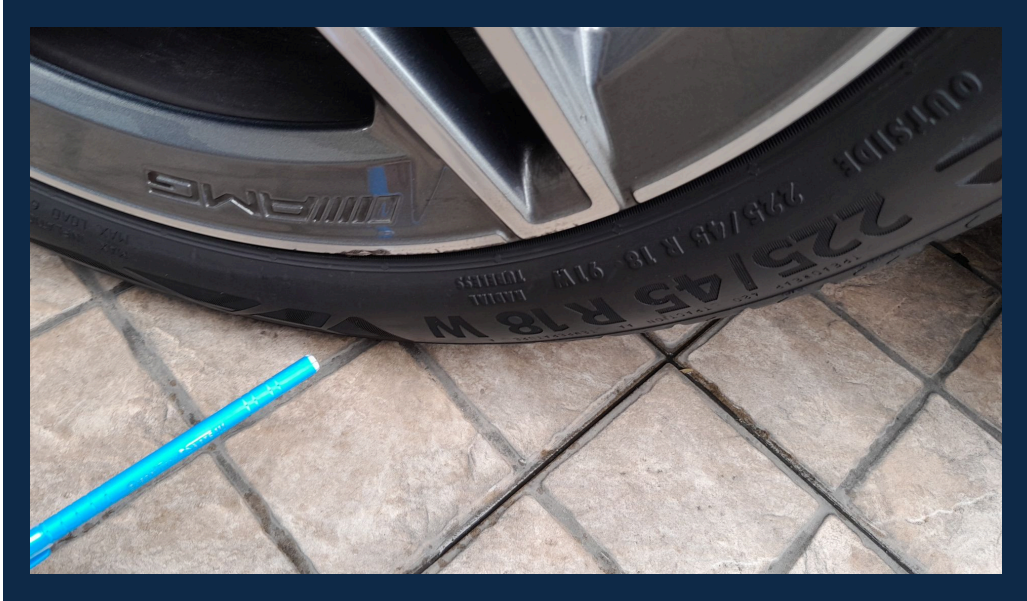
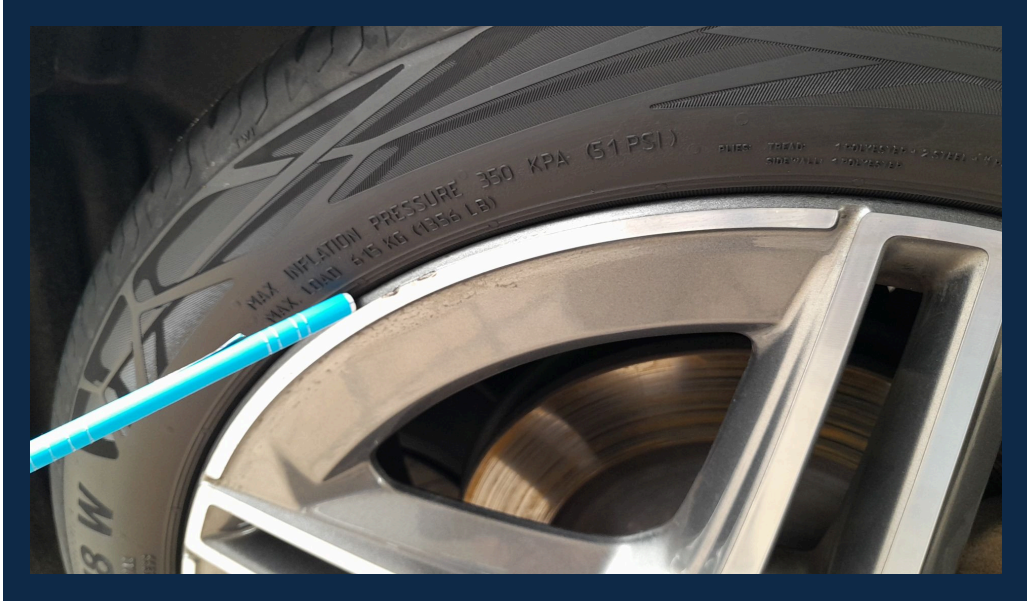
Vehicle Defect Notices

Inspector : ภายนอก(Exterior) : การตรวจสภาพภายนอกโดยรวมพบหลักฐานการซ่อมแซมทำสีมาบางชิ้น / สภาพยางทั้ง4เส้น ปี 20 เสื่อมสภาพ / ล้อแม็กเป็นรอยถลอก ภายใน(Interior) : ภายในปกติ สะอาดเรียบร้อย , อุปกรณ์ไฟฟ้า แอร์ วิทยุFM ใช้งานได้สมบูรณ์ครบปกติ เครื่องยนต์(Engine) : เครื่องยนต์ทำงานได้ปกติ , วิเคราะห์ปัญหาด้วยเครื่อง OBDII ไม่พบสิ่งผิดปกติ (ไม่ได้ทดสอบขับเคลื่อน) โครงสร้าง(Frame) : อุบัติเหตุไม่มี , โครงสร้างหลักปกติ ไม่มีการซ่อมแซมโครงสร้างหรือมีการชนถึงโครงสร้าง

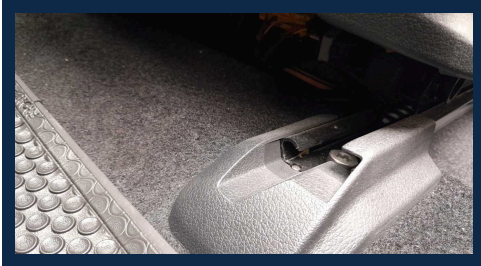
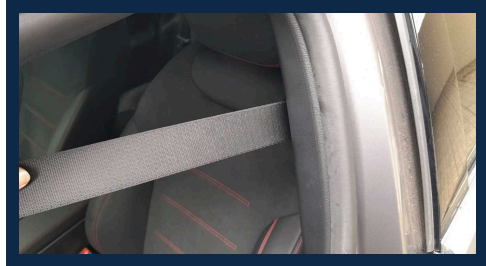
Flood Report

Evidence of Flood	No
-------------------	----

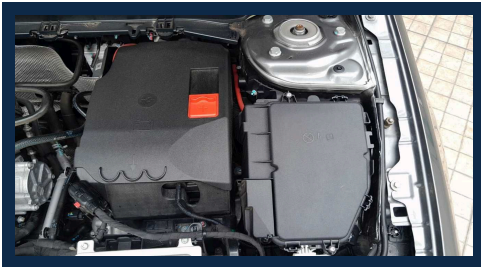
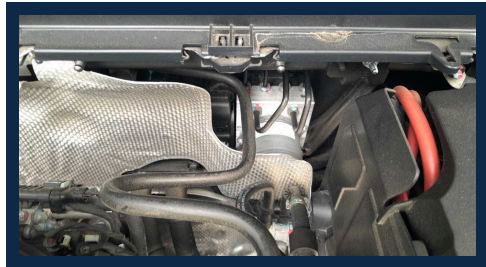
Fire Report

Evidence of Fire	No
------------------	----
