**Vehicle :** MERCEDES BENZ C300 5ขบ2972

**Chassis number :** WDD2050536L055707

**Inspection date :** 2024-08-02

**Vehicle Certification :** Pass the inspection standard of SCHIC INSPECTION BY LEMON-AIDE

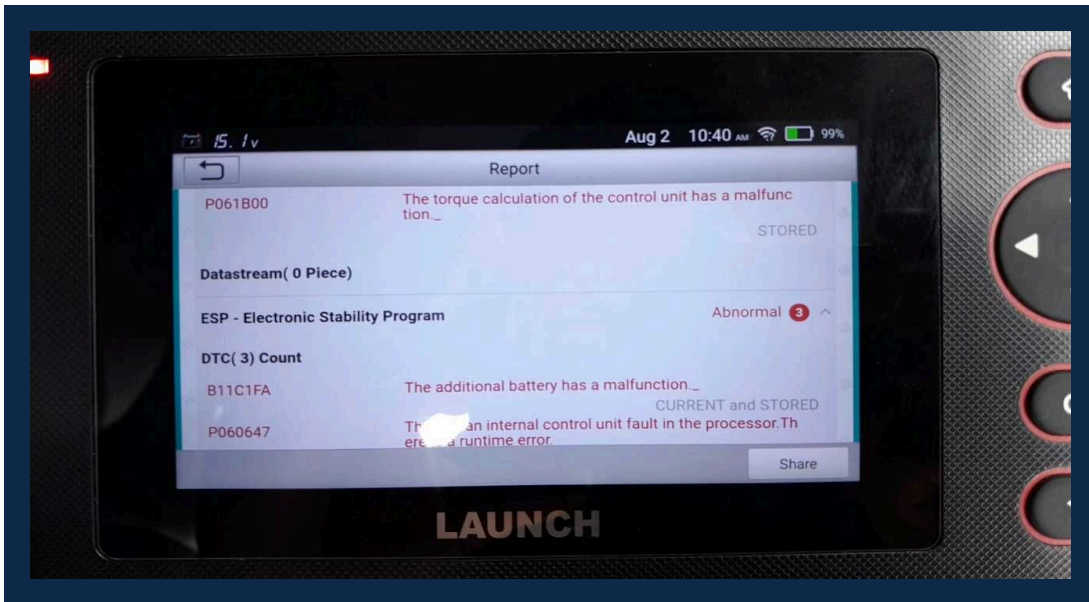
**OBD Vehicle Health Analysis**

**เครื่องยนต์(Engine) :** เครื่องยนต์ทำงานได้ปกติ ,วิเคราะห์ปัญหาด้วยเครื่อง OBDII พบสิ่งผิดปกติแนะนำตรวจเช็ค

แบตเตอรี่สำรองเสื่อมสภาพ เช็ค ด้วยเครื่อง OBDII พบโค้ด B11C1FA / P06047 / P061FF โค้ดทั้ง 3 ตัว หน้าจะเกิดจากแรงดันแบตเตอรี่สำรองต่ำ แนะนำตรวจเช็คโดยละเอียดอีกครั้ง

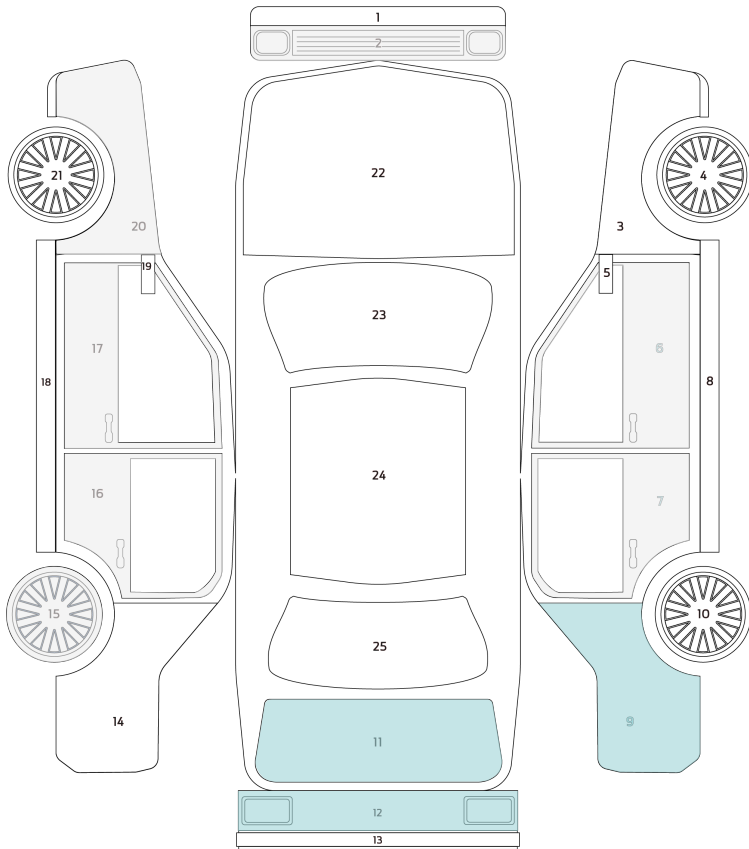
### Exterior Inspection Points

1. Front Skirt	O	14. Left Skirt	O
2. Front Bumper	O (S1)	15. Left Wing Mirror	O
3. Front Right Fender	O	16. Front Windshield	O
4. Front Right Wheel	O	17. Roof	O
5. Front Left Fender	O (S1)	18. Rear right fender	BP
6. Front Left Wheel	O	19. Rear Bonnet	BP
7. Front Bonnet	O	20. Back Right Wheel	O
8. Right Wing Mirror	O	21. Rear Bumper	BP
9. Front right door	O (S1)	22. Rear Skirt	O
10. Rear right door	O (S1)	23. Rear Left Fender	O
11. Right Skirt	O	24. Back left wheel	O (S1)
12. Rear Left door	O (S1)	25. Back Windshield	O
13. Front left door	O (S1)

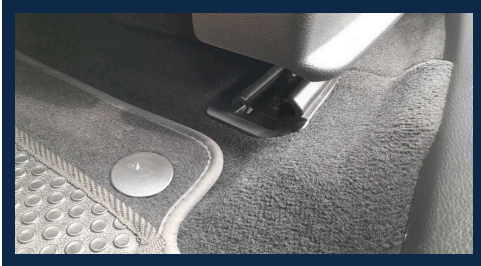
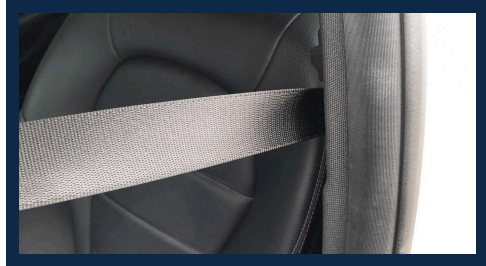
**Flood Report**

Evidence of Flood	No
-------------------	----

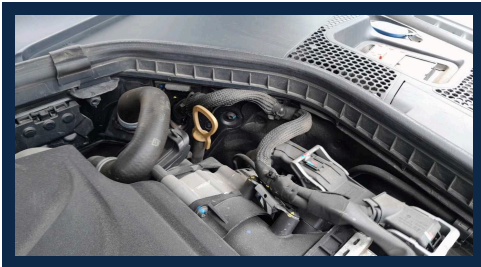
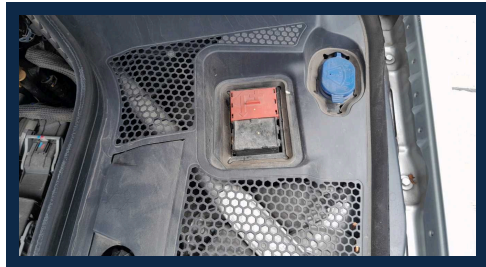
**Fire Report**

Evidence of Fire	No
------------------	----
