Preowned Vehicle Inspection Report

Premium Inspection Analysis

Customer Name : MERCEDES-BENZ MOBILITY (THAILAND) CO., LTD. Inspection Date : 2024-08-08
Tel. : Lemon Inspection ID : LEMON24080142
Inspector : แทนรัก ทิพย์อินทร์ Approved By : ไซยมงคล ไพรเสียง

Brand	MERCEDES BENZ	Model year	2021
Model	A200	Engine Code - No.	28291430554008
Sub-model	Progressive	Registration year	2021-09-13
Registration No.		Chassis No.	W1K1771876L001947
Current Mileage(km.)	125113	Engine Capacity(cc.)	1300

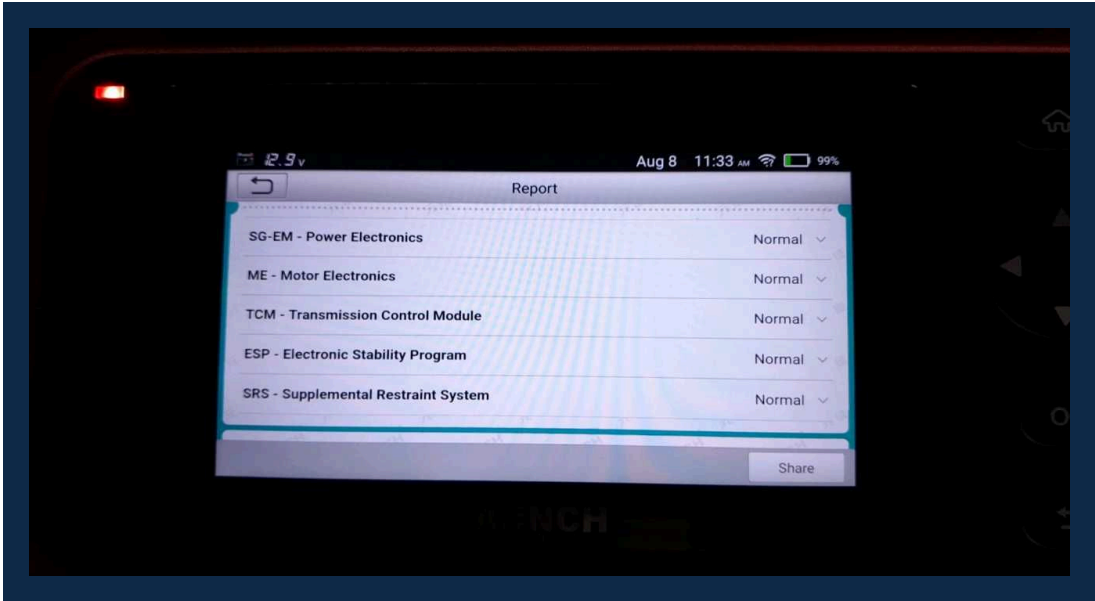
OBD Vehicle Health Analysis

Inspector : ภายนอก(Exterior) : การตรวจสภาพภายนอกโดยรวมไม่พบหลักฐานการซ่อมแซมทำสี รื้อรอยขีดข่วน ถลอกรอบคัน / สภาพยางปกติทั้ง4เส้น ปี 23 ภายใน(Interior) : ภายในปกติ สะอาดเรียบร้อย , อุปกรณ์ไฟฟ้า แอร์ วิทยุFM ใช้งานได้สมบูรณ์ครบปกติ เครื่องยนต์(Engine) : เครื่องยนต์ทำงานได้ปกติ , วิเคราะห์ปัญหาด้วยเครื่อง OBDII ไม่พบสิ่งผิดปกติ (ไม่ได้ทดสอบขับเคลื่อน) โครงสร้าง(Frame) : อุบัติเหตุไม่มี , โครงสร้างหลักปกติ ไม่มีการซ่อมแซม โครงสร้างหรือมีการชนถึงโครงสร้าง

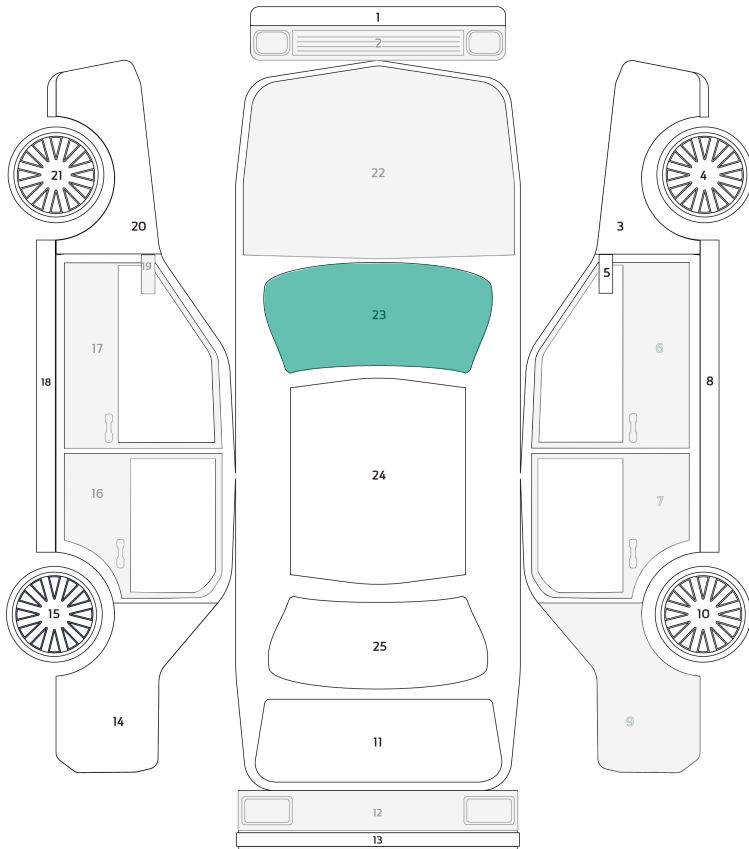
Exterior Inspection Points

1. Front Skirt	O	14. Left Skirt	O
2. Front Bumper	O (S2)	15. Left wing mirror	O (S1)
3. Front Right Fender	O	16. Front windshield	N
4. Front Right Wheel	O	17. Roof	O
5. Front Left Fender	O	18. Rear right fender	O (S1)
6. Front Left Wheel	O	19. Rear Bonnet	O
7. Front bonnet	O (S1)	20. Back Right Wheel	O
8. Right Wing Mirror	O	21. Rear Bumper	O (S1)
9. Front right door	O (S2)	22. Rear Skirt	O
10. Rear right door	O (S1)	23. Rear Left Fender	O
11. Right Skirt	O	24. Back Left Wheel	O
12. Rear Left door	O (D1)	25. Back Windshield	O
13. Front left door	O (S1)
