# Preowned Vehicle Inspection Report

Premium Inspection Analysis

**Inspector Note****Vehicle :** MERCEDES BENZ GLC43**Chassis number :** WDC2533646L019940**Inspection date :** 2024-08-06

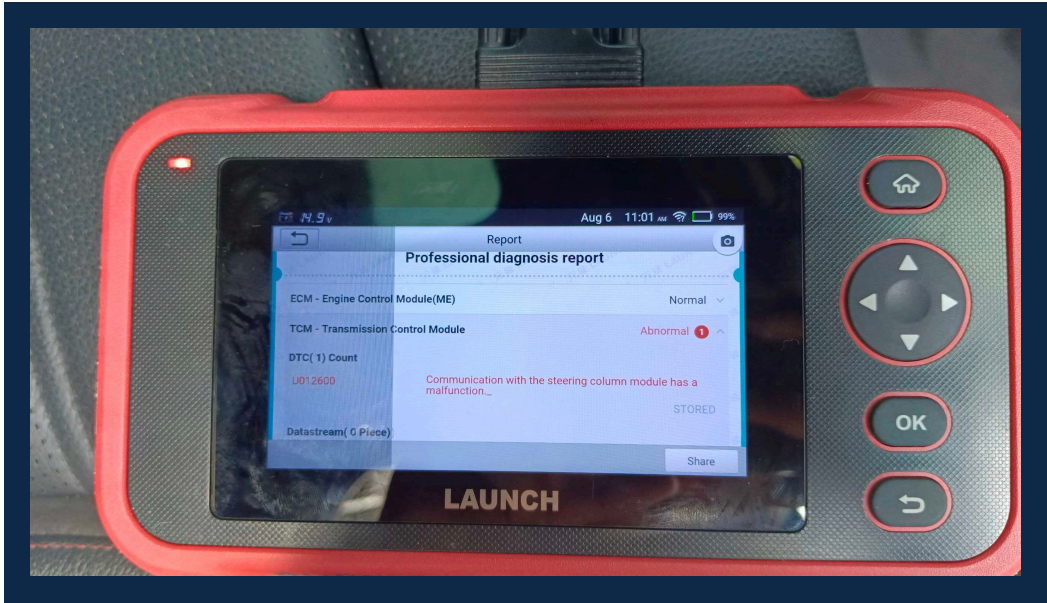
**OBD Vehicle Health Analysis**

**Inspector :** ภายนอก(Exterior) : การตรวจสอบสภาพภายนอกโดยรวมไม่พบหลักฐานการซ่อมแซมทำสี /พบกันชนหน้า ถลอก/กันชนหลังถลอก/ล้อแม็กหลังซ้ายถลอก/ สภาพยางปกติทั้ง4เส้น ปี23 ภายใน(Interior) : ภายในปกติ สะอาด เรียบร้อย ,อุปกรณ์ไฟฟ้า แอร์ ใช้งานได้/วิทยุไม่ทำงาน/เบาะหน้าซ้ายมีคราบสีเหลือง เครื่องยนต์(Engine) : เครื่องยนต์ ทำงานได้ปกติ ,วิเคราะห์ปัญหาด้วยเครื่อง OBDII พบสิ่งผิดปกติ แนะนำเข้าตรวจเช็คที่ศูนย์บริการ(ไม่ได้ทดสอบขับ) โครงสร้าง(Frame) : อุบัติเหตุไม่มี ,โครงสร้างหลักปกติ ไม่มีการซ่อมแซมโครงสร้างหรือมีการชนถึงโครงสร้าง หมย เหตุ หน้าปิดรีนโมล์ไม่มีไฟโชว์ เช็คด้วยเครื่อง opd2 พบโค้ด B012600 เกี่ยวกับสัญญาณโมดูลตรงคอปวงมาลัย มา จากอุณหภูมิและความชื้นภายในรถทำให้สัญญาณผิดปกติ แนะนำตรวจเช็คให้ละเอียดอีกครั้ง

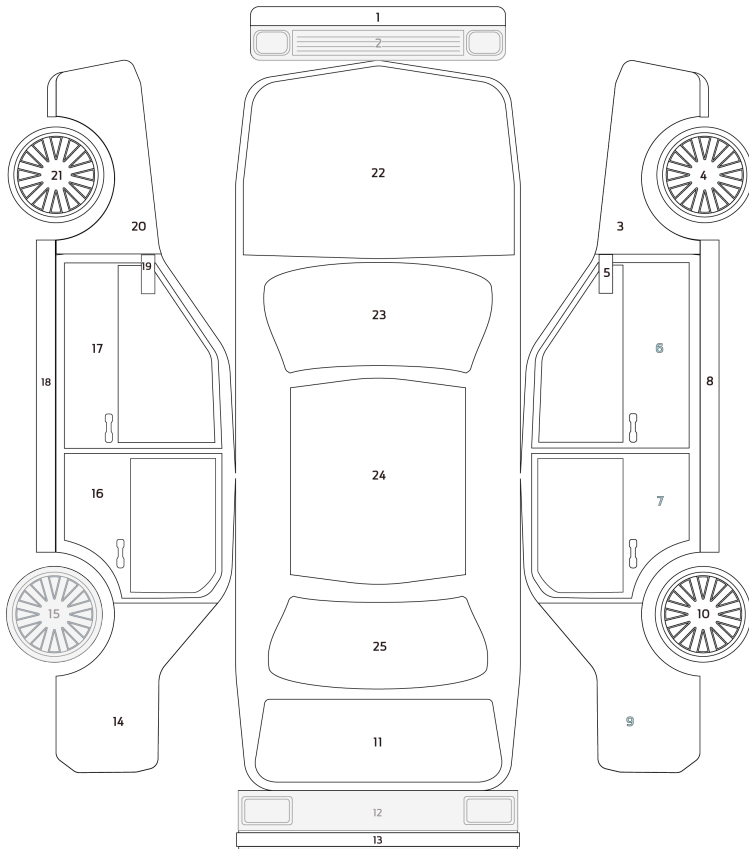
### Exterior Inspection Points

1. Front Skirt	O	14. Left Skirt	O
2. Front Bumper	O (S1)	15. Left Wing Mirror	O
3. Front Right Fender	O	16. Front Windshield	O
4. Front Right Wheel	O	17. Roof	O
5. Front Left Fender	O	18. Rear Right Fender	O
6. Front Left Wheel	O	19. Rear Bonnet	O
7. Front Bonnet	O	20. Back Right Wheel	O
8. Right Wing Mirror	O	21. Rear Bumper	O (S1)
9. Front Right Door	O	22. Rear Skirt	O
10. Rear Right Door	O	23. Rear Left Fender	O
11. Right Skirt	O	24. Back left wheel	O (S2)
12. Rear Left Door	O	25. Back Windshield	O
13. Front Left Door	O
