Preowned Vehicle Inspection Report

Premium Inspection Analysis

Vehicle : MERCEDES BENZ E350

Inspection date : 2024-08-26

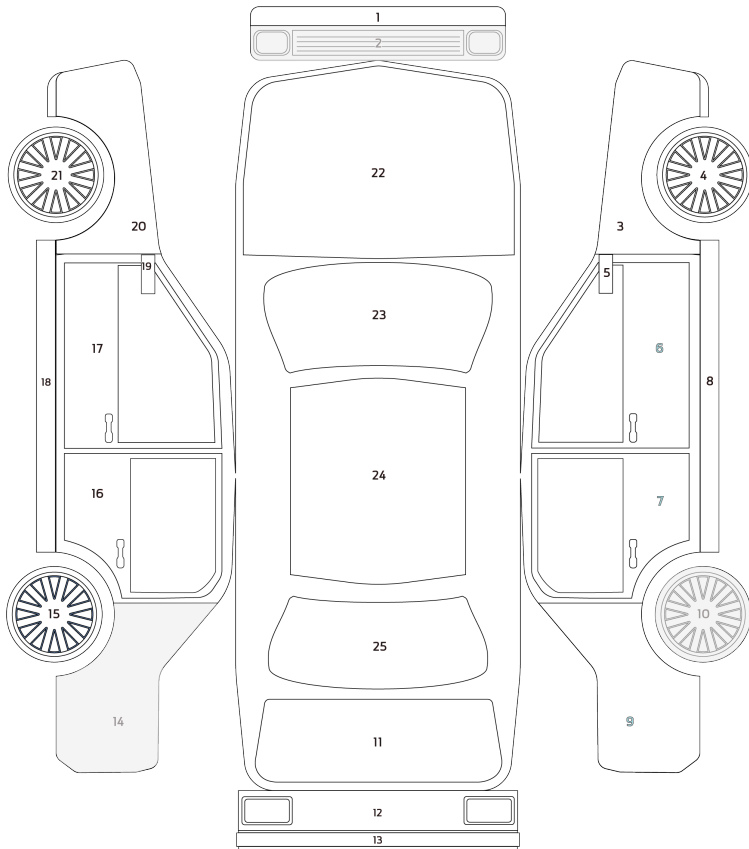
Exterior Inspection Points

1. Front Skirt	O	14. Left Skirt	O
2. Front Bumper	O (S1)	15. Left Wing Mirror	O
3. Front Right Fender	O	16. Front Windshield	O
4. Front Right Wheel	O	17. Roof	O
5. Front Left Fender	O	18. Rear Right Fender	O
6. Front Left Wheel	O	19. Rear Bonnet	O
7. Front Bonnet	O	20. Back right wheel	O (S2)
8. Right Wing Mirror	O	21. Rear Bumper	O
9. Front Right Door	O	22. Rear Skirt	O
10. Rear Right Door	O	23. Rear left fender	O (S1)
11. Right Skirt	O	24. Back Left Wheel	O
12. Rear Left Door	O	25. Back Windshield	O
13. Front Left Door	O

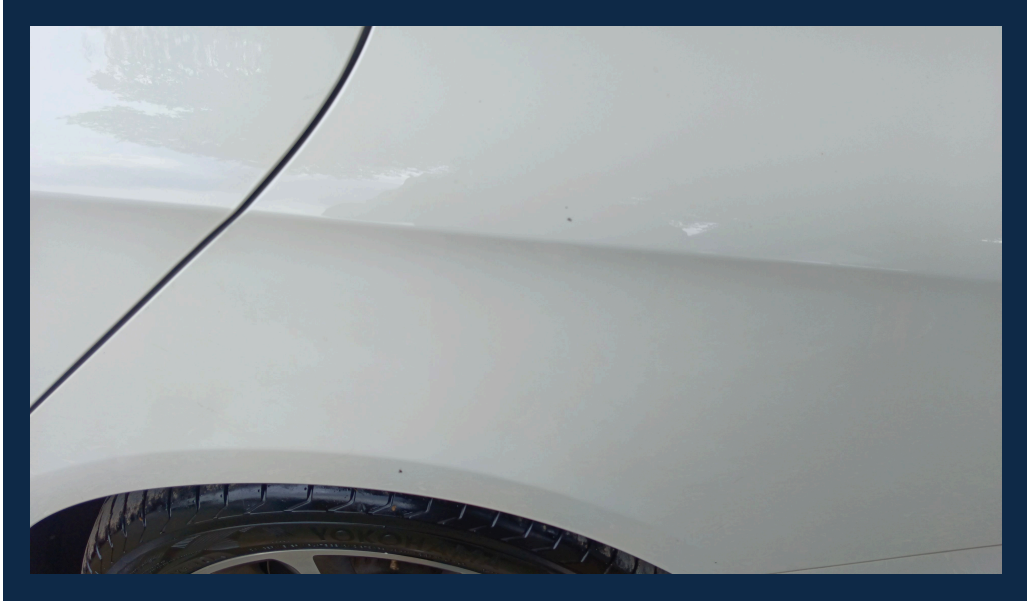
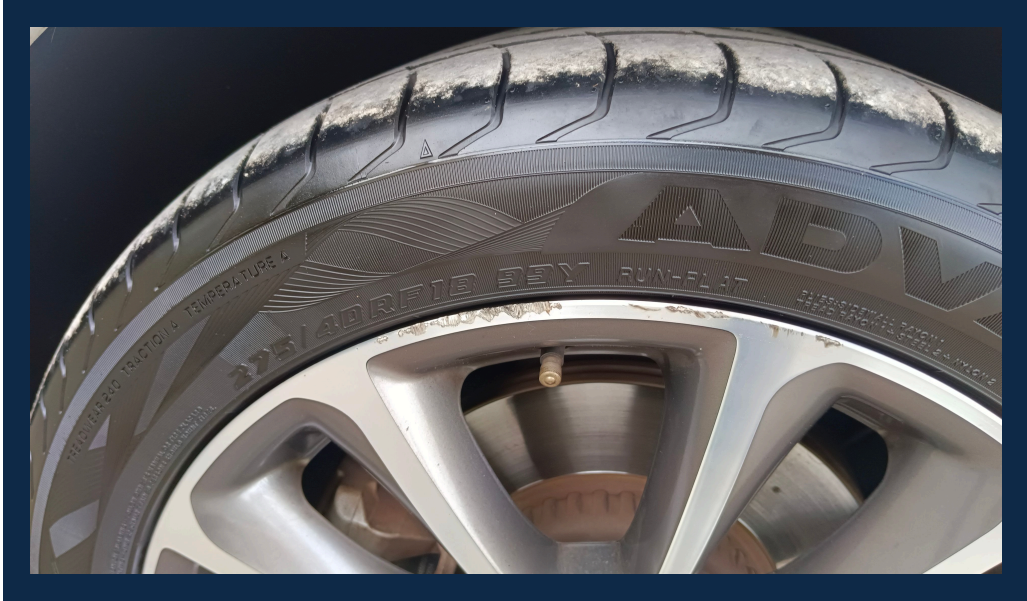
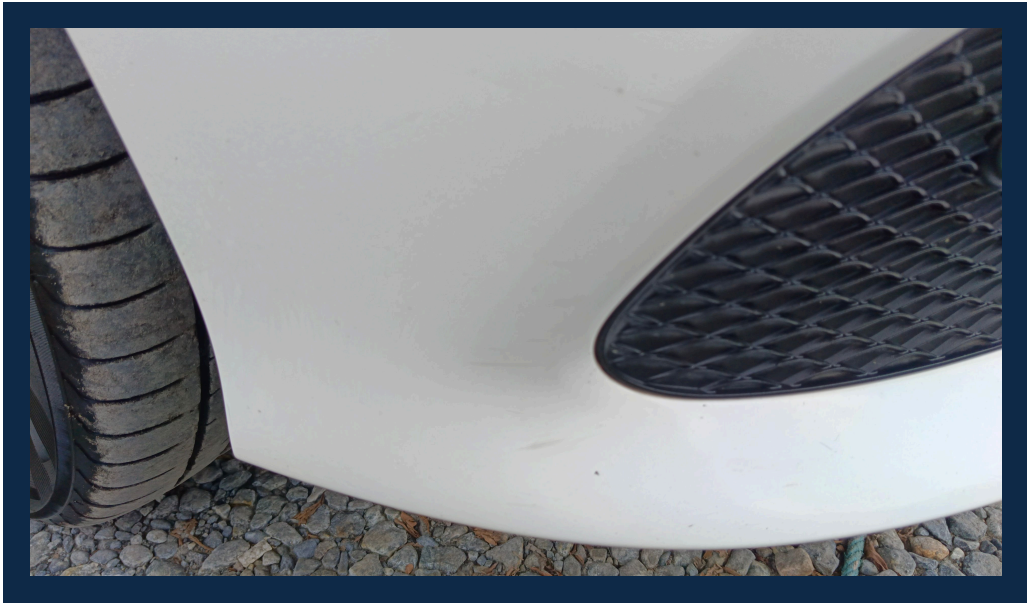
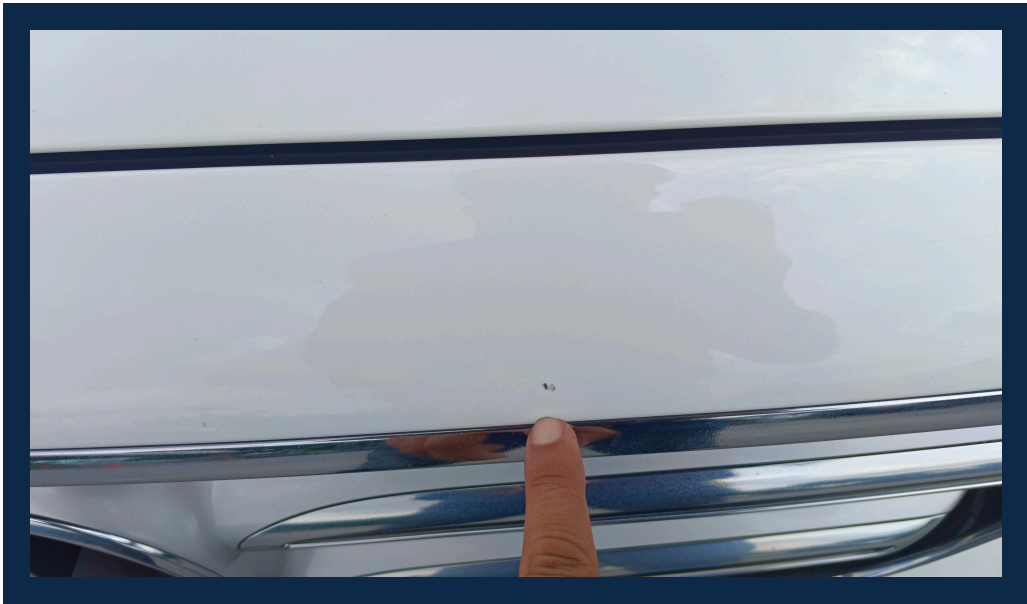
Vehicle Defect Notices

Inspector : ภายนอก(Exterior) : การตรวจสภาพภายนอกโดยรวมไม่พบหลักฐานการซ่อมแซมทำสี /พบกันชนหน้ามีรอยขีดข่วน/พบกระจกหน้ามีรอยขีดข่วน/พบล้อแม็กหลังขูดลอก/ สภาพยางปกติทั้ง4เส้น ปี23 ภายใน(Interior) : ภายในปกติ สะอาดเรียบร้อย/พบเบาะนั่งหน้าซ้ายขวาขอบเบาะล่อน ,อุปกรณ์ไฟฟ้า แอร์ วิทยุFM ใช้งานได้สมบูรณ์ครบปกติ เครื่องยนต์(Engine) : เครื่องยนต์ทำงานได้ปกติ ,วิเคราะห์ปัญหาด้วยเครื่อง OBDII ไม่พบสิ่งผิดปกติ (ไม่ได้ทดสอบขับ) โครงสร้าง(Frame) : อุบัติเหตุไม่มี ,โครงสร้างหลักปกติ ไม่มีการซ่อมแซมโครงสร้างหรือมีการชนถึงโครงสร้าง
