Preowned Vehicle Inspection Report

Premium Inspection Analysis

Customer Name : MERCEDES-BENZ MOBILITY (THAILAND) CO., LTD. Inspection Date : 2024-08-30
Tel. : _____ Lemon Inspection ID : LEMON24080373
Inspector : อนุรัก ทัพย์อินทร์ Approved By : Sakulpong S

Brand	MERCEDES BENZ	Model year	2019
Model	C200	Engine Code - No.	26491530107084
Sub-model	COUPE AMG DYNAMIC	Registration year	2020-02-05
License Plate		Chassis No.	WDD2053776L048536
Current Mileage(km.)	58081	Engine Capacity(cc.)	1500

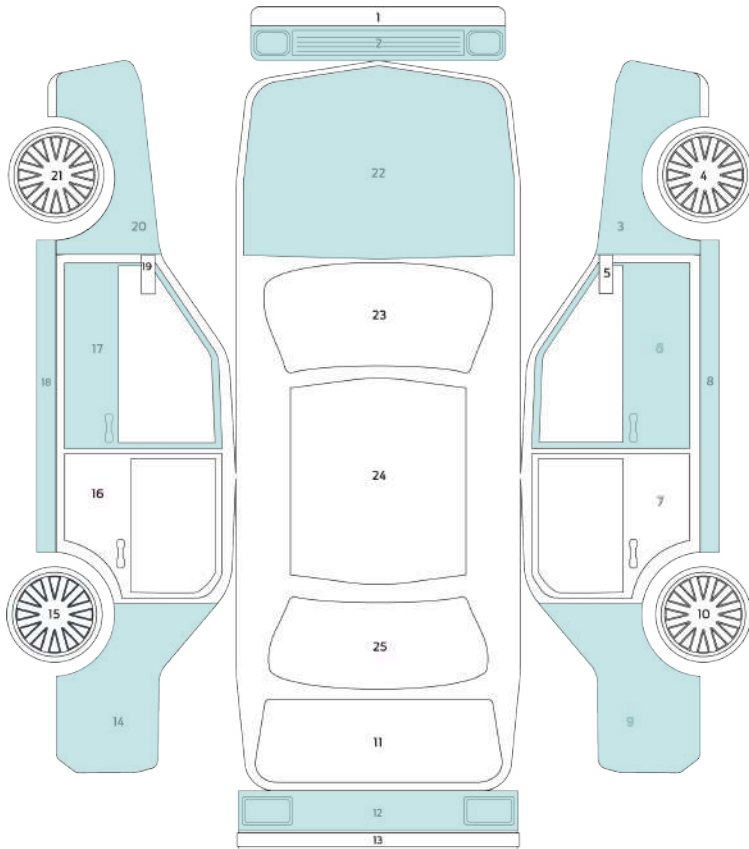
Exterior Inspection Points

1. Front Skirt	O	14. Left skirt	BP
2. Front Bumper	BP	15. Left Wing Mirror	O
3. Front Right Fender	BP	16. Front Windshield	O
4. Front Right Wheel	O	17. Roof	O
5. Front Left Fender	BP	18. Rear right fender	BP
6. Front Left Wheel	O	19. Rear Bonnet	O
7. Front bonnet	BP	20. Back Right Wheel	O
8. Right Wing Mirror	O	21. Rear Bumper	BP
9. Front right door	BP	22. Rear Skirt	O
10. Rear Right Door	O	23. Rear left fender	BP
11. Right Skirt	BP	24. Back Left Wheel	O
12. Rear Left Door	O	25. Back Windshield	O
13. Front left door	BP

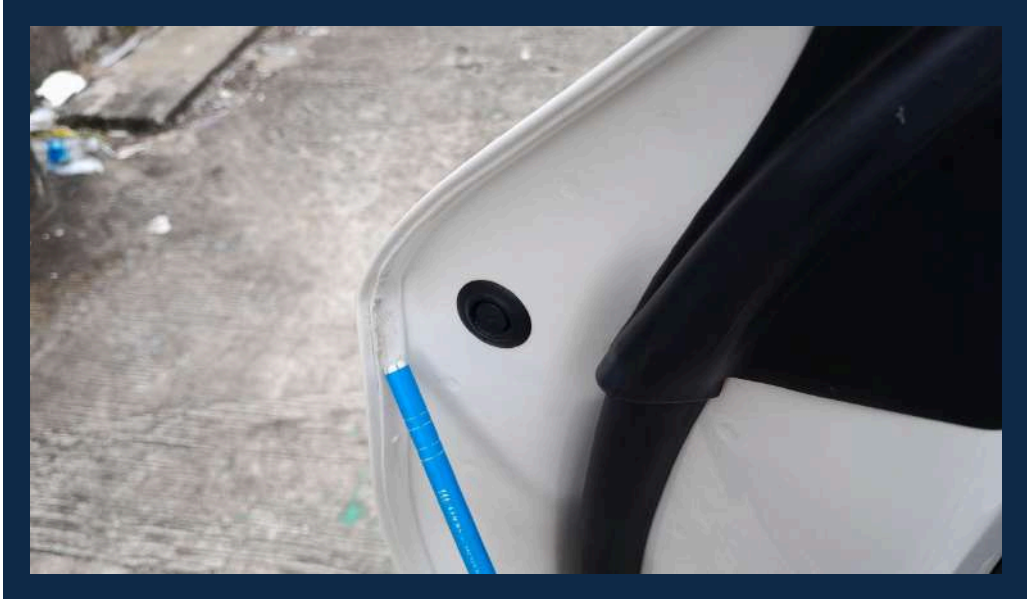
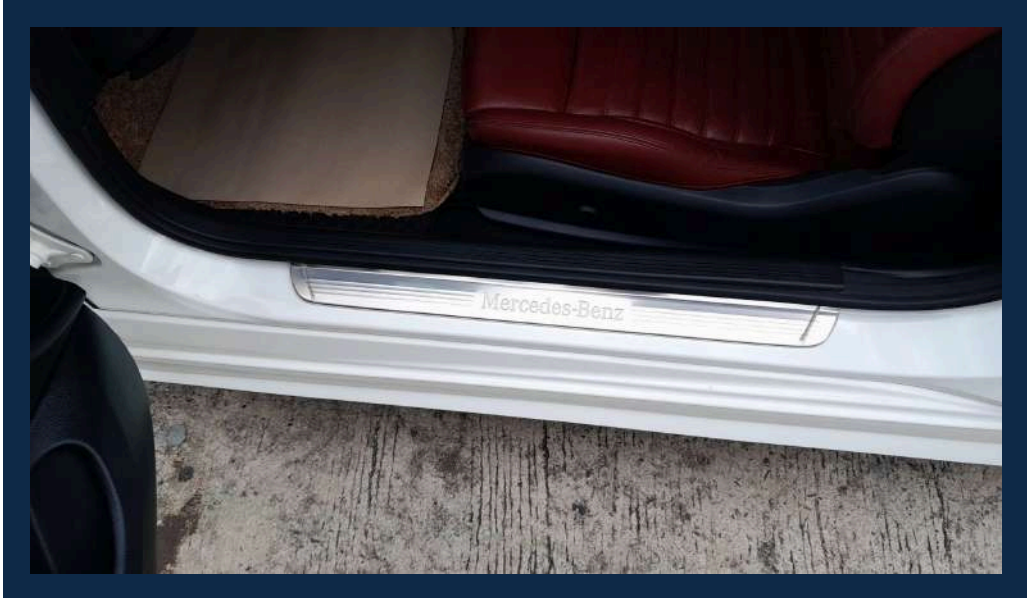
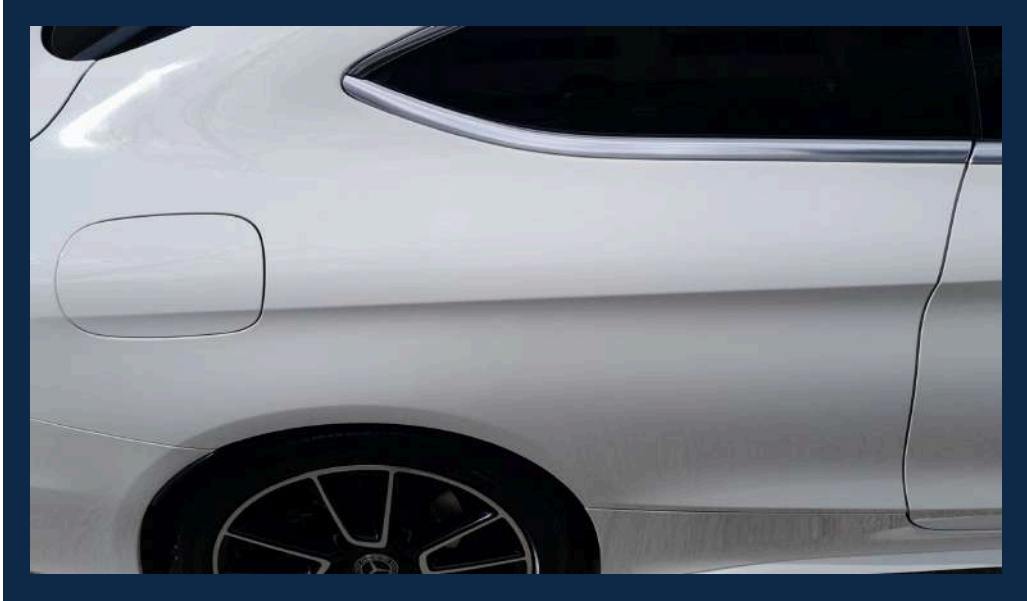
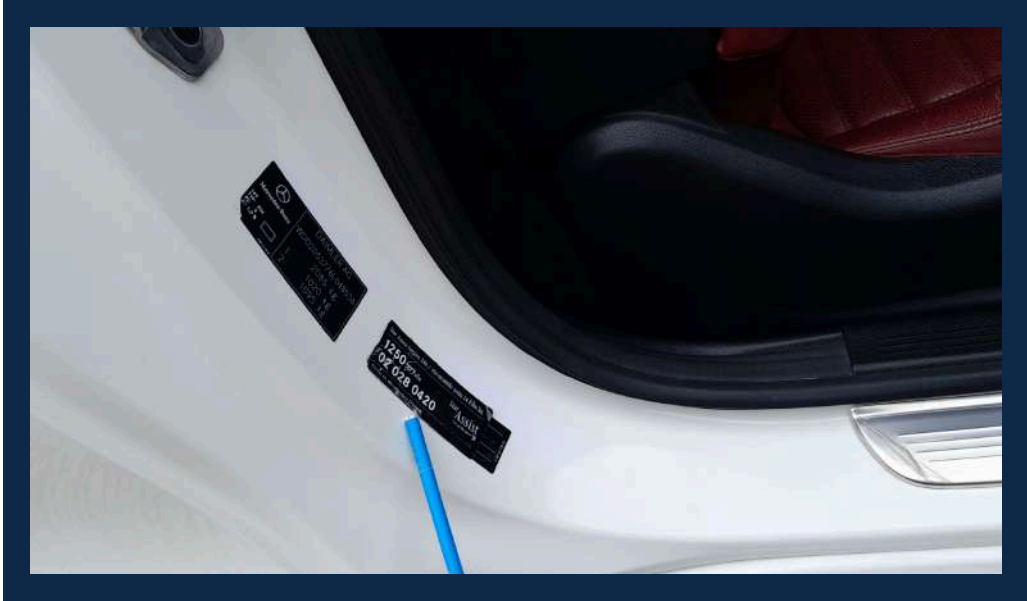
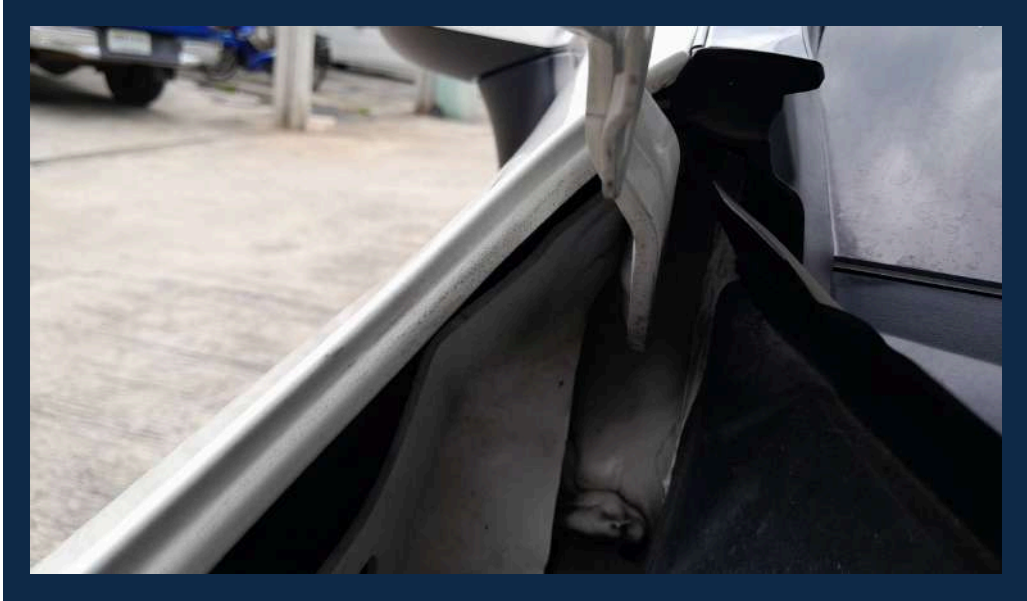
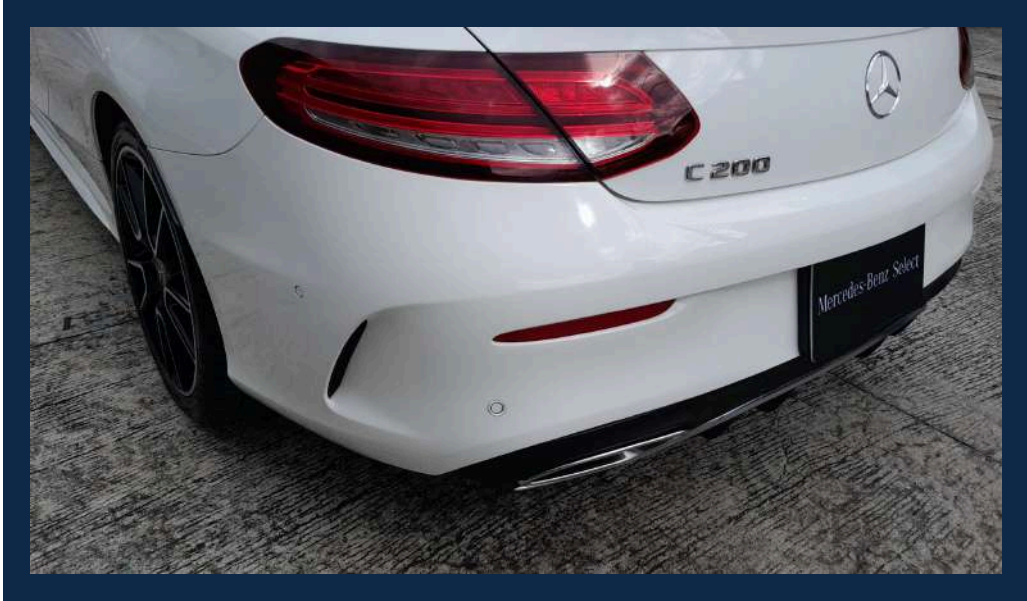
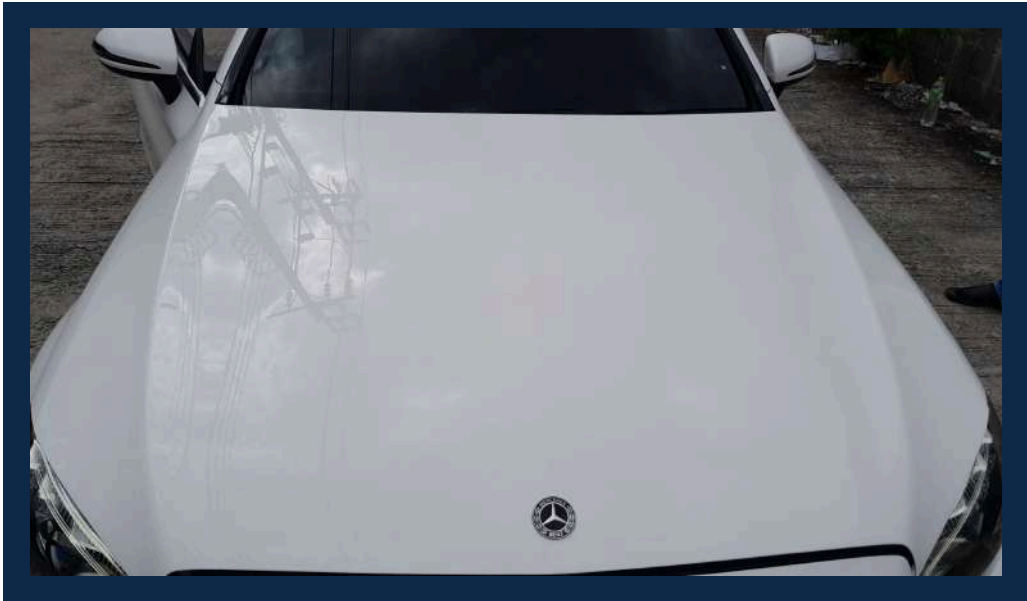
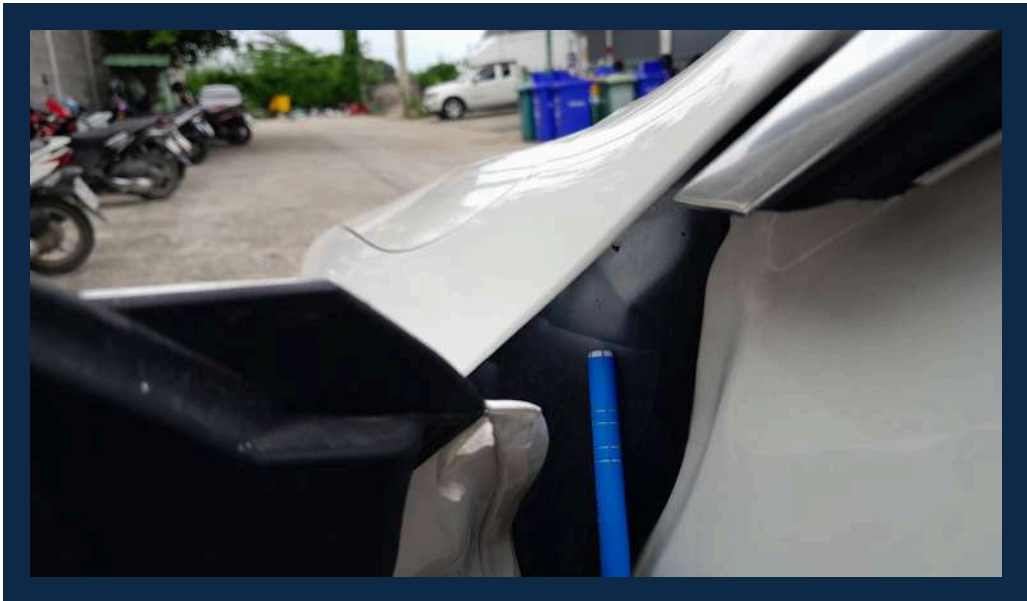
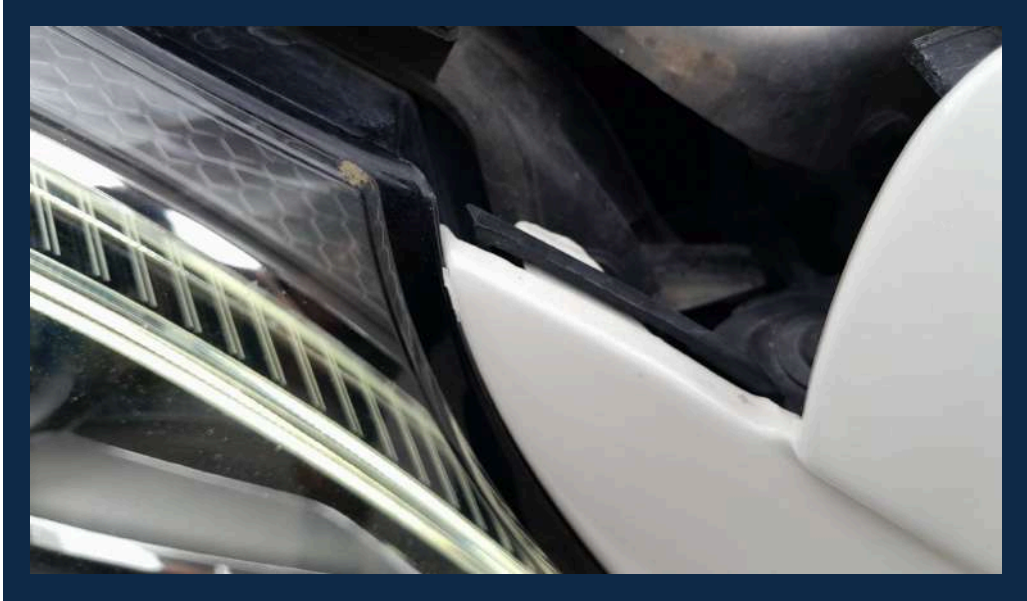
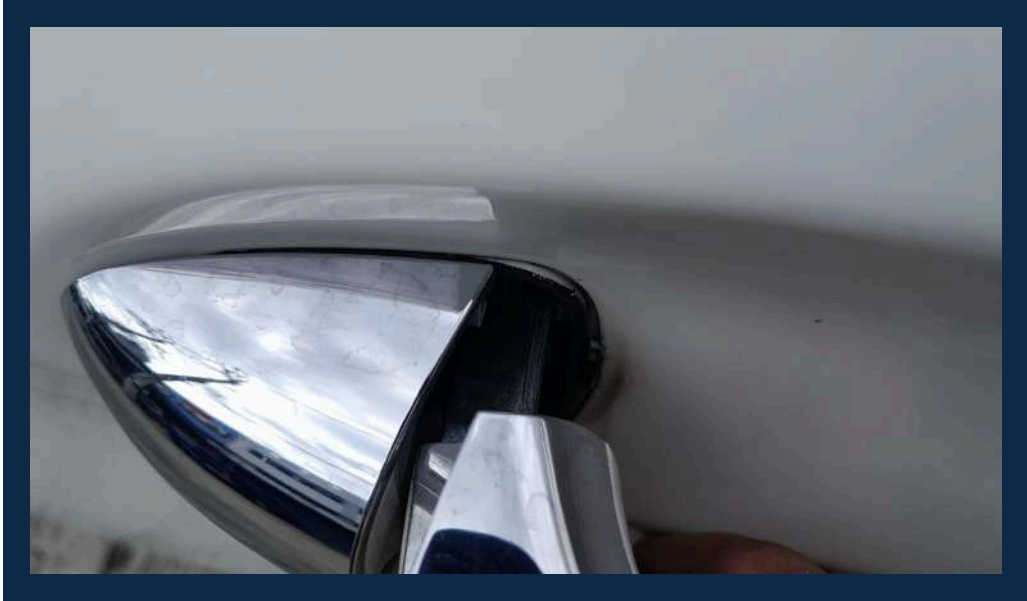
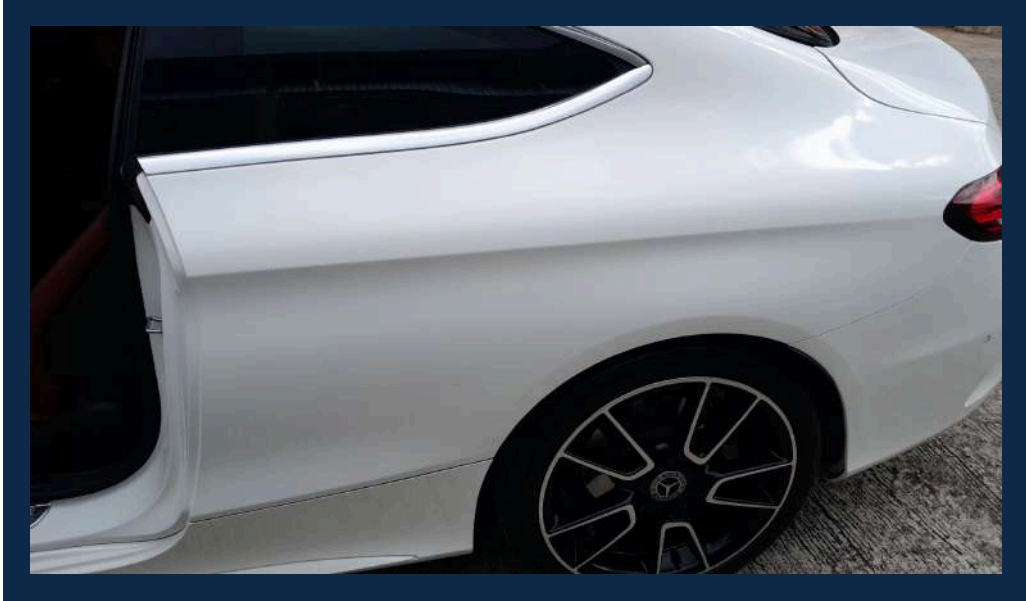
Vehicle Defect Notices

Inspector : ภายนอก(Exterior) : การตรวจสภาพภายนอกโดยรวมพบหลักฐานการซ่อมแซมทำสีรอบคัน / สภาพยางคู่น้ำปกติปี23 ยางหลังซ้ายปกติปี24 ยางหลังขวาเสื่อมสภาพปี19 ล้อหน้าซ้ายมีรอยถลอก ภายใน(Interior) : ภายในปกติ สะอาดเรียบร้อย ,อุปกรณ์ไฟฟ้า แอร์ วิทยุFM ใช้งานได้สมบูรณ์ครบปกติ เครื่องยนต์(Engine) : เครื่องยนต์ทำงานได้ปกติ ,วิเคราะห์ปัญหาด้วยเครื่อง OBDII ไม่พบสิ่งผิดปกติ (ไม่ได้ทดสอบขับขี) โครงสร้าง(Frame) : โครงสร้างหลักปกติ ไม่มีการซ่อมแซมโครงสร้างหรือมีการชนถึงโครงสร้าง / ชับในประตูหน้าขวาทำสี

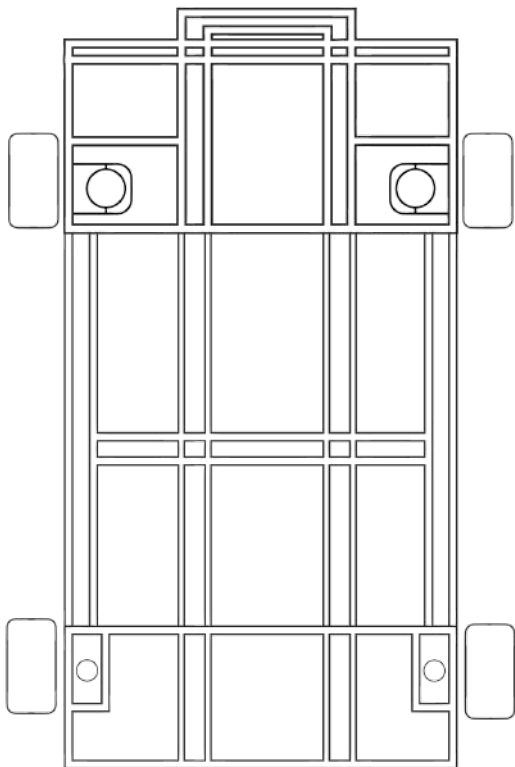
Chassis Report

No dent in the under carriage	PASS
No deform chassis or chassis frame	PASS
No visible corrosion on the chassis or chassis frame	PASS
No missing part on the chassis frame	PASS
Half cut Analysis	PASS

Chassis Damage Level	no-damage
----------------------	-----------
