Preowned Vehicle Inspection Report

Premium Inspection Analysis

Customer Name : MERCEDES-BENZ MOBILITY (THAILAND) CO., LTD. Inspection Date : 2024-09-05
Tel. _____ Lemon Inspection ID : LEMON24090031
Inspector : เหนือรัก ทิพย์อินทร์ Approved By : ชัยมงคล โพธิ์เสียง

Brand	MERCEDES BENZ	Model year	2019
Model	E53	Engine Code - No.	25693030078582
Sub-model	AMG DYNAMIC PLUS	Registration year	2021-05-21
License Plate		Chassis No.	WDD2130616L029142
Current Mileage(km.)	33071	Engine Capacity(cc.)	3000

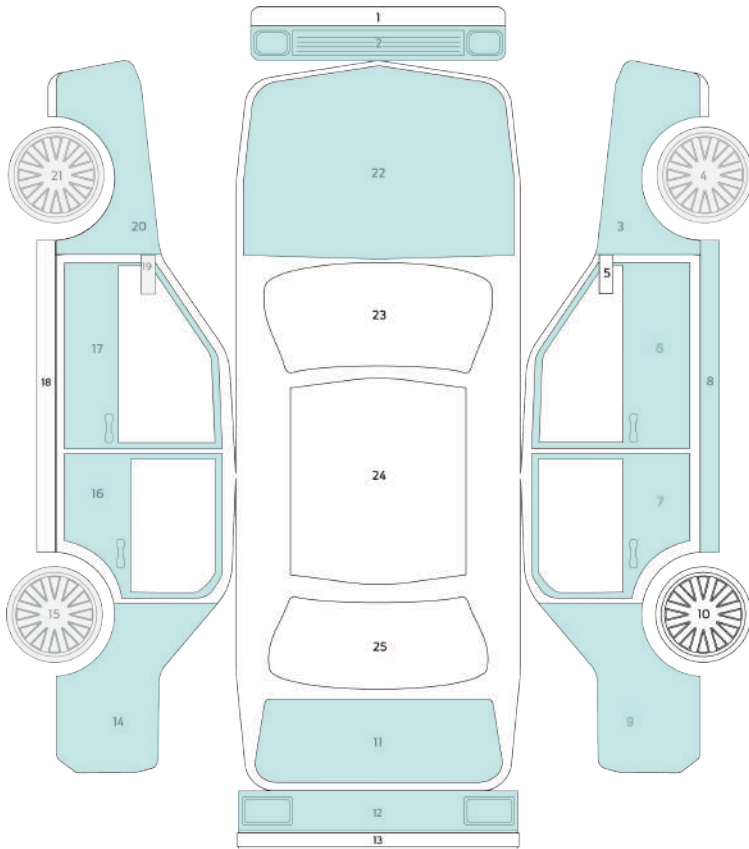
Exterior Inspection Points

1. Front Skirt	O	14. Left Skirt	O
2. Front Bumper	BP	15. Left wing mirror	O (S1)
3. Front Right Fender	BP	16. Front Windshield	O
4. Front Right Wheel	O (S1)	17. Roof	O
5. Front Left Fender	BP	18. Rear right fender	BP
6. Front Left Wheel	O (S1)	19. Rear Bonnet	BP
7. Front bonnet	BP	20. Back Right Wheel	O
8. Right Wing Mirror	O	21. Rear Bumper	BP
9. Front right door	BP	22. Rear Skirt	O
10. Rear right door	BP	23. Rear left fender	BP
11. Right Skirt	BP	24. Back left wheel	O (S1)
12. Rear Left door	BP (D1)	25. Back Windshield	O
13. Front left door	BP (S1)

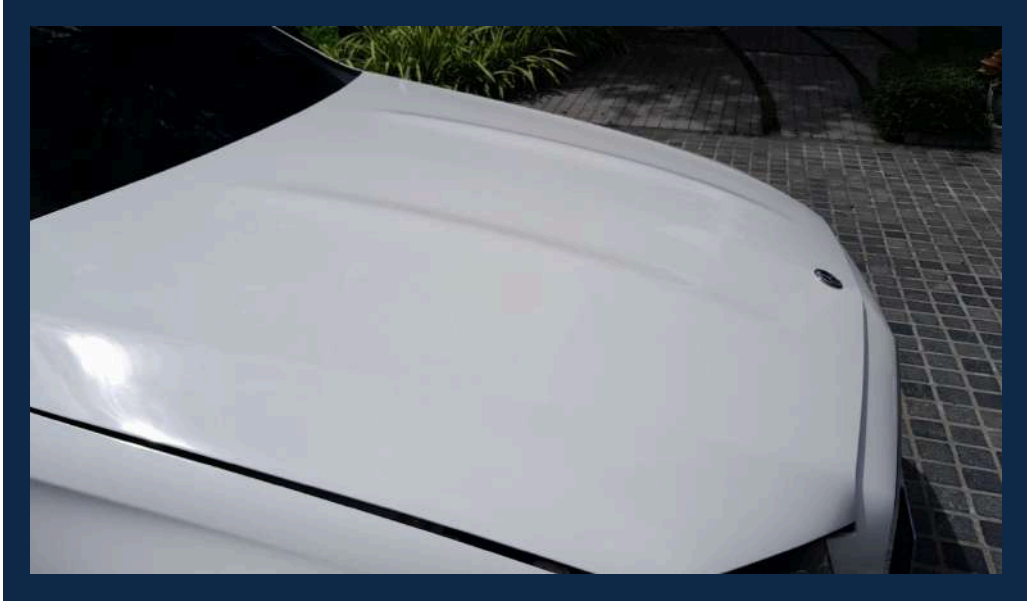
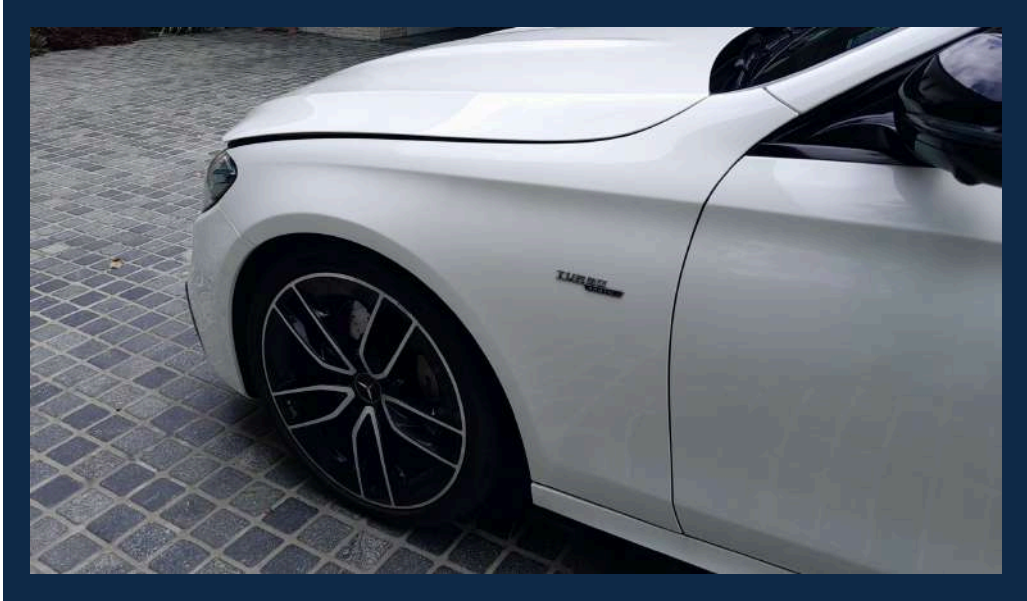
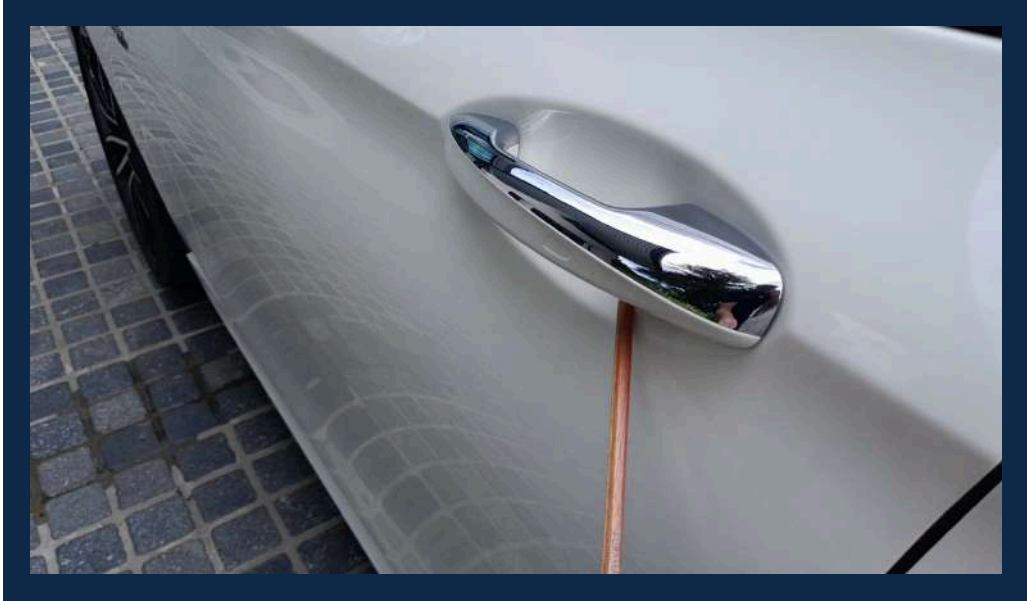
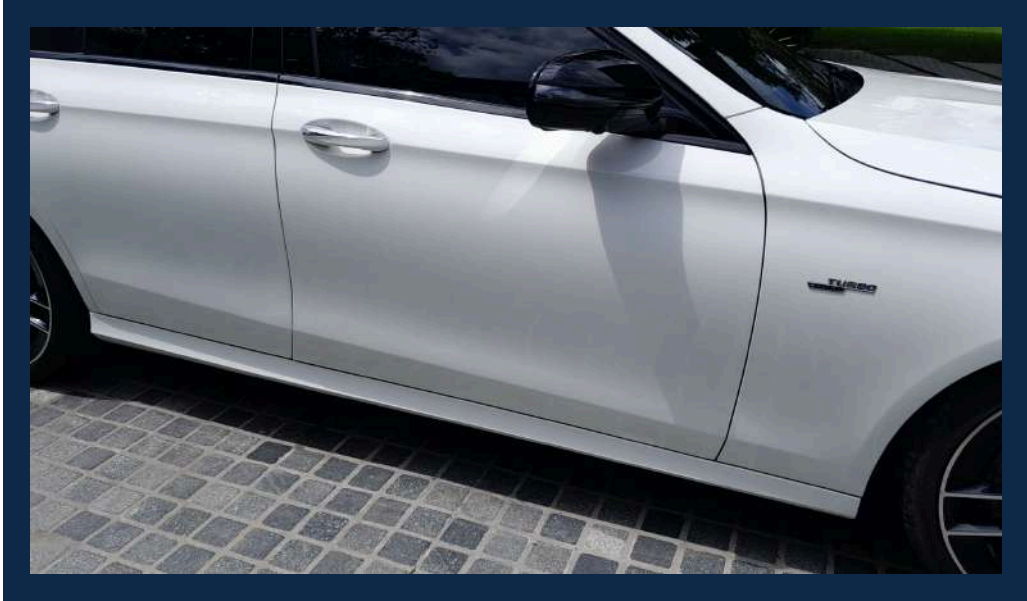
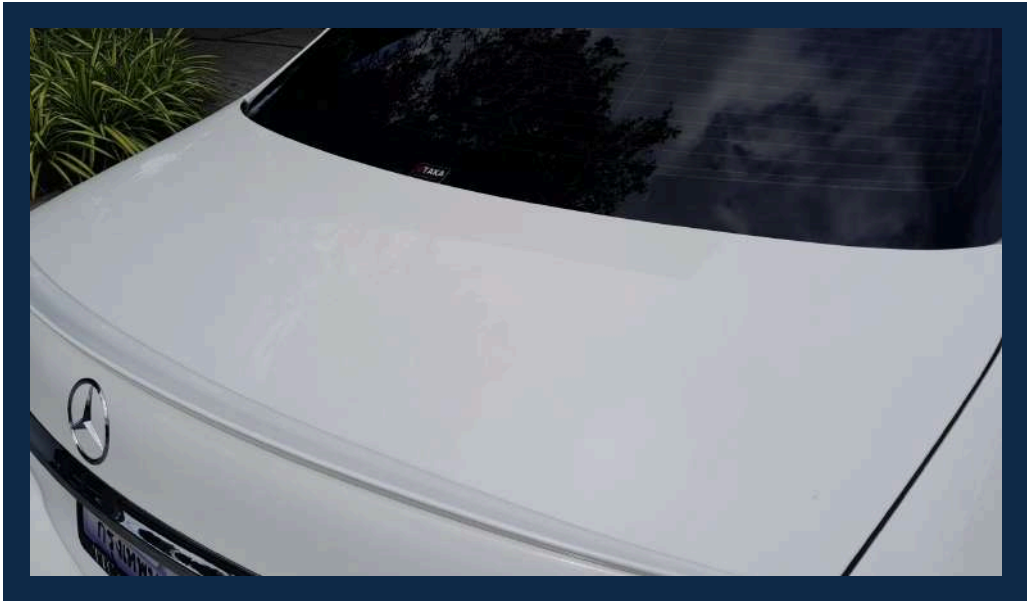
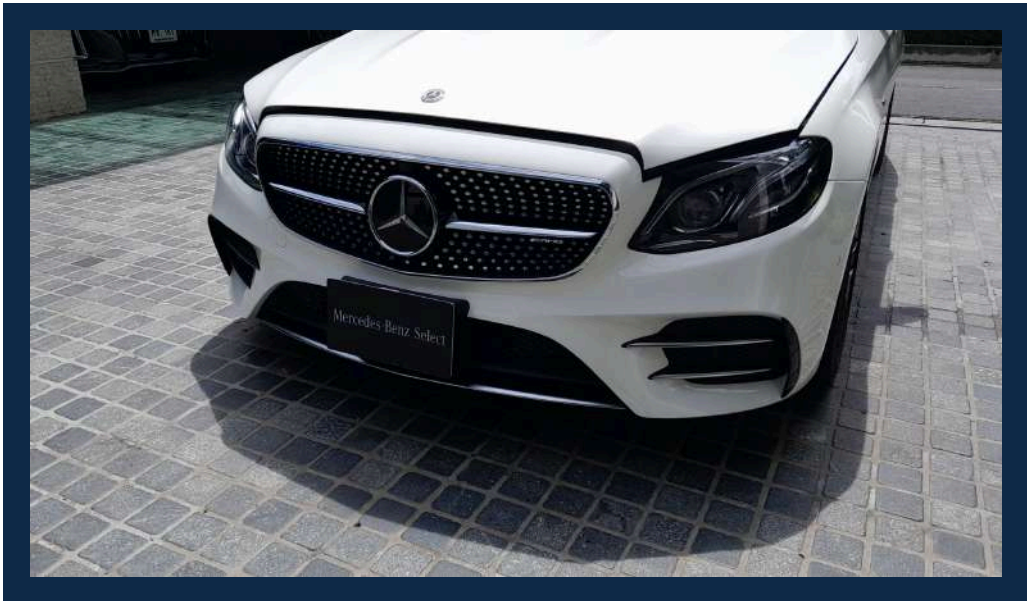
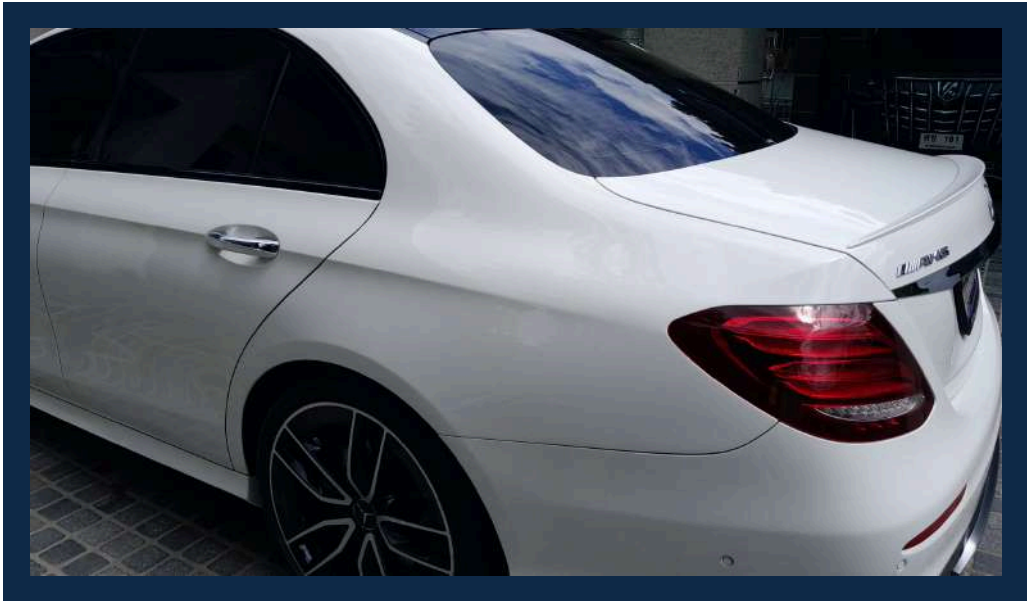
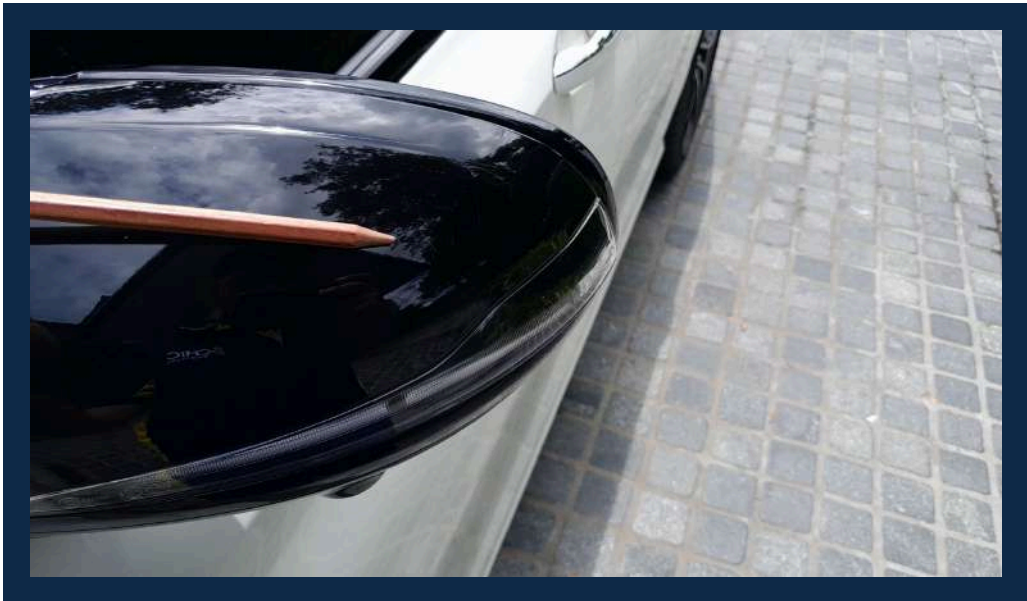
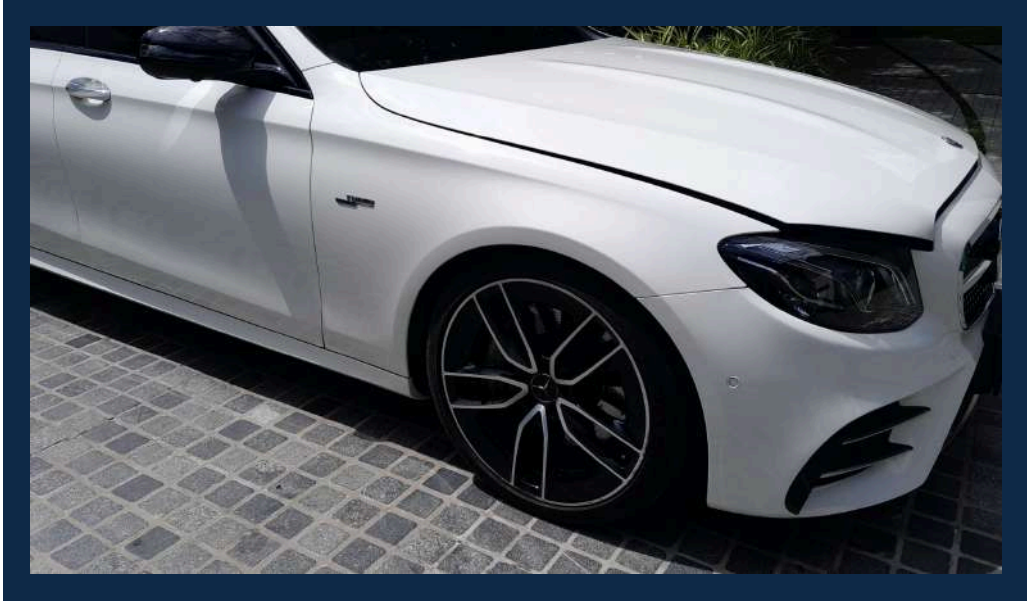
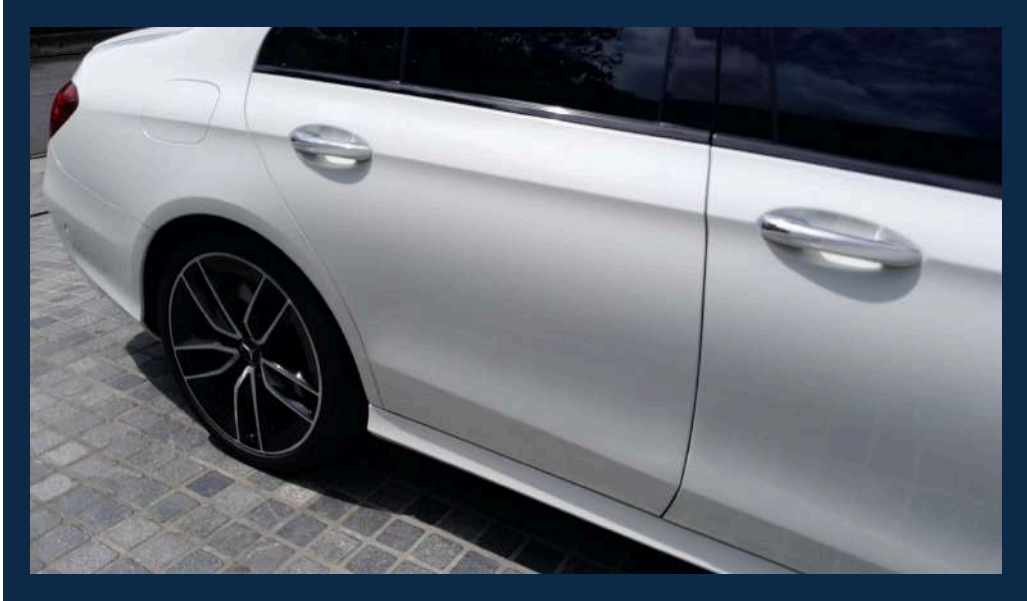
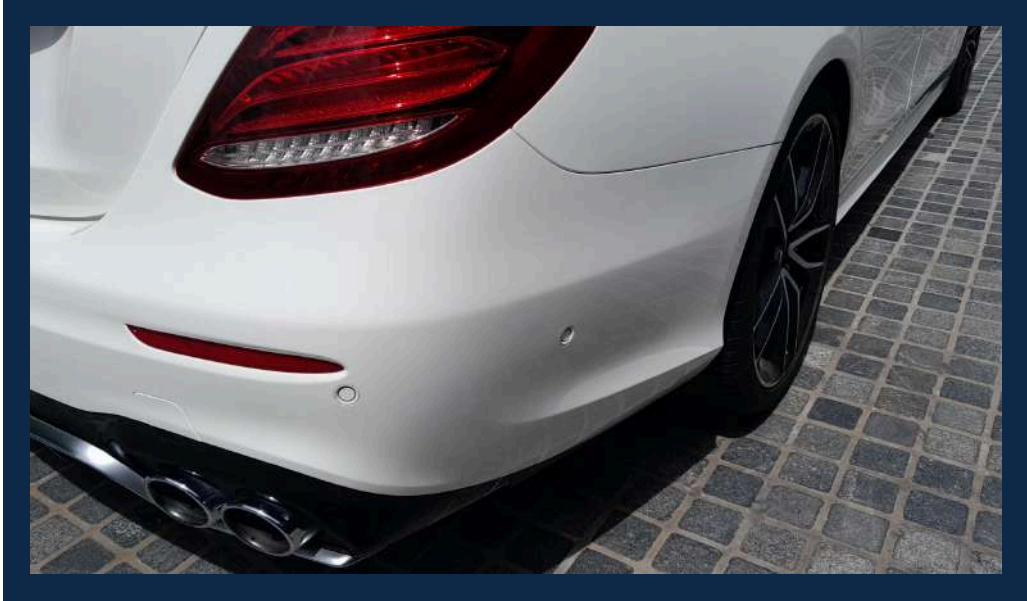
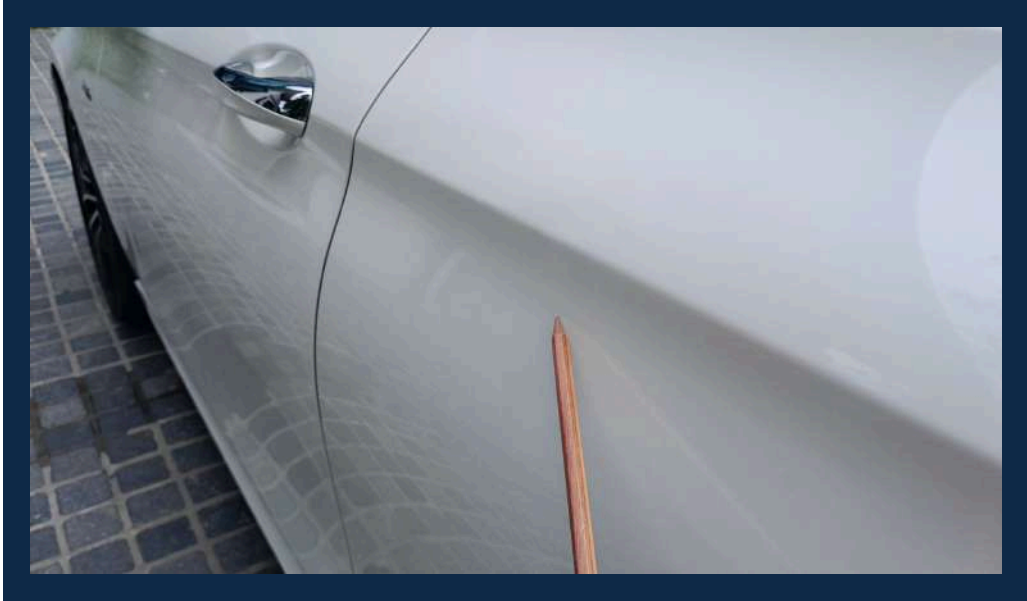
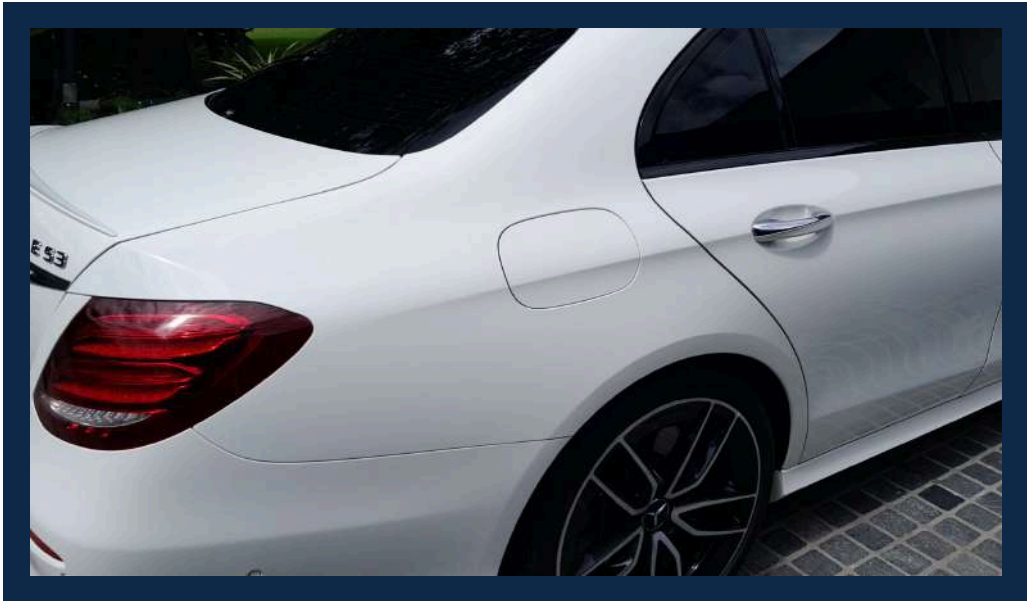
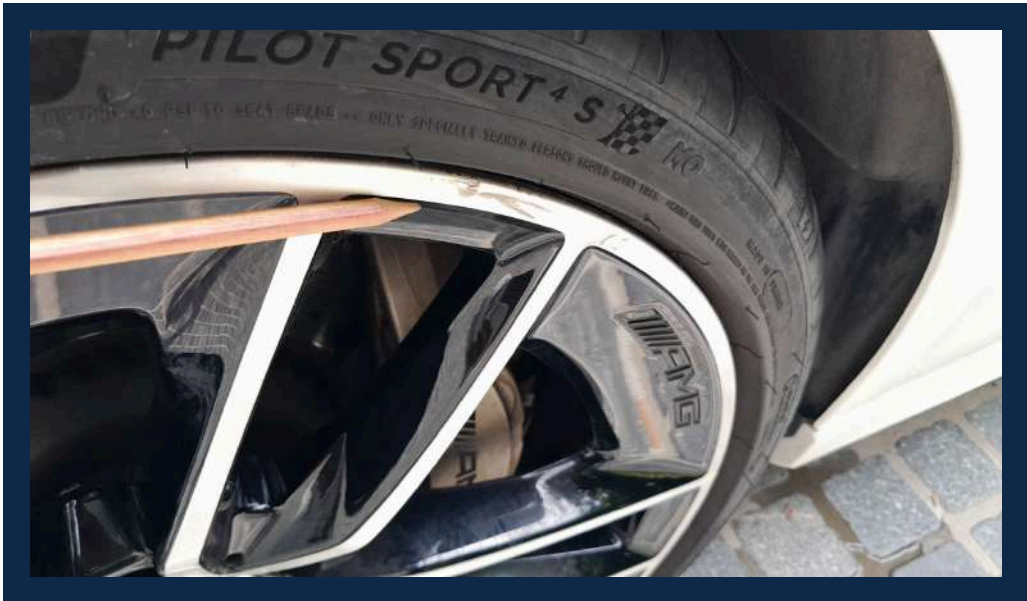
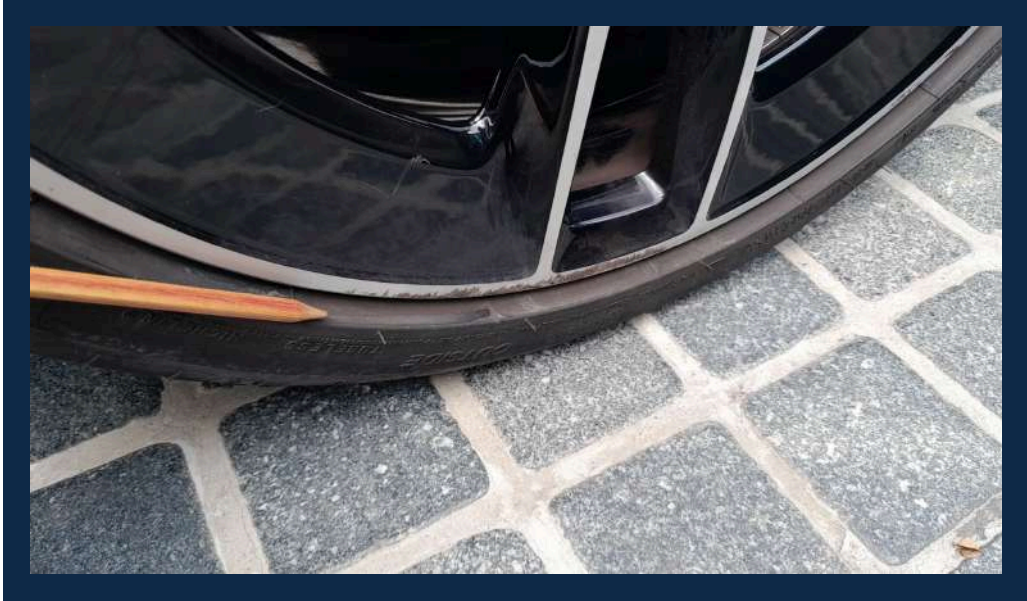
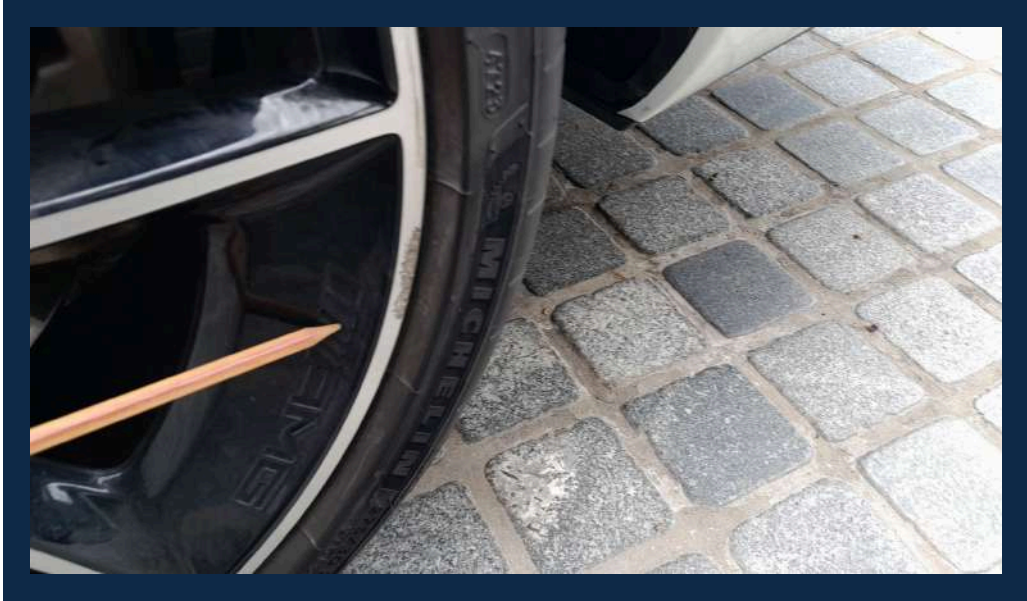
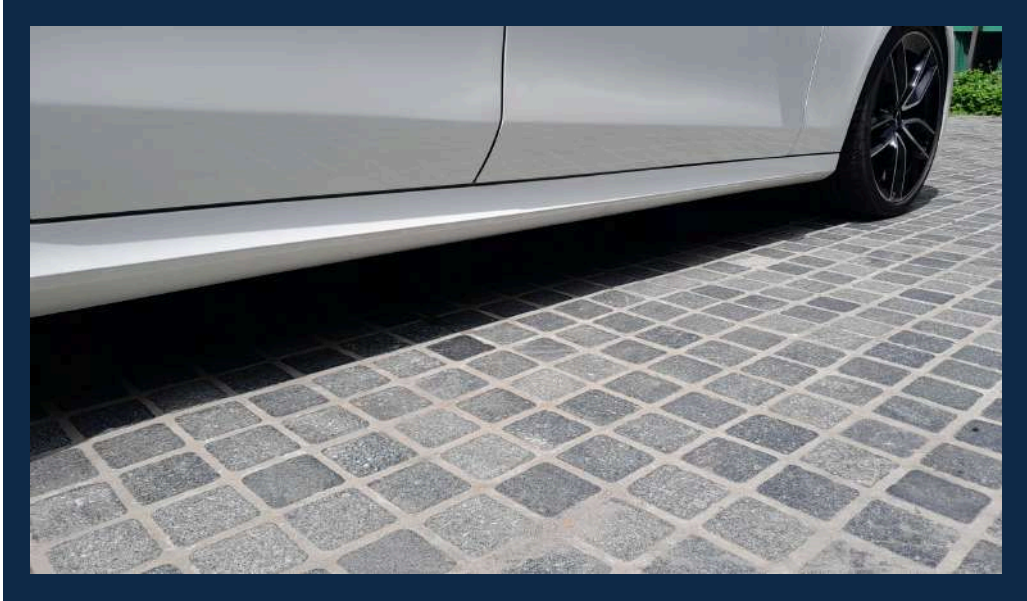
Vehicle Defect Notices

Inspector : ภายนอก(Exterior) : การตรวจสอบสภาพภายนอกโดยรวมพบหลักฐานการซ่อมแซมทำสีมารอบคัน ฝากระโปรงหน้าถอดทำสี ประตูหน้าขวาถอดทำสี / รั้วขีดข่วนและบุบเล็กน้อย / สภาพยางปกติทั้ง4เส้น ปี 23 / ล้อแม็กเป็นรอยถลอก ภายใน(Interior) : ภายใน พวงมาลัยเป็นคราบเข็มน , อุปกรณ์ไฟฟ้า แอร์ วิทยุFM ใช้งานได้สมบูรณ์ครบปกติ เครื่องยนต์(Engine) : - โครงสร้าง(Frame) : -

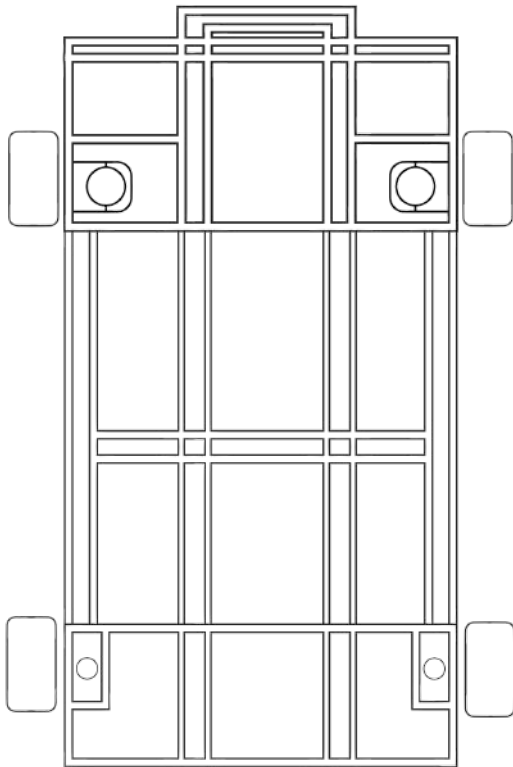
Chassis Report

No dent in the under carriage	PASS
No deform chassis or chassis frame	PASS
No visible corrosion on the chassis or chassis frame	PASS
No missing part on the chassis frame	PASS
Half cut Analysis	PASS

Chassis Damage Level	No Damage
----------------------	-----------
