Preowned Vehicle Inspection Report

Premium Inspection Analysis

Customer Name : MERCEDES-BENZ MOBILITY (THAILAND) CO., LTD. Inspection Date : 2024-09-05
 Tel. : _____ Lemon Inspection ID : LEMON24090037
 Inspector : ธีมนันท์ ทัพย์อัฐนธ์ Approved By : Chaimongkol C

Brand	MERCEDES BENZ	Model year	2021
Model	C220	Engine Code - No.	65492081061258
Sub-model	d AMG Dynamic	Registration year	2021-10-04
License Plate		Chassis No.	W1K2050146L062723
Current Mileage(km.)	84597	Engine Capacity(cc.)	2000

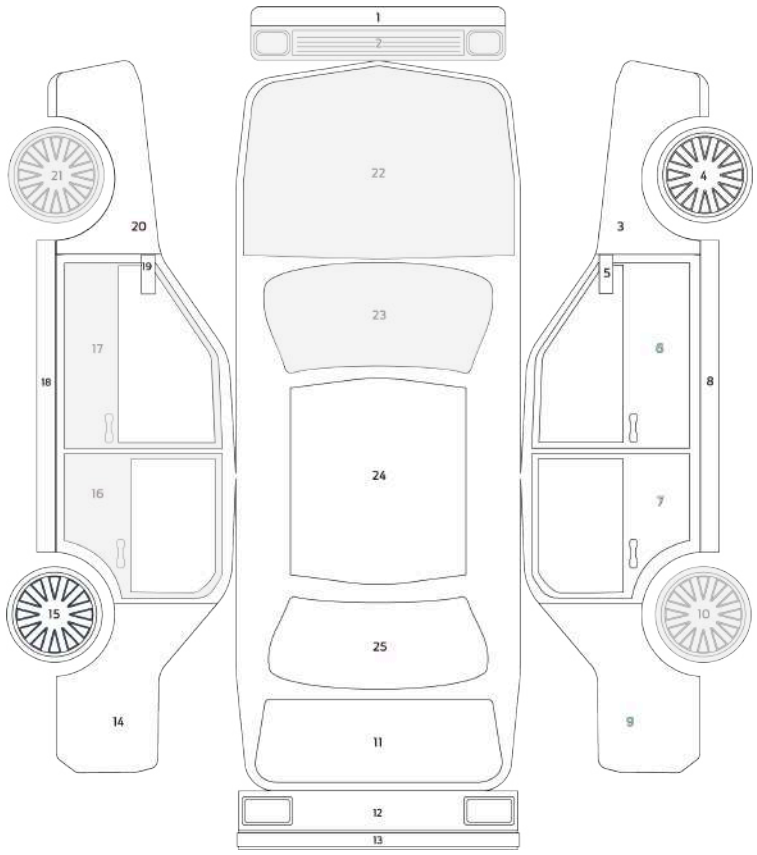
Exterior Inspection Points

1. Front Skirt	O	14. Left Skirt	O
2. Front Bumper	O (S2)	15. Left Wing Mirror	O
3. Front Right Fender	O	16. Front windshield	O (G1)
4. Front Right Wheel	O	17. Roof	O
5. Front Left Fender	O	18. Rear Right Fender	O
6. Front Left Wheel	O (S1)	19. Rear Bonnet	O
7. Front bonnet	O (S1)	20. Back right wheel	O (S1)
8. Right Wing Mirror	O	21. Rear Bumper	O
9. Front Right Door	O	22. Rear Skirt	O
10. Rear Right Door	O	23. Rear Left Fender	O
11. Right Skirt	O	24. Back Left Wheel	O
12. Rear Left door	O (S2)	25. Back Windshield	O
13. Front left door	O (S2)

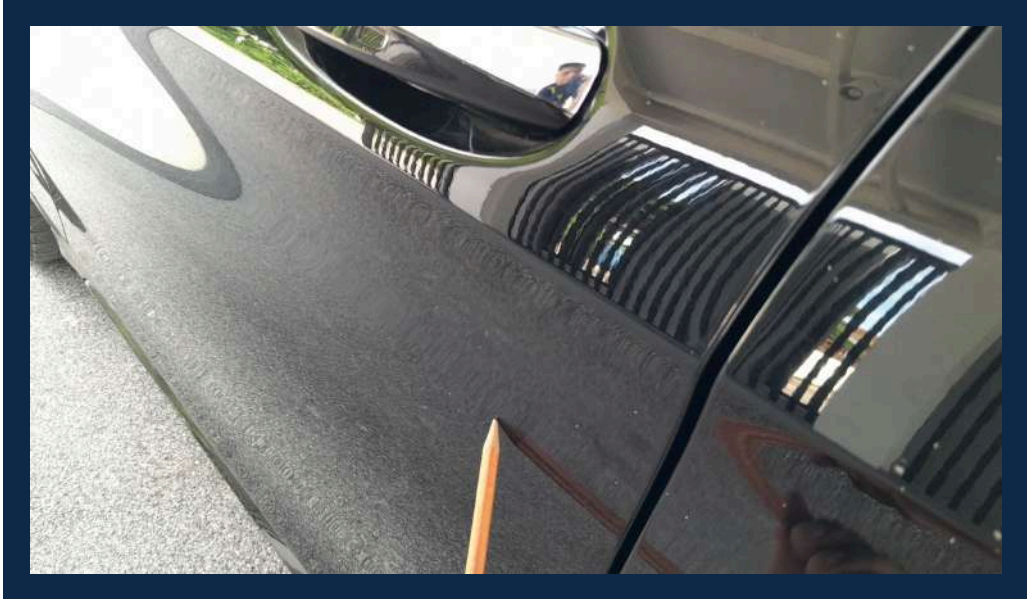
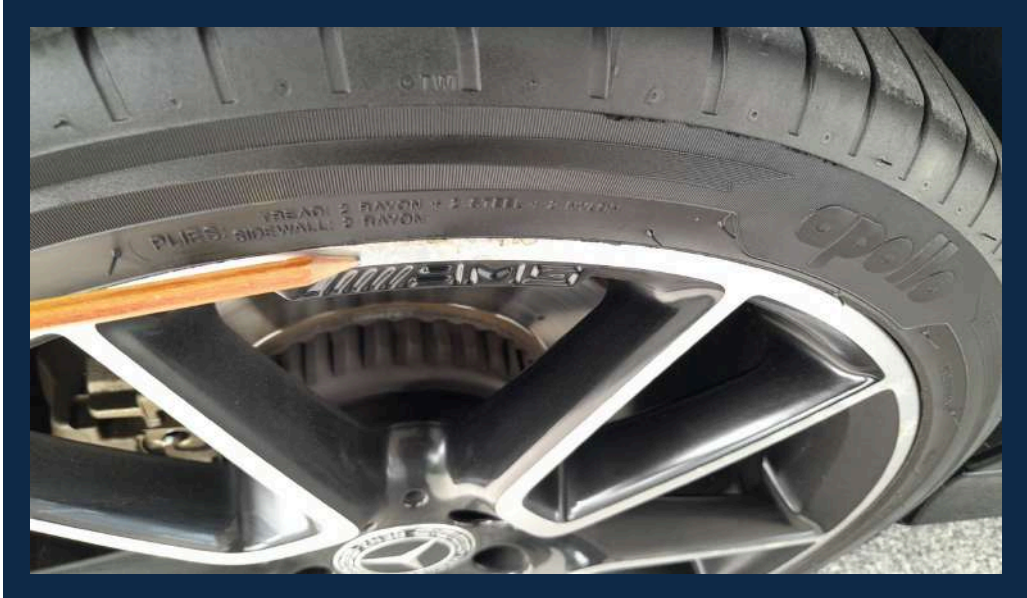
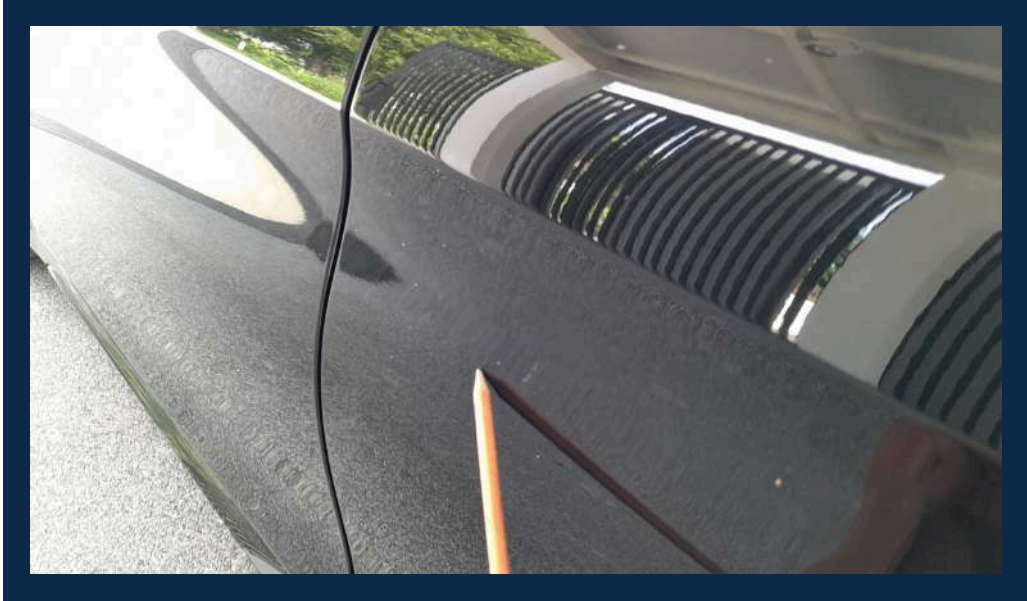
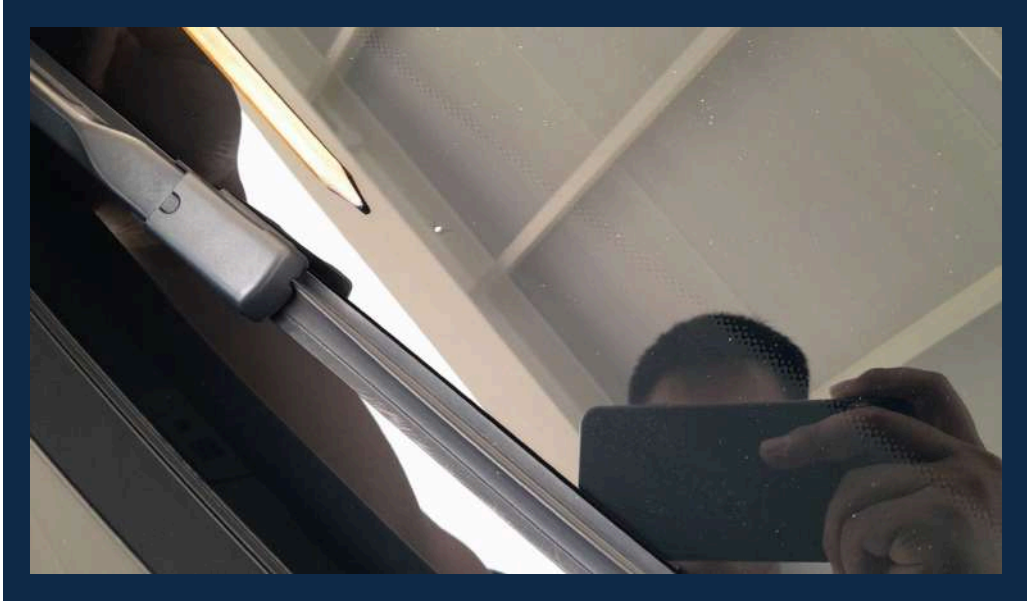
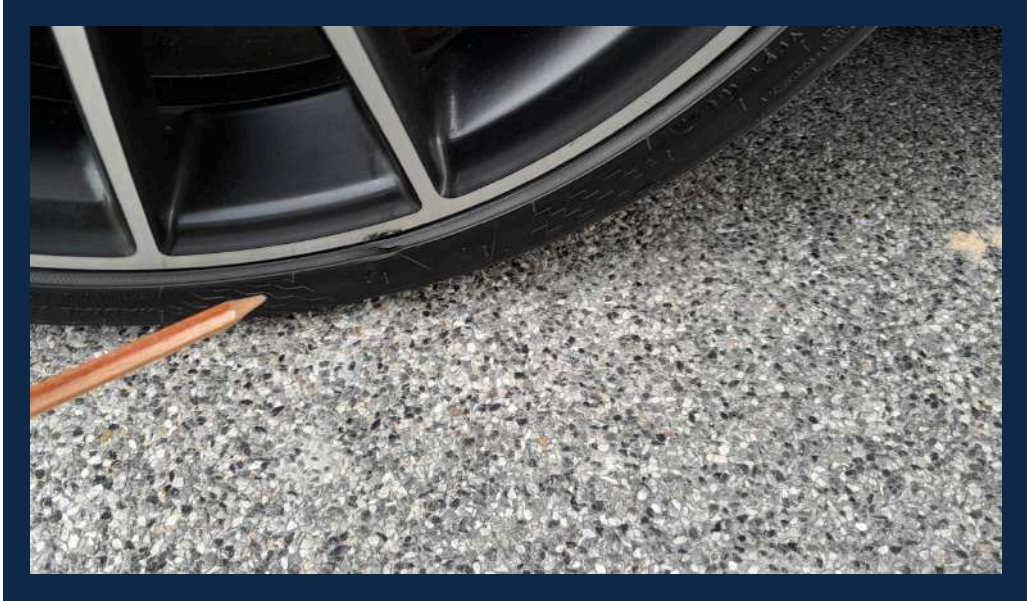
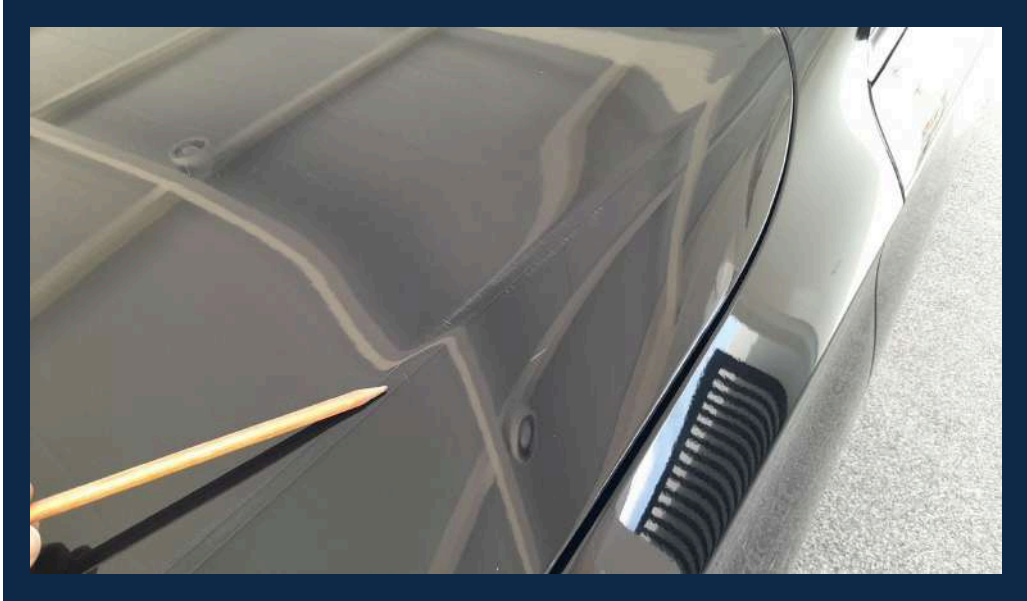
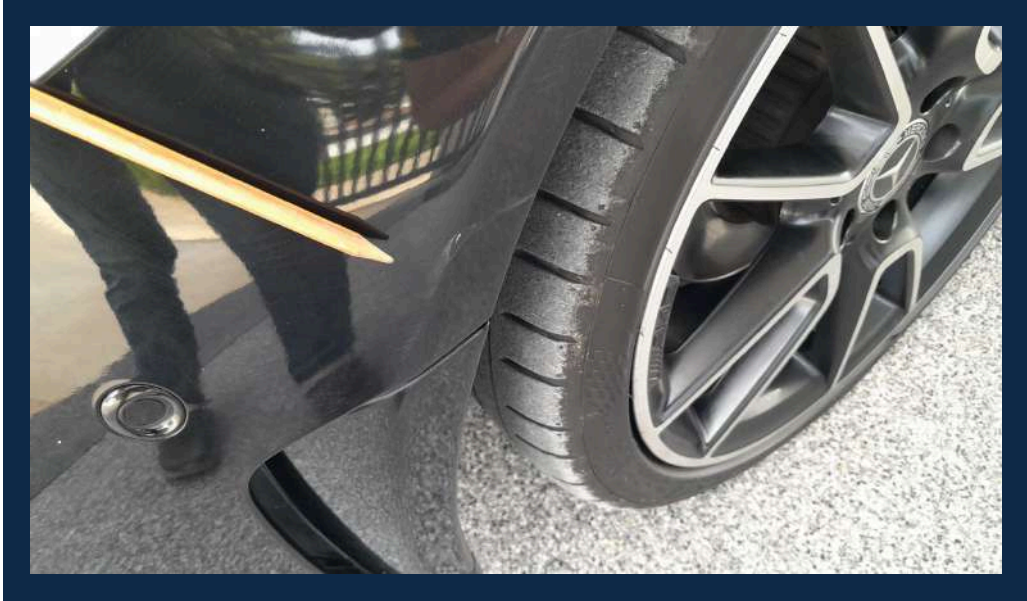
Vehicle Defect Notices

Inspector : ภายนอก(Exterior) : การตรวจสภาพภายนอกโดยรวมไม่พบหลักฐานการซ่อมแซมทำสี ไร้รอยถลอกรอบคัน / กระจกหน้าเป็นรอยสะเก็ดหิน / ยางหลังซ้ายขวาเสื่อมสภาพ ปี 20 / ล้อแม็กเป็นรอยถลอก ภายใน(Interior) : ภายใน พลาสติกกระจกชั้นรูปเป็นคลื่น เบาะหน้าหลังเป็นรอยถลอก ผ้าบุหลังคาเป็นคราบเปื้อน ,อุปกรณ์ไฟฟ้า แอร์ วิทยุFM ใช้งานได้ตามมาตรฐานครบปกติ เครื่องยนต์(Engine) : - โครงสร้าง(Frame) : -
