# Preowned Vehicle Inspection Report

Customer Name : MERCEDES-BENZ MOBILITY (THAILAND) CO., LTD. Inspection Date : 2024-09-05  
 Tel. \_\_\_\_\_ Lemon Inspection ID : LEMON24090035  
 Inspector : ธีณัฐ ทัพย์อินทร์ Approved By : Chaimongkol C

Brand	MERCEDES BENZ	Model year	2021
Model	C200	Engine Code - No.	26492030364325
Sub-model	COUPE AMG DYNAMIC	Registration year	2022-08-05
License Plate		Chassis No.	W1K2053806L062570
Current Mileage(km.)	66693	Engine Capacity(cc.)	2000

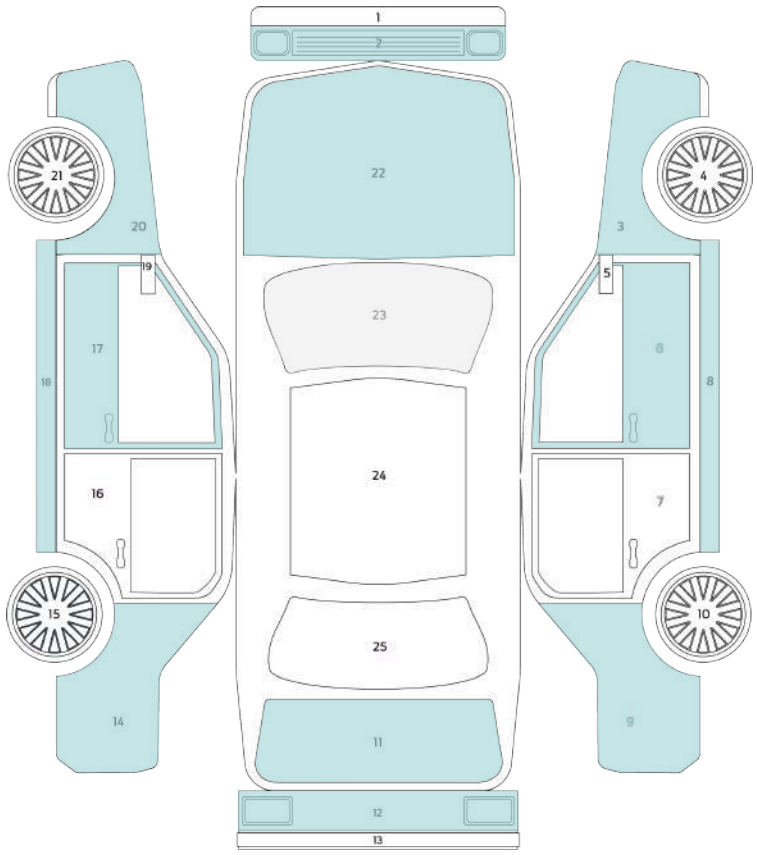
1. Front Skirt	O	14. Left skirt	BP
2. Front Bumper	BP (S1)	15. Left Wing Mirror	O
3. Front Right Fender	BP	16. Front windshield	O (G1)
4. Front Right Wheel	O	17. Roof	O
5. Front Left Fender	BP	18. Rear right fender	BP
6. Front Left Wheel	O	19. Rear Bonnet	BP
7. Front bonnet	BP (S1)	20. Back Right Wheel	O
8. Right Wing Mirror	O	21. Rear Bumper	BP
9. Front right door	BP (S1)	22. Rear Skirt	O
10. Rear Right Door	O	23. Rear left fender	BP
11. Right Skirt	BP	24. Back Left Wheel	O
12. Rear Left Door	O	25. Back Windshield	O
13. Front left door	BP

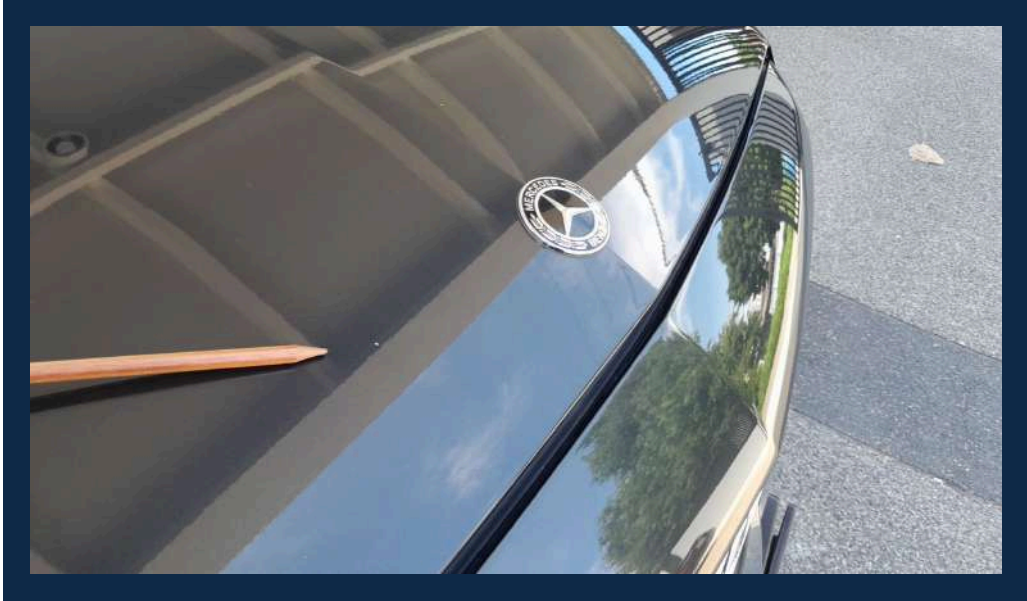
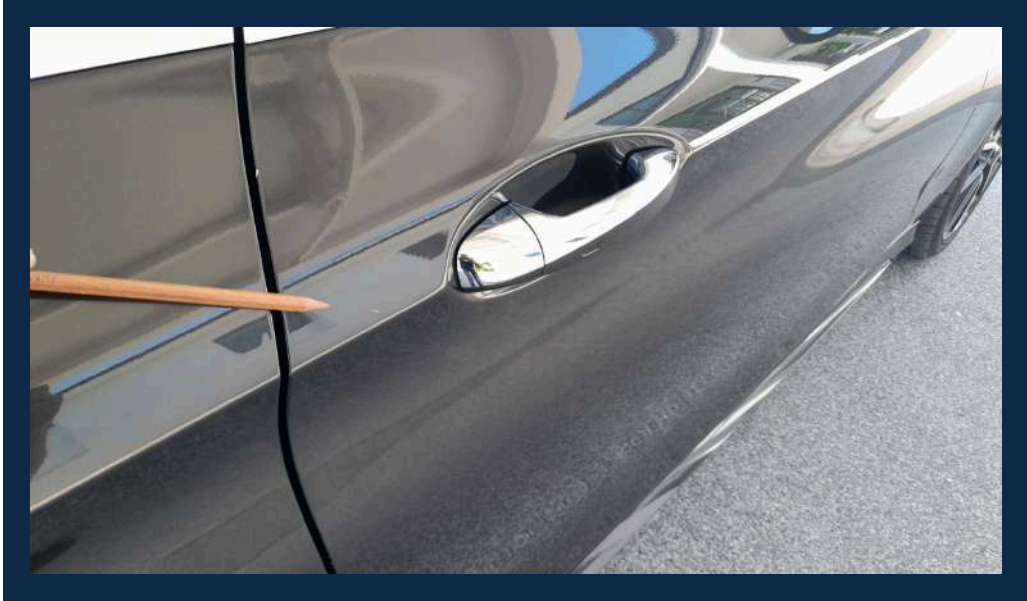
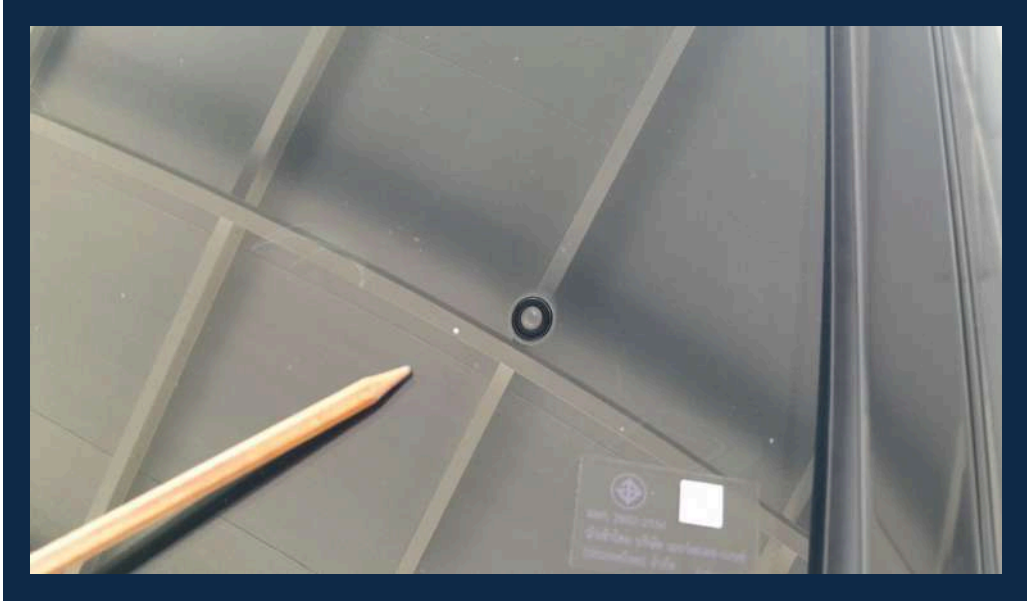
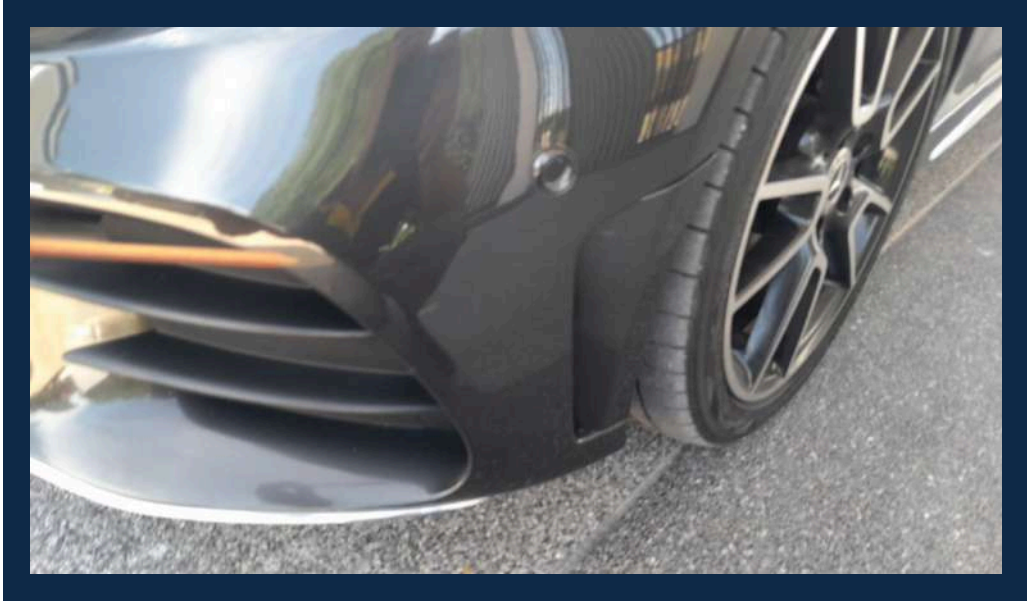
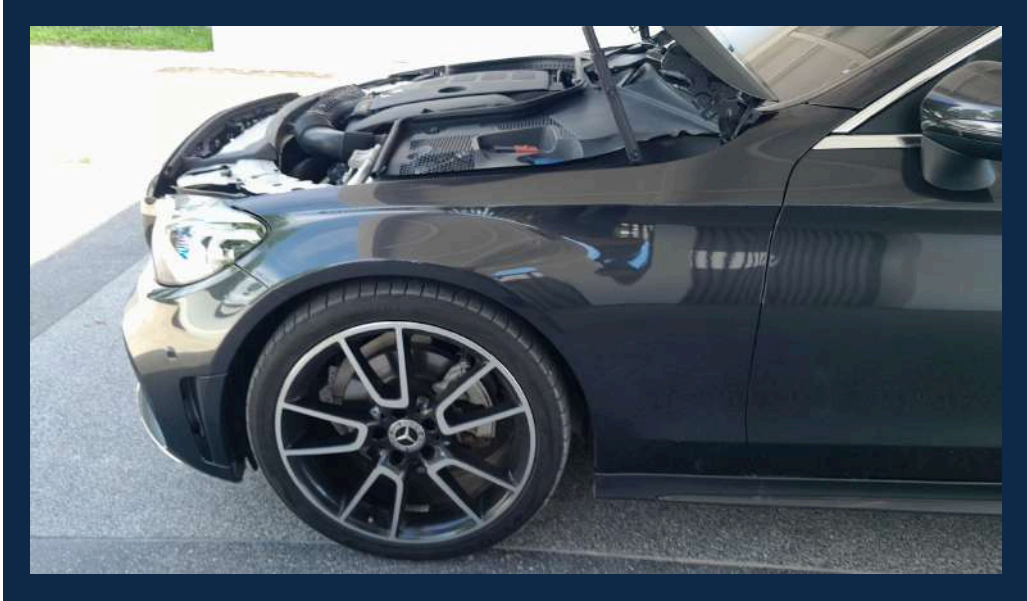
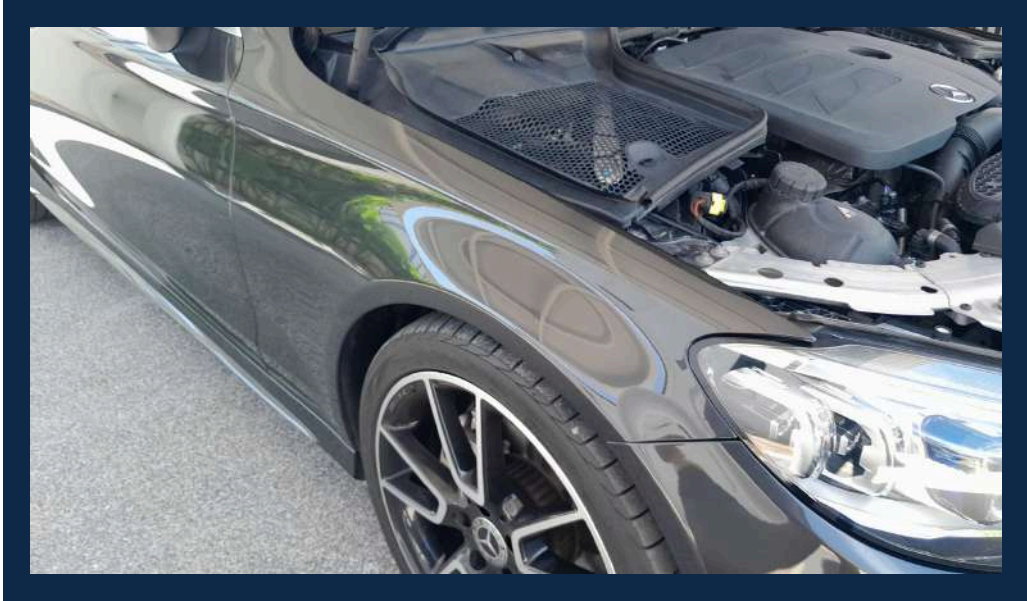
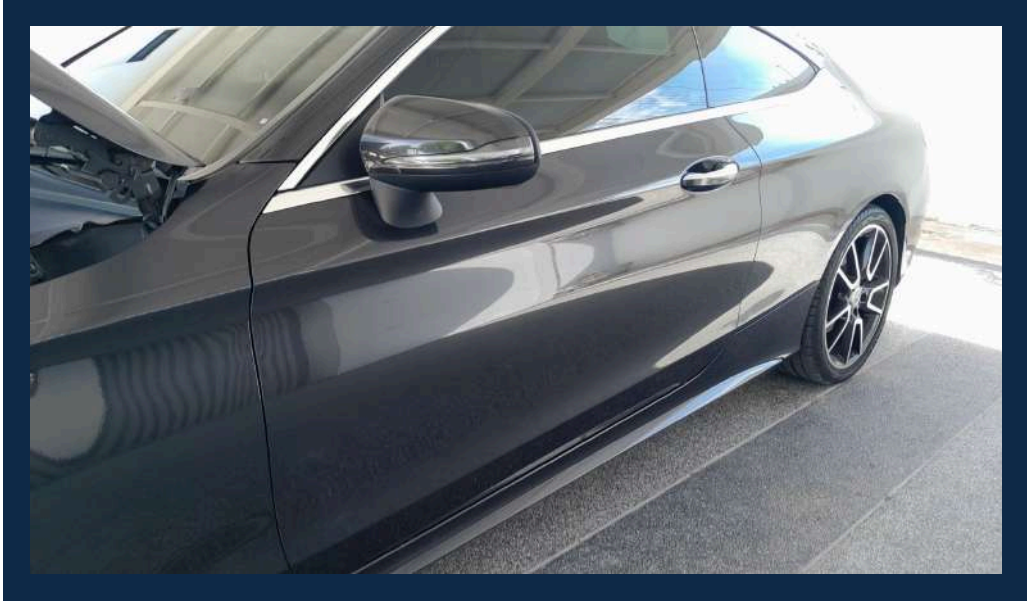
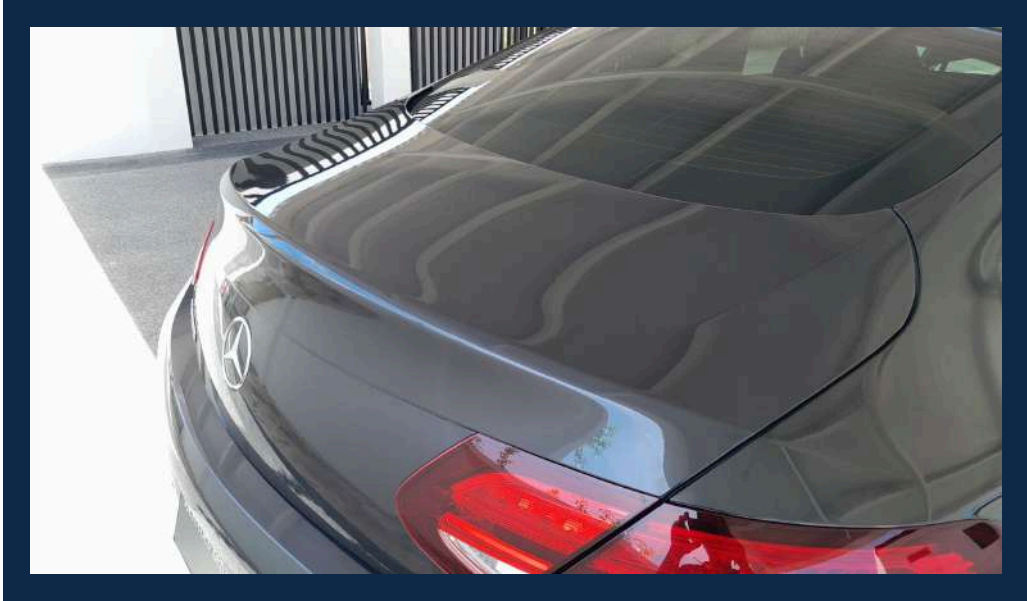
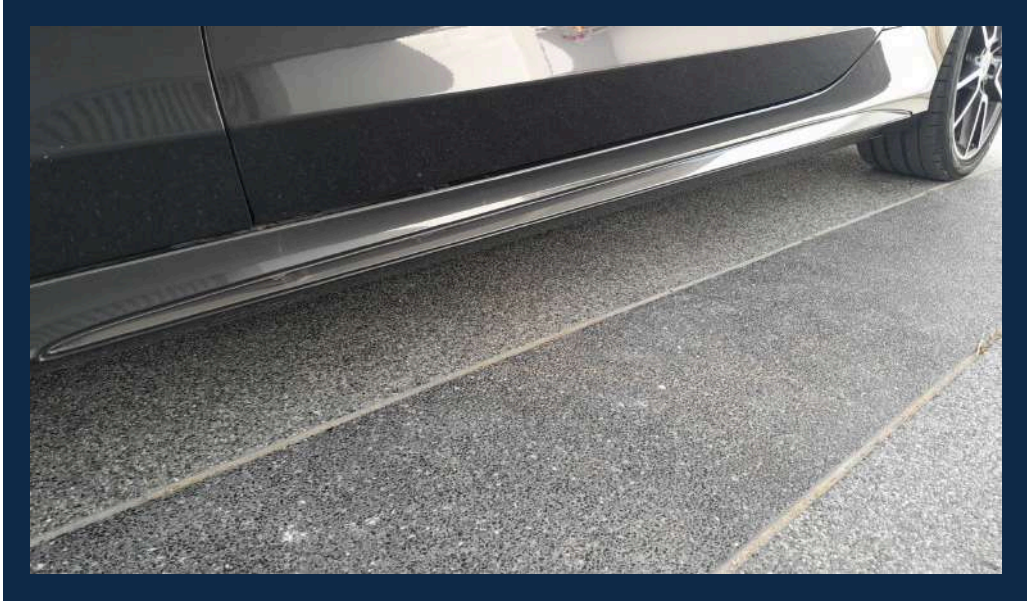
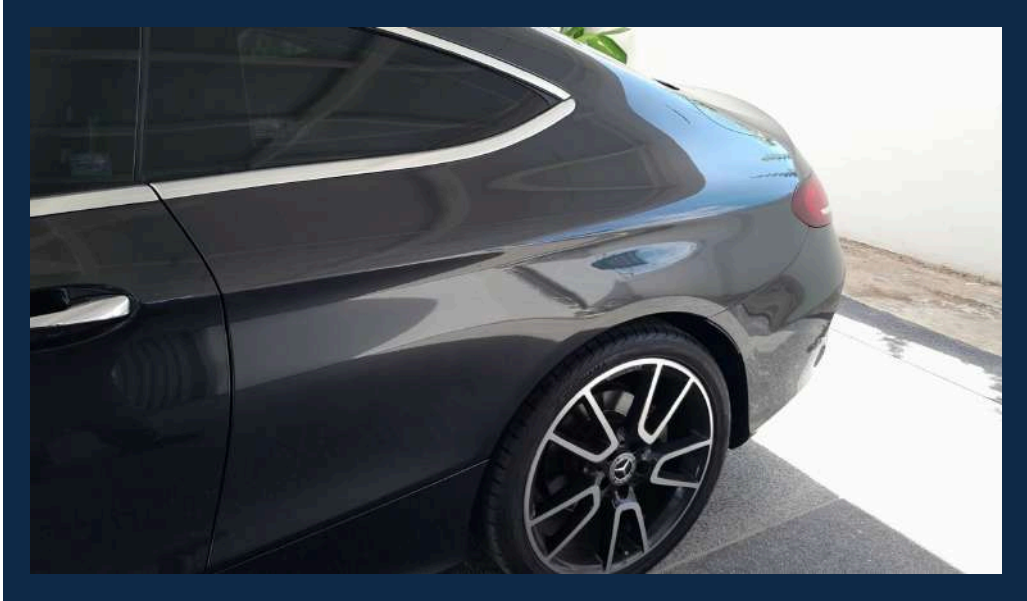
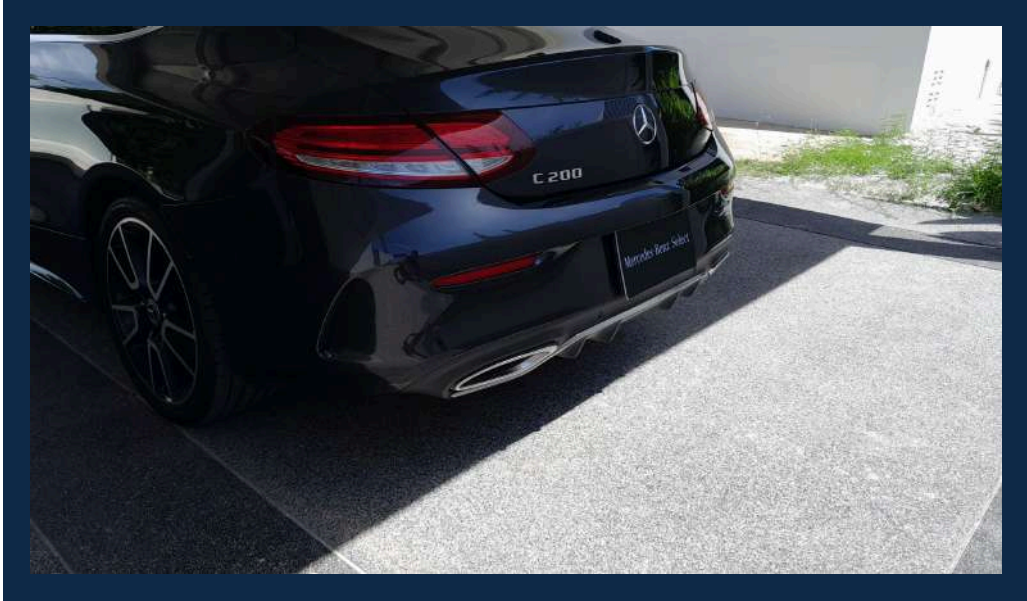
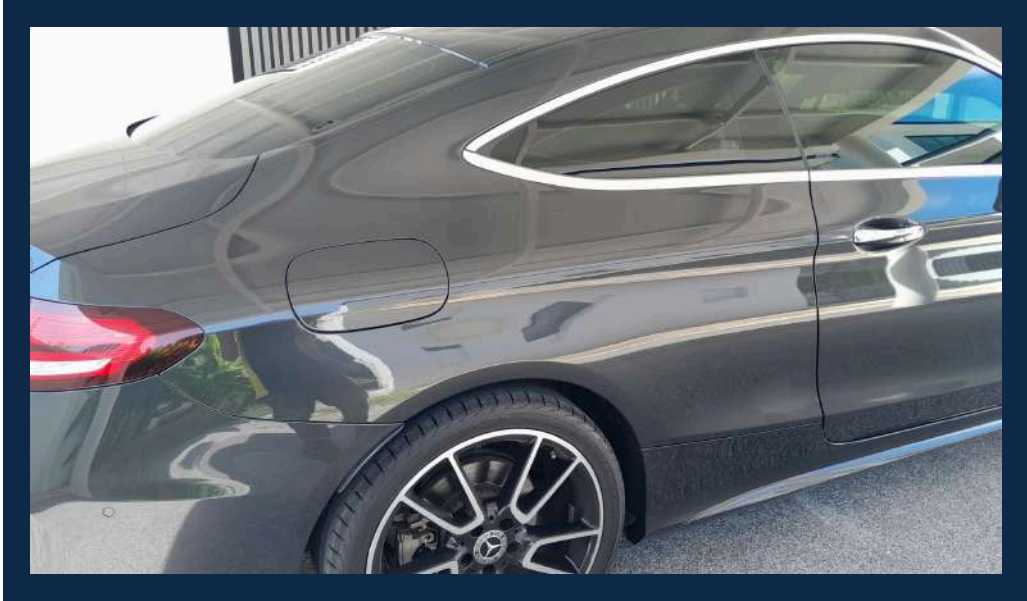
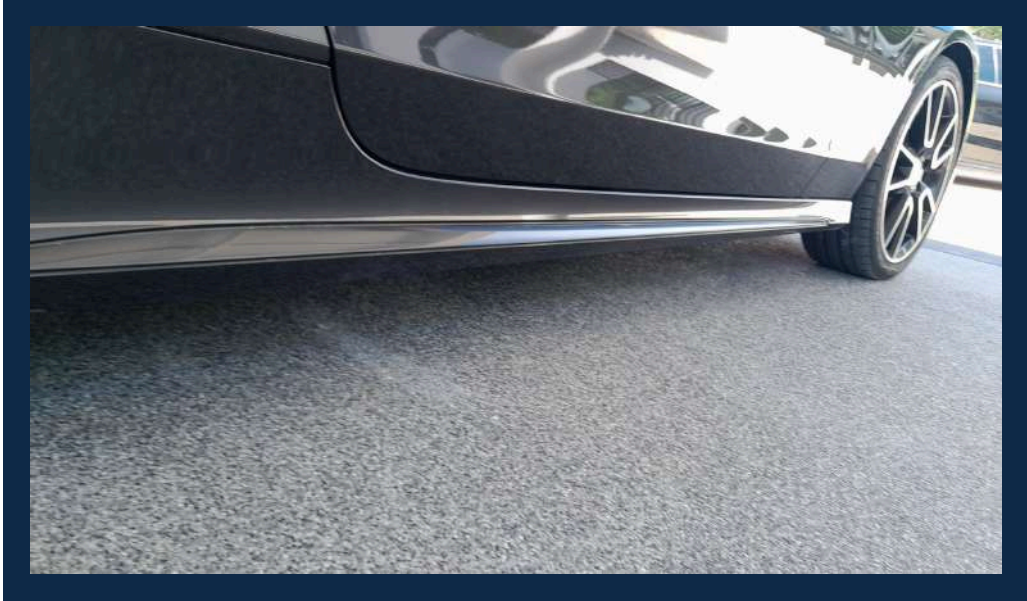
**Vehicle Defect Notices**

**Inspector :** ภายนอก(Exterior) : การตรวจสภาพภายนอกโดยรวมพบหลักฐานการซ่อมแซมทำสีมารอบคัน / รั้วรอย สะเก็ดเล็กน้อย / สภาพยางปกติทั้ง4เส้น ปี 22 ภายใน(Interior) : ภายใน ผ้าบุหลังคาเป็นคราบเข็อน พวงมาลัยเป็น รอยขีดข่วน เบาะหน้าขวาเป็นรอยย่น ,อุปกรณ์ไฟฟ้า แอร์ วิทยุFM ใช้งานได้สมบูรณ์ครบปกติ เครื่องยนต์(Engine) : - โครงสร้าง(Frame) : -

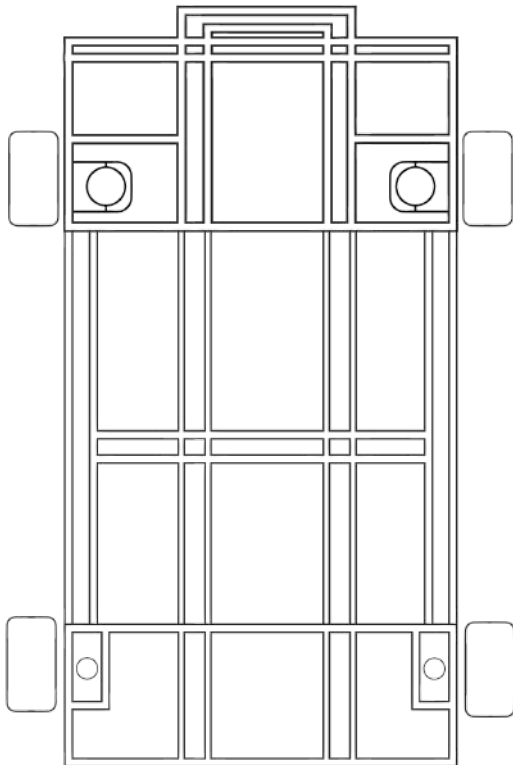
## Chassis Report

No dent in the under carriage	PASS
No deform chassis or chassis frame	PASS
No visible corrosion on the chassis or chassis frame	PASS
No missing part on the chassis frame	PASS
Half cut Analysis	PASS

Chassis Damage Level	No Damage
----------------------	-----------
