Premium Inspection Analysis

Customer Name	: MERCEDES-BENZ MOBILITY (THAILAND) CO., LTD.	Inspection Date	: 2024-09-11
Tel.	:	Lemon Inspection ID	: LEMON24090096
Inspector	:แทนรัก ทิพย์อินทร์	Approved By	: Sakulpong S

Brand	MERCEDES BENZ	Model year	2019
Model	GLA250	Engine Code - No.	27092031899344
Sub-model	AMG Dynamic	Registration year	2021-11-09
License Plate		Chassis No.	WDC1569446L013512
Current Mileage(km.)	18842	Engine Capacity(cc.)	2000

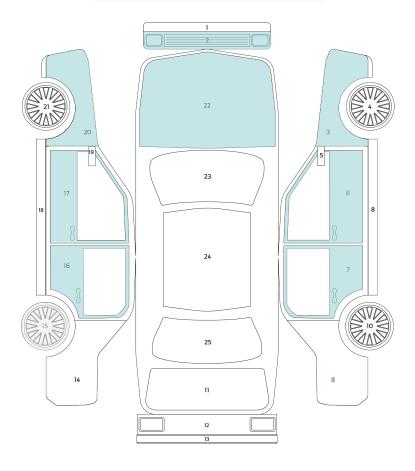
Exterior Inspection Points

1. Front Skirt	0	14. Left Skirt	0
2. Front Bumper	ВР	15. Left Wing Mirror	0
3. Front Right Fender	BP	16. Front Windshield	0
4. Front Right Wheel	0	17. Roof	0
5. Front Left Fender	BP	18. Rear Right Fender	0
6. Front Left Wheel	0	19. Rear Bonnet	0
7. Front bonnet	ВР	20. Back Right Wheel	0
8. Right Wing Mirror	0	21. Rear Bumper	0
9. Front right door	BP (S1)	22. Rear Skirt	0
10. Rear right door	ВР	23. Rear Left Fender	0
11. Right Skirt	0	24. Back left wheel	O (S1)
12. Rear Left door	BP	25. Back Windshield	0
13. Front left door	BP

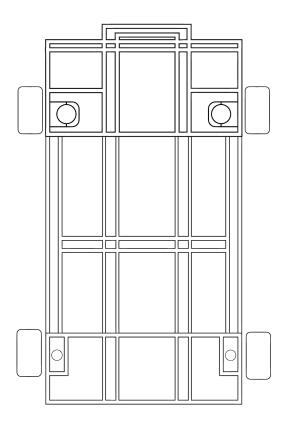
Chassis Report

No dent in the under carriage	PASS
No deform chassis or chassis frame	PASS
No visible corrosion on the chassis or chassis frame	PASS
No missing part on the chassis frame	PASS
Half cut Analysis	PASS

Chassis Damage Level	No Damage
----------------------	-----------
