# Preowned Vehicle Inspection Report

Customer Name : MERCEDES-BENZ MOBILITY (THAILAND) CO., LTD. Inspection Date : 2024-09-12  
Tel. \_\_\_\_\_ Lemon Inspection ID : LEMON24090106  
Inspector : ไชยมงคล ไพโรเลี้ยง Approved By : Tanrak T

Brand	MERCEDES BENZ	Model year	2021
Model	GLC300	Engine Code - No.	27492031986849
Sub-model	e 4MATIC AMG Dynamic (Coupe)	Registration year	2021-12-07
License Plate		Chassis No.	W1N2533536L038726
Current Mileage(km.)	46099	Engine Capacity(cc.)	2000

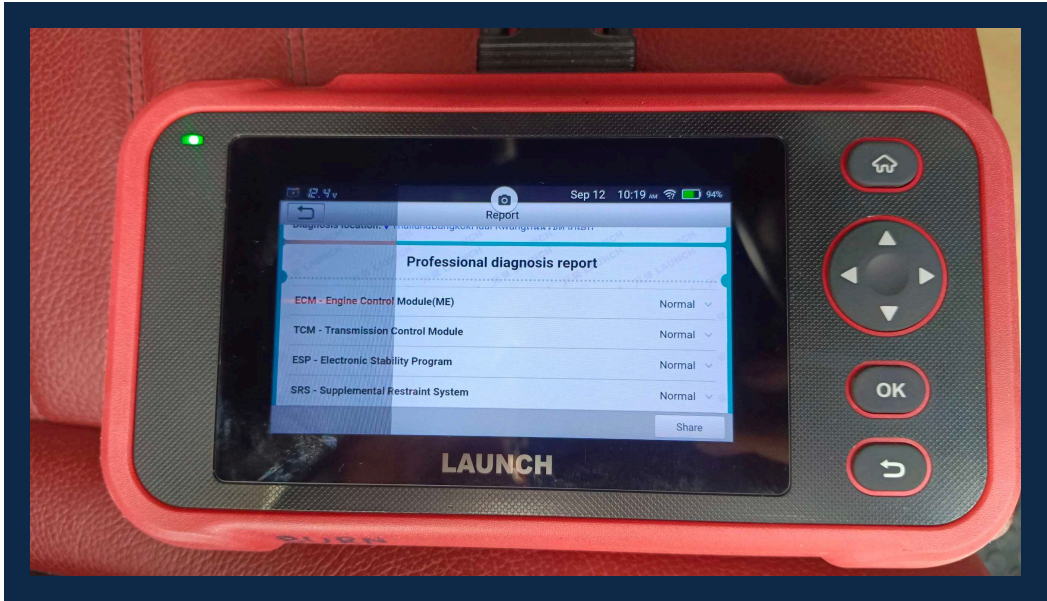
**OBD Vehicle Health Analysis**

**Inspector :** ภายนอก(Exterior) : - ภายใน(Interior) : - เครื่องยนต์(Engine) : วิเคราะห์ปัญหาด้วยเครื่อง OBDII ไม่พบสิ่งผิดปกติ (ไม่ได้ทดสอบขับเคลื่อน) โครงสร้าง(Frame) : -
