Preowned Vehicle Inspection Report

Premium Inspection Analysis

Inspection Date : 2024-08-13

Brand	MERCEDES BENZ	Model year	2021
Model	GLC300	Engine Code - No.	27492031966617
Sub-model	e 4MATIC AMG Dynamic	Registration year	2021-08-31
License Plate		Chassis No.	W1N2539536L034130
Current Mileage(km.)	37790	Engine Capacity(cc.)	2000

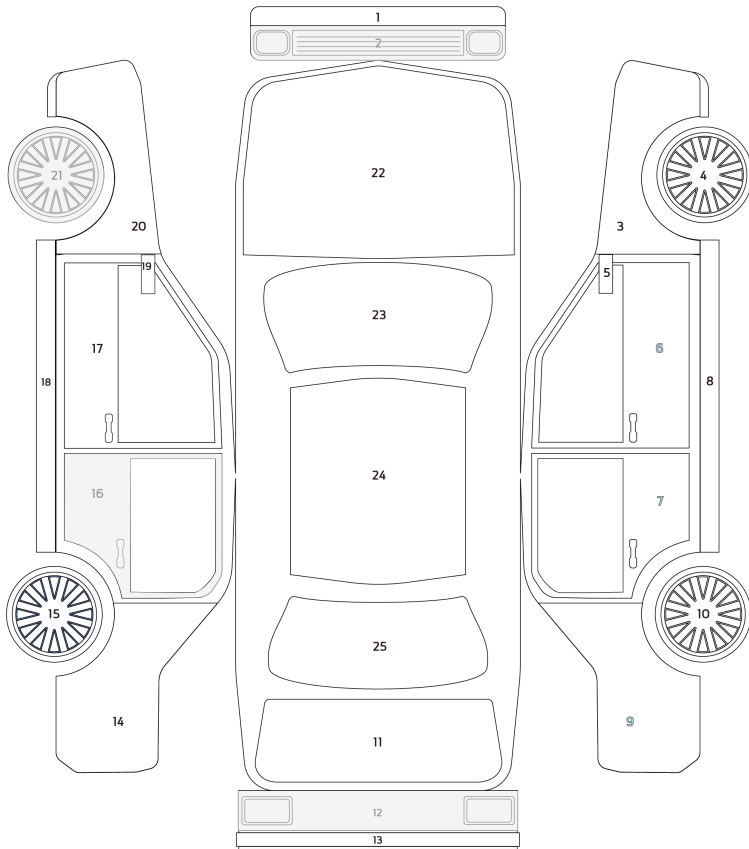
Exterior Inspection Points

1. Front Skirt	O	14. Left Skirt	O
2. Front Bumper	O (F)	15. Left Wing Mirror	O
3. Front Right Fender	O	16. Front Windshield	O
4. Front Right Wheel	O	17. Roof	O
5. Front Left Fender	O	18. Rear Right Fender	O
6. Front Left Wheel	O (S2)	19. Rear Bonnet	O
7. Front Bonnet	O	20. Back Right Wheel	O
8. Right Wing Mirror	O	21. Rear Bumper	O (S1)
9. Front Right Door	O	22. Rear Skirt	O
10. Rear Right Door	O	23. Rear Left Fender	O
11. Right Skirt	O	24. Back Left Wheel	O
12. Rear Left door	O	25. Back Windshield	O
13. Front Left Door	O

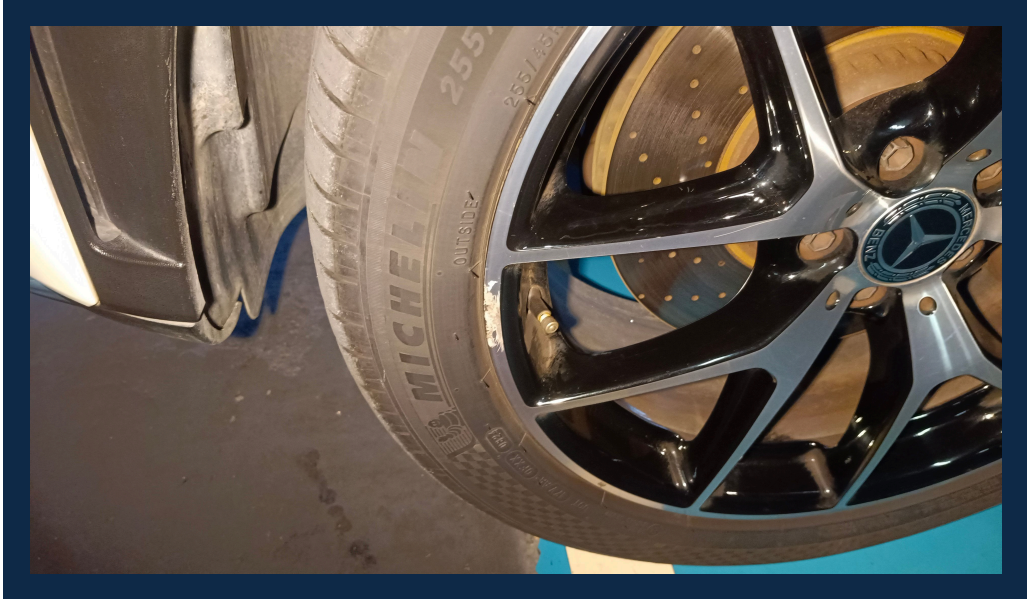
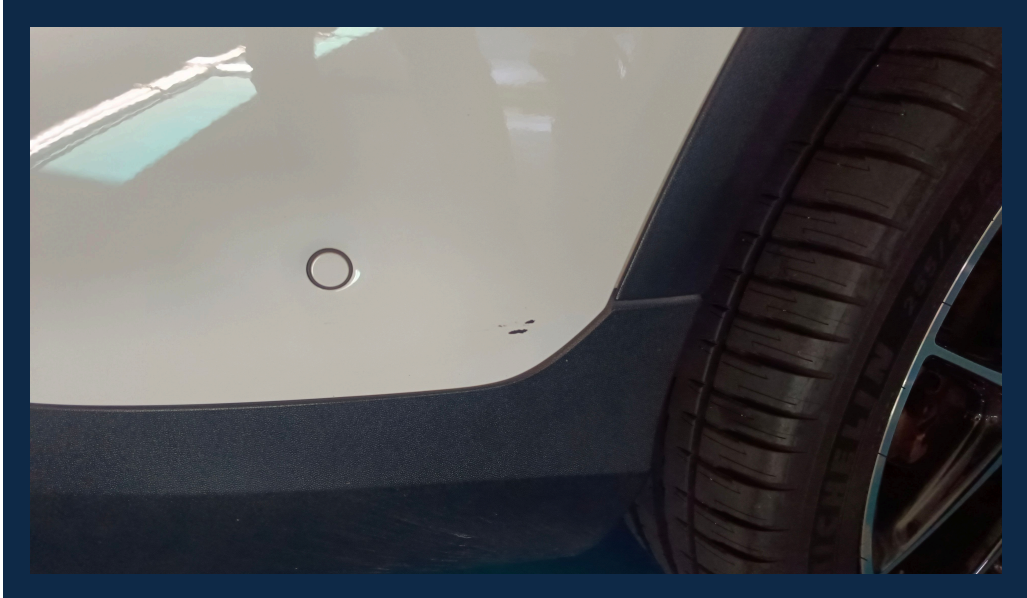
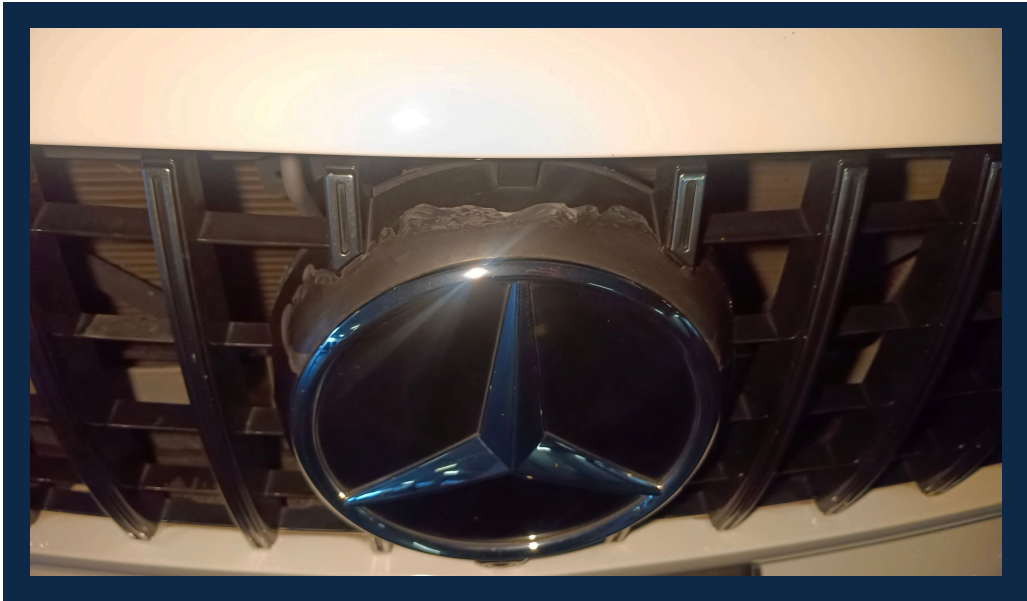
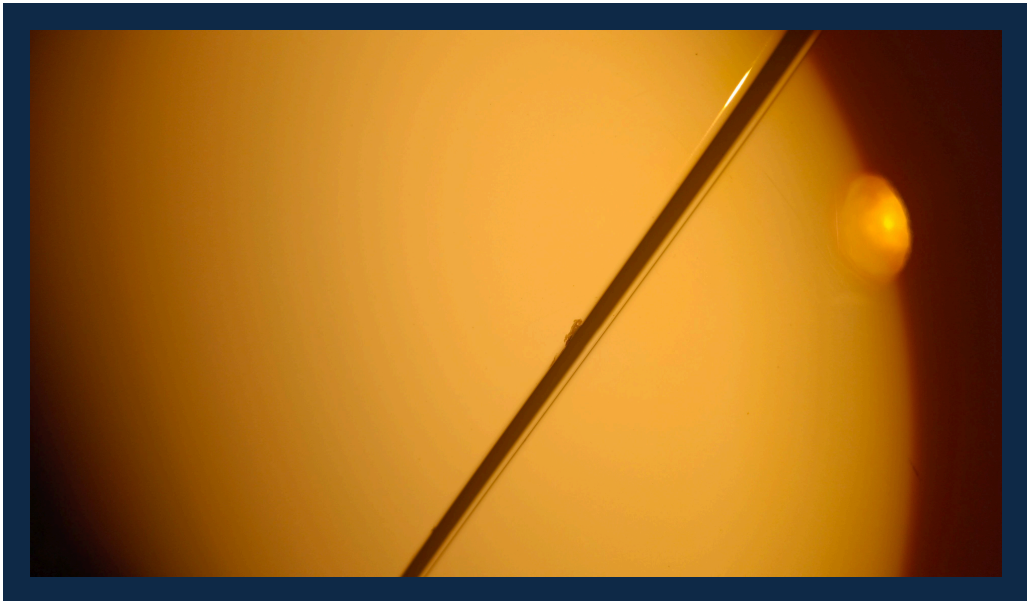
Vehicle Defect Notices

Inspector : ภายนอก(Exterior) : การตรวจสภาพภายนอกโดยรวมไม่พบหลักฐานการซ่อมแซมทำสี /พบกันชนหน้าและกันชนหลังถลอก/โลโก้บนชั่งกระจหน้าลอก/ สภาพยางปกติทั้ง4เส้น ปี24 ภายใน(Interior) : ภายในปกติ สะอาดเรียบร้อย ,อุปกรณ์ไฟฟ้า แอร์ วิทยุFM ใช้งานได้สมบูรณ์ครบปกติ เครื่องยนต์(Engine) : เครื่องยนต์ทำงานได้ปกติ ,วิเคราะห์ปัญหาด้วยเครื่อง OBDII พบสิ่งผิดปกติเกี่ยวกับระบบ ESP แนะนำเข้าตรวจเช็คที่ศูนย์บริการ(ไม่ได้ทดสอบขับ) โครงสร้าง(Frame) : อุบัติเหตุไม่มี ,โครงสร้างหลักปกติ ไม่มีการซ่อมแซมโครงสร้างหรือมีการชนถึงโครงสร้าง
