Preowned Vehicle Inspection Report

Premium Inspection Analysis

Vehicle : MERCEDES BENZ GLC220

Inspection date : 2024-08-08

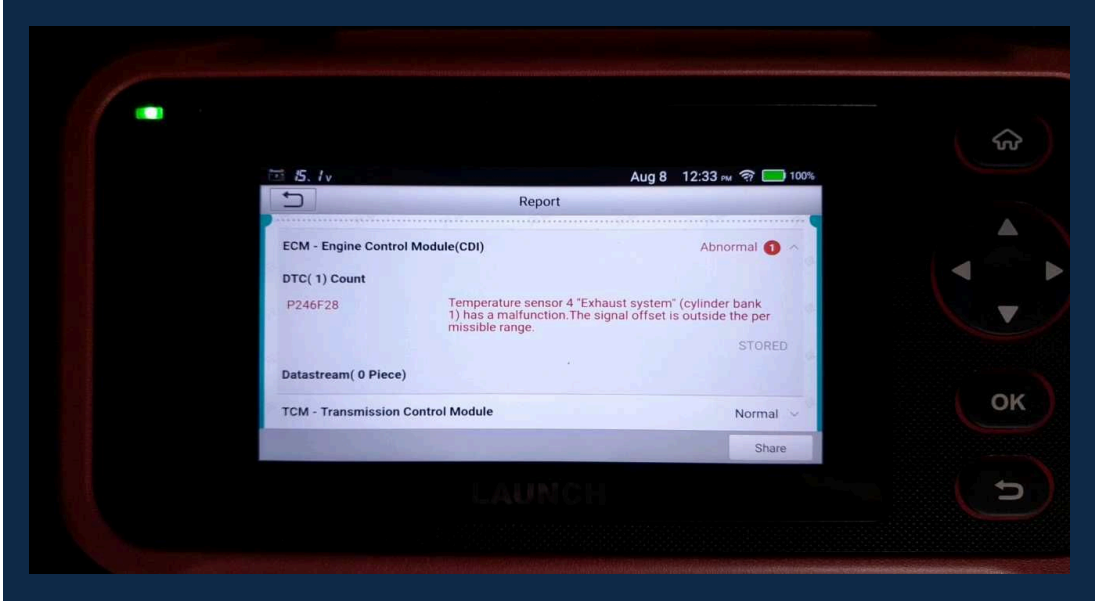
OBD Vehicle Health Analysis

Inspector : ภายนอก(Exterior) : การตรวจสอบสภาพภายนอก โดยรวมพบหลักฐานการซ่อมแซมทำสีมาบางชิ้น มีริ้วรอย เล็กน้อย / กระจกหน้าเป็นรอยสะเก็ดหิน / สภาพยางปกติทั้ง4เส้น ปี 23 ภายใน(Interior) : ภายใน เบาะหน้าขวาเป็นรอย ย่นถลอก / สะอาดเรียบร้อย , อุปกรณ์ไฟฟ้า แอร์ วิทยุFM ใช้งานได้สมบูรณ์ครบปกติ เครื่องยนต์(Engine) : เครื่องยนต์ ทำงานได้ปกติ ,วิเคราะห์ปัญหาด้วยเครื่อง OBDII พบสิ่งผิดปกติ รหัส P246F28 แนะนำตรวจเช็คศูนย์บริการ (ไม่ได้ ทดสอบขับขี) โครงสร้าง(Frame) : อุบัติเหตุไม่มี ,โครงสร้างหลักปกติ ไม่มีการซ่อมแซมโครงสร้างหรือมีการชนถึง โครงสร้าง หมายเลข หน้าปิดเรือนโมสไม่มีไฟโชว์ เช็ค OBDII พบโค้ด P246F28 เกี่ยวกับระบบไอเสีย แนะนำตรวจเช็ค โดยละเอียดอีกครั้ง

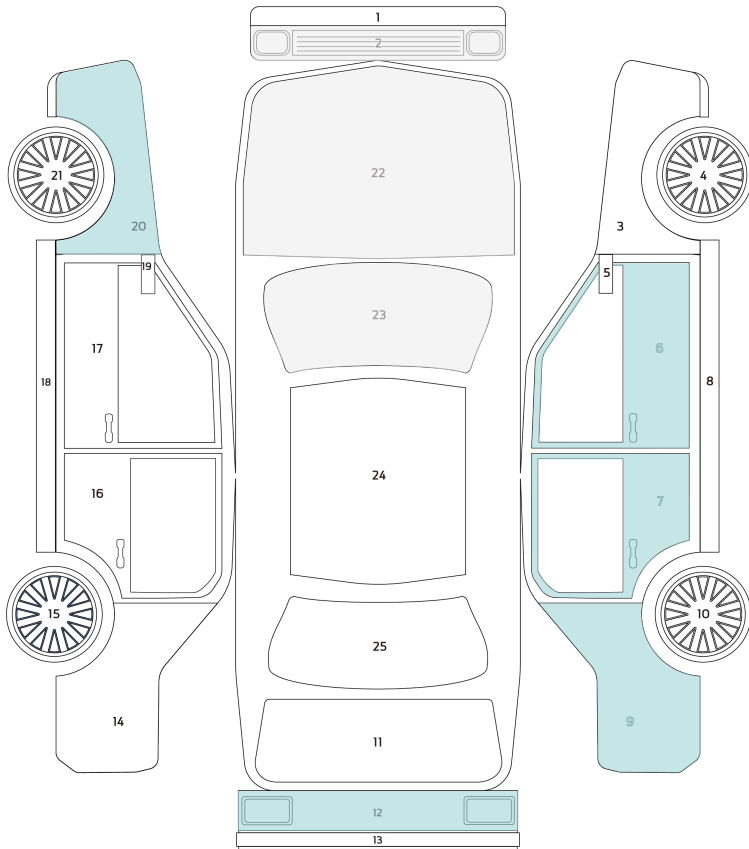
Exterior Inspection Points

1. Front Skirt	O	14. Left Skirt	O
2. Front Bumper	O (S1)	15. Left Wing Mirror	O
3. Front Right Fender	O	16. Front windshield	O (G1)
4. Front Right Wheel	O	17. Roof	O
5. Front Left Fender	BP	18. Rear right fender	BP
6. Front Left Wheel	O	19. Rear Bonnet	O
7. Front bonnet	O (S1)	20. Back Right Wheel	O
8. Right Wing Mirror	O	21. Rear Bumper	BP (S1)
9. Front right door	BP	22. Rear Skirt	O
10. Rear right door	BP	23. Rear Left Fender	O
11. Right Skirt	O	24. Back Left Wheel	O
12. Rear Left Door	O	25. Back Windshield	O
13. Front Left Door	O
