Preowned Vehicle Inspection Report

Premium Inspection Analysis

Inspector Note**Vehicle :** MERCEDES BENZ E300**Chassis number :** W1K2130536L049992**Inspection date :** 2024-08-08

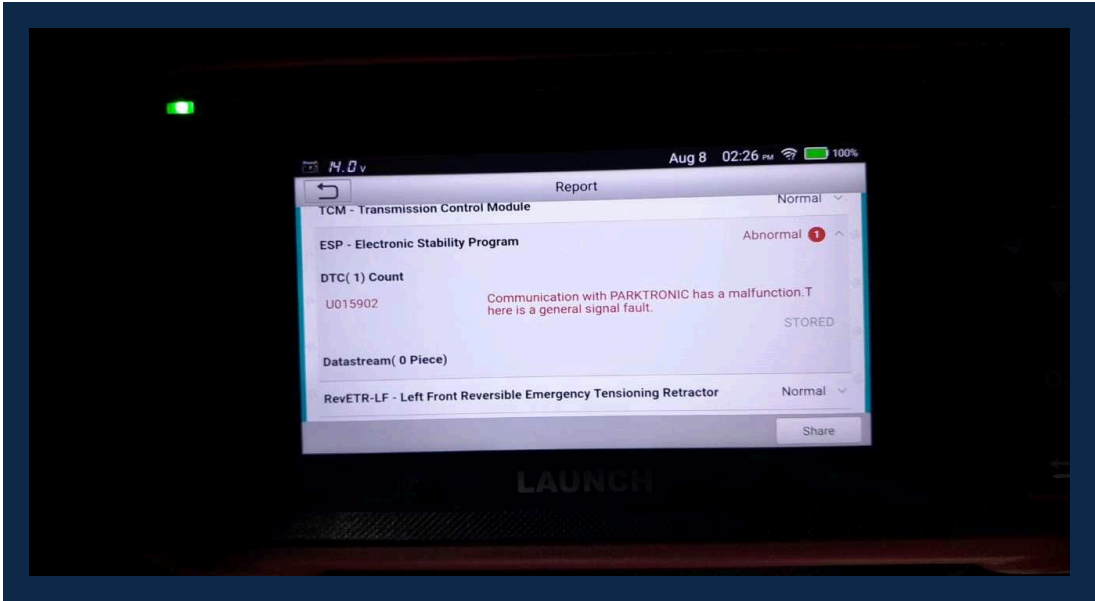
OBD Vehicle Health Analysis

เครื่องยนต์(Engine) : เครื่องยนต์ทำงานได้ปกติ ,วิเคราะห์ปัญหาด้วยเครื่อง OBDII พบสิ่งผิดปกติ รหัสU015902 แนะนำตรวจเช็คเข้าศูนย์บริการ (ไม่ได้ทดสอบขับขี) โครงสร้าง(Frame) : อุบัติเหตุไม่มี ,โครงสร้างหลักปกติ ไม่มีการซ่อมแซมโครงสร้างหรือมีการชนถึงโครงสร้าง หมายเหตุ หน้าปิดรีอนไม่มีไฟโซว เช็ค OBDII พบ โค้ด U015902 สัญญาณ Parktronic ทำงานผิดปกติ แนะนำตรวจเช็คโดยละเอียดอีกครั้ง

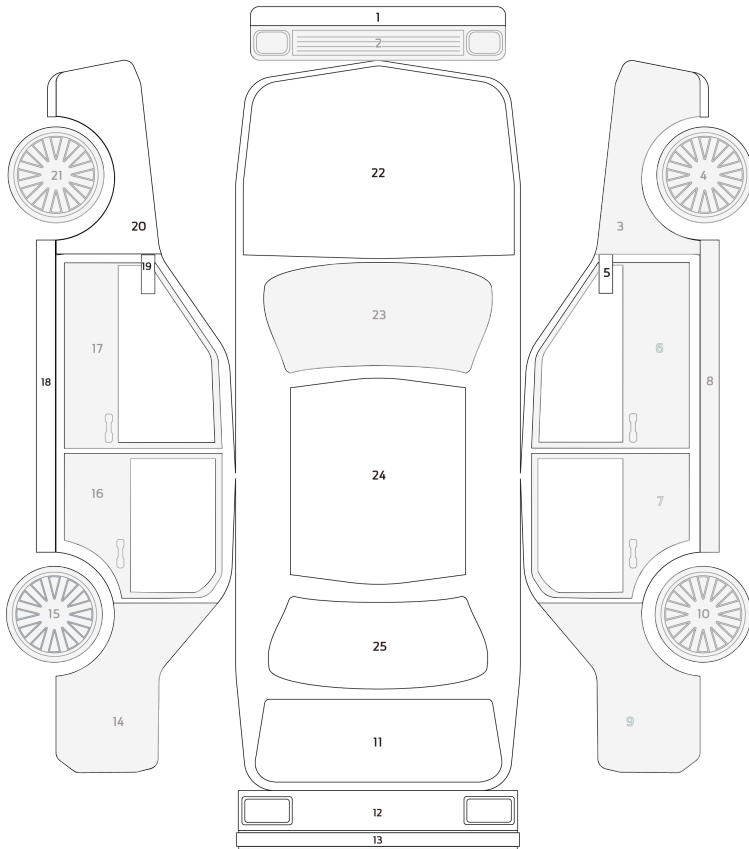
Exterior Inspection Points

1. Front Skirt	O	14. Left Skirt	O
2. Front Bumper	O (S3)	15. Left Wing Mirror	O
3. Front Right Fender	O (S1)	16. Front windshield	O (G2)
4. Front Right Wheel	O (S1)	17. Roof	O
5. Front Left Fender	O	18. Rear right fender	O (D1)
6. Front Left Wheel	O (S1)	19. Rear Bonnet	O
7. Front Bonnet	O	20. Back right wheel	O (S2)
8. Right Wing Mirror	O	21. Rear Bumper	O
9. Front right door	O (S2)	22. Rear Skirt	O
10. Rear right door	O (S1)	23. Rear left fender	O (D1)
11. Right Skirt	O (S2)	24. Back left wheel	O (S1)
12. Rear Left door	O (D1)	25. Back Windshield	O
13. Front left door	O (S1)

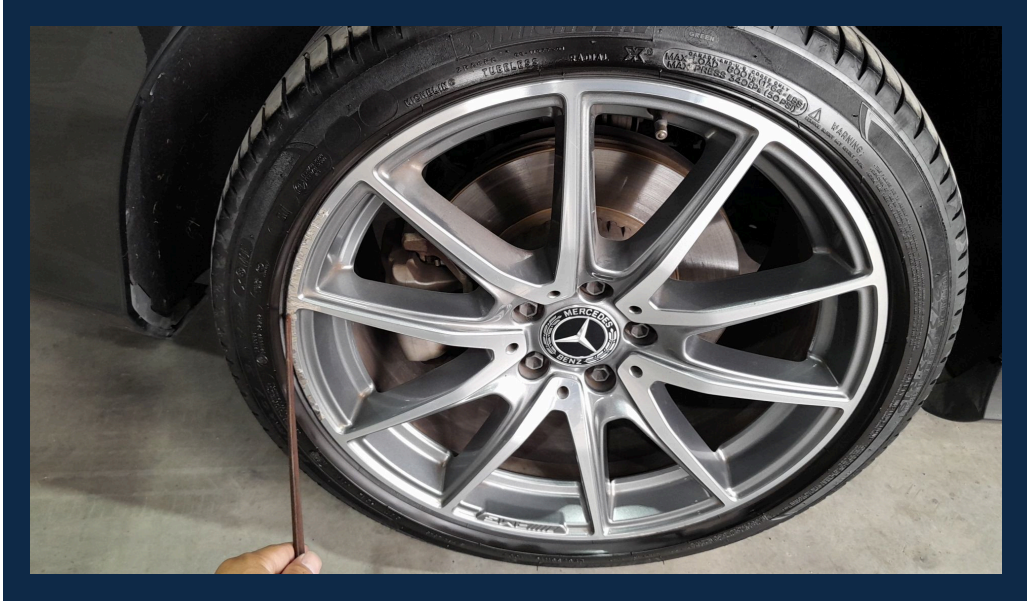
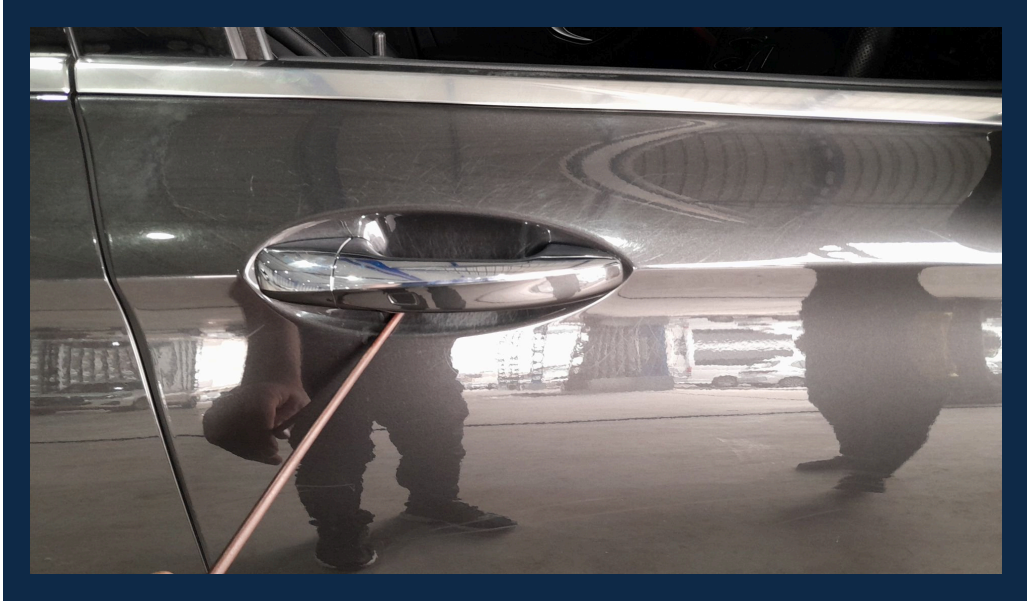
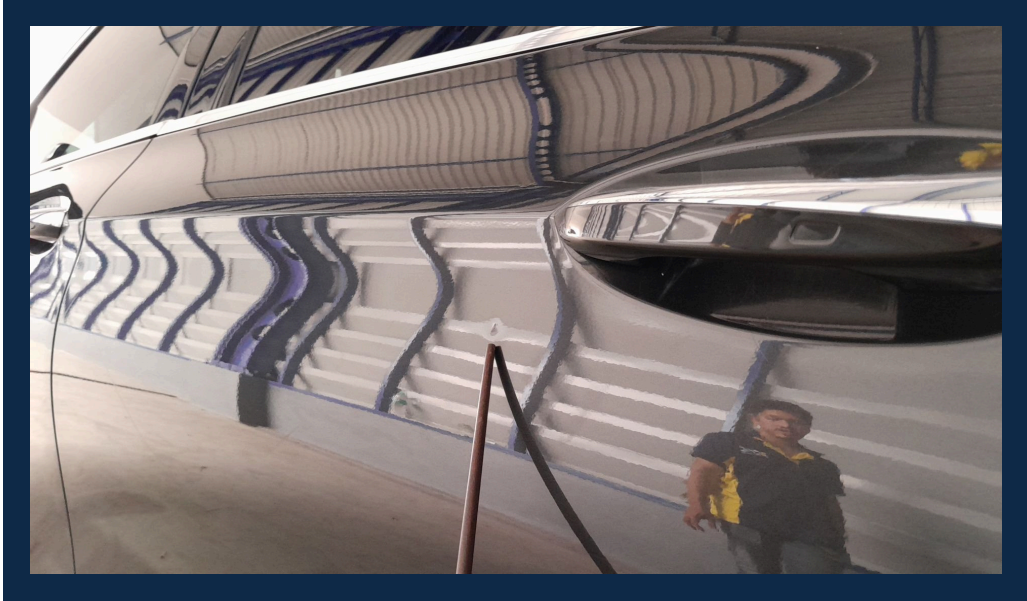
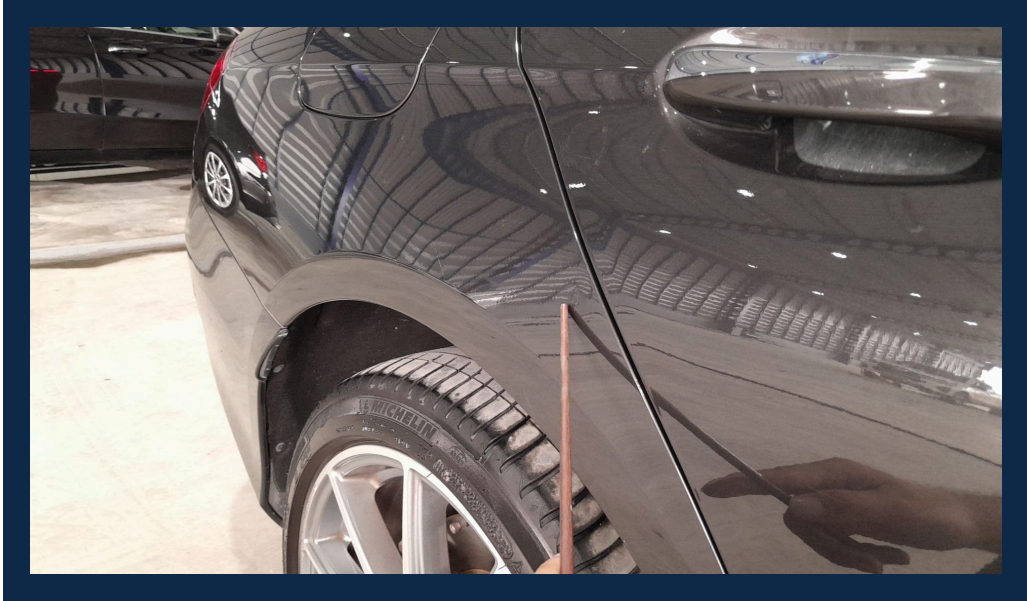
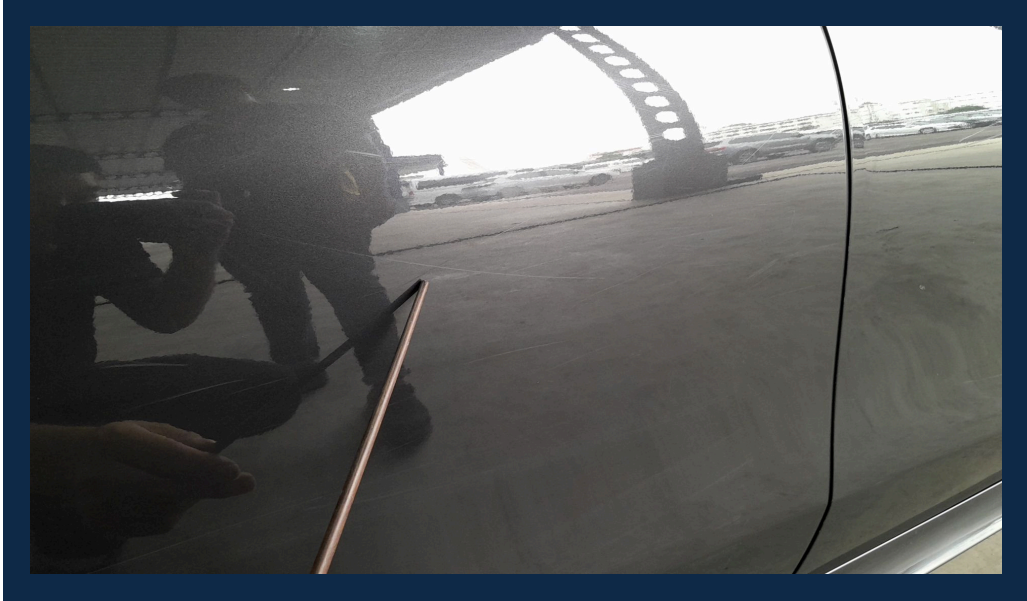
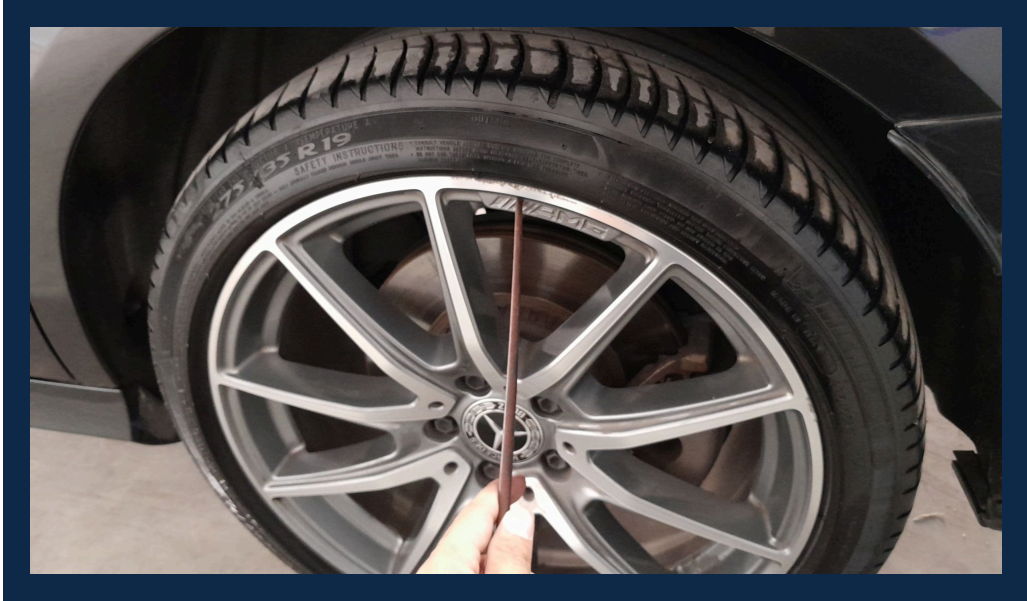
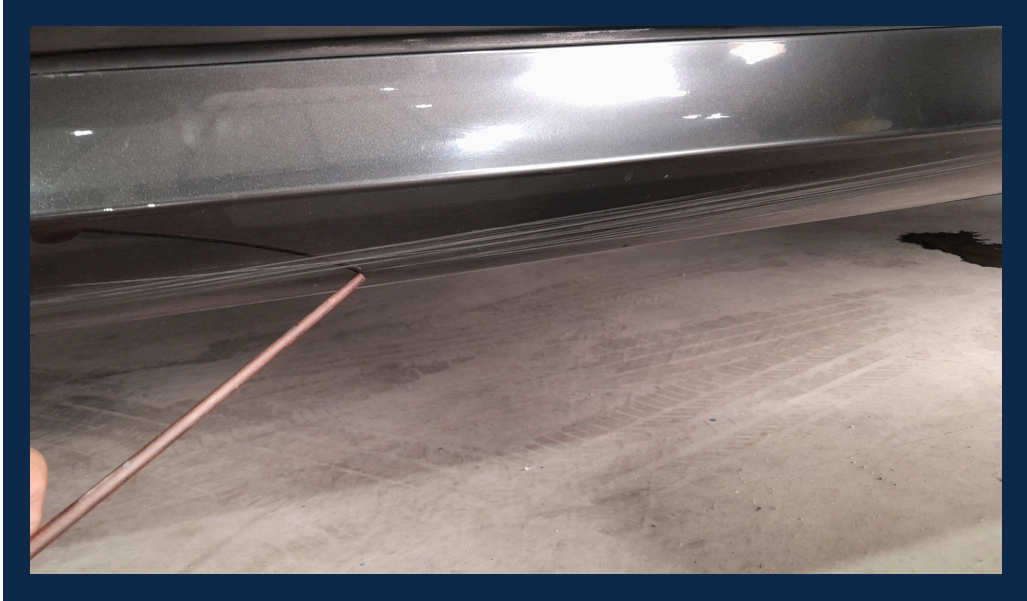
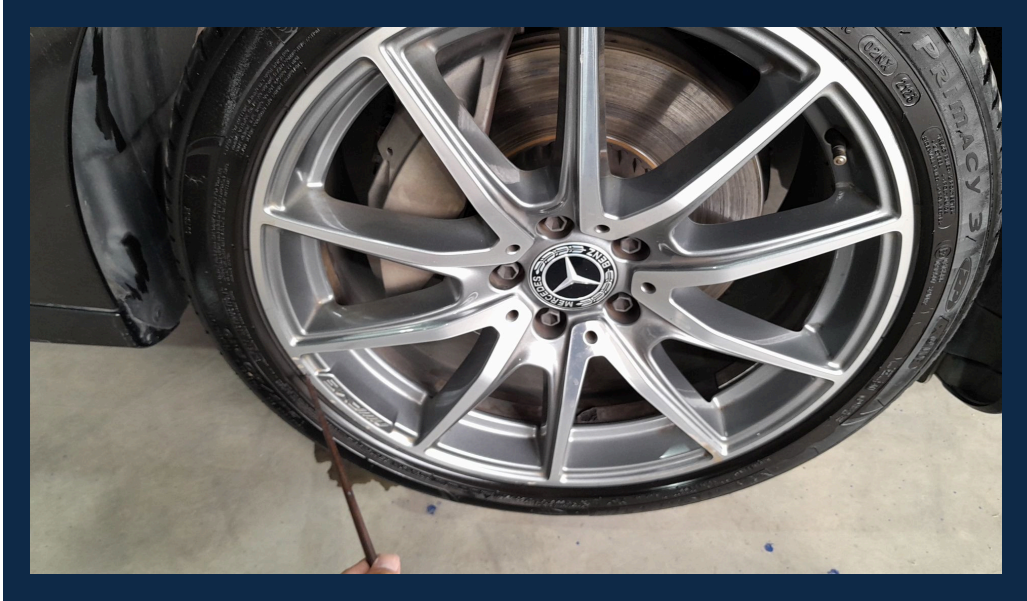
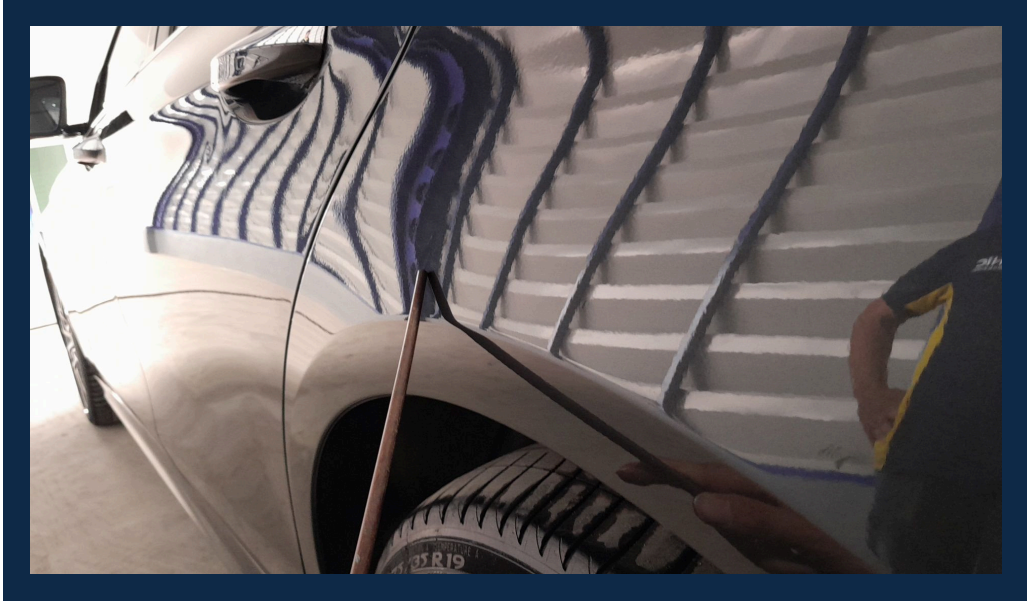
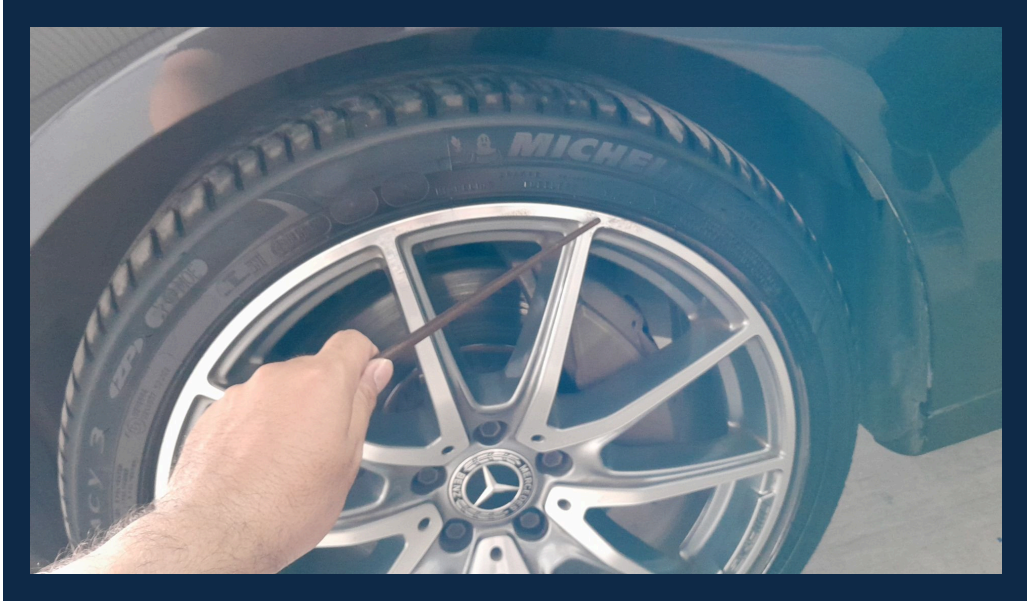
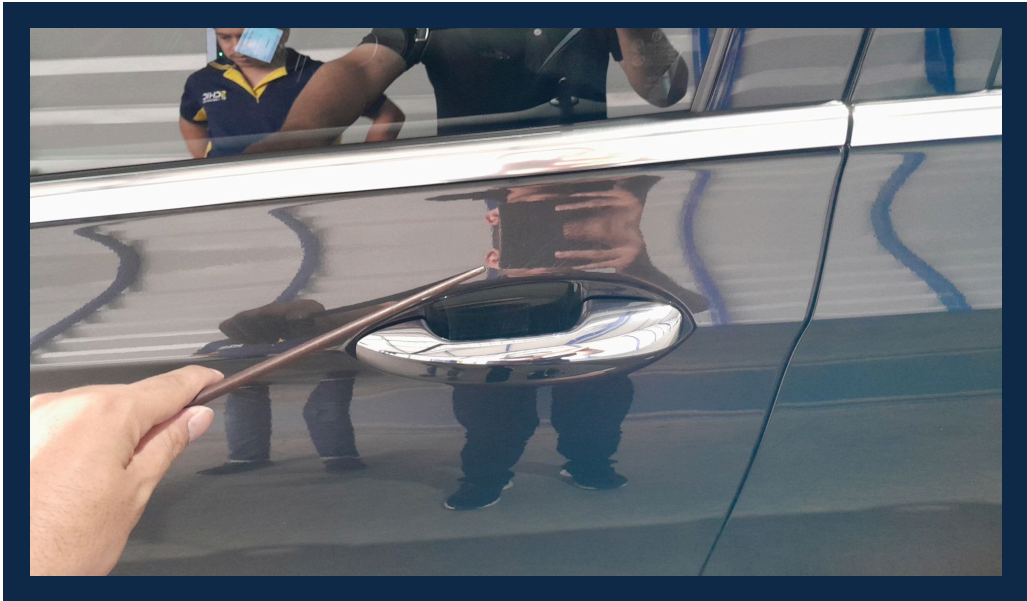
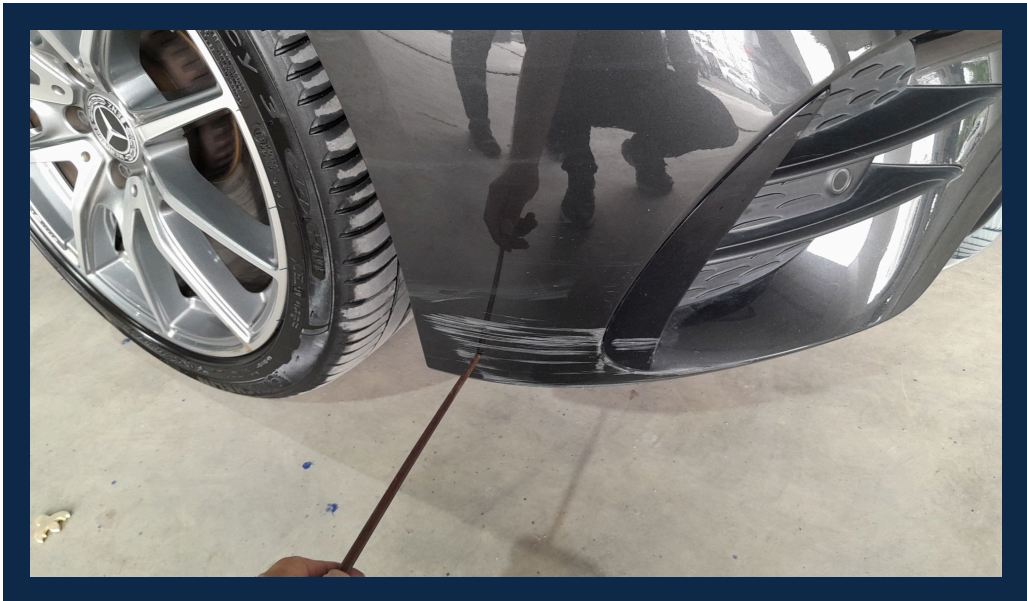
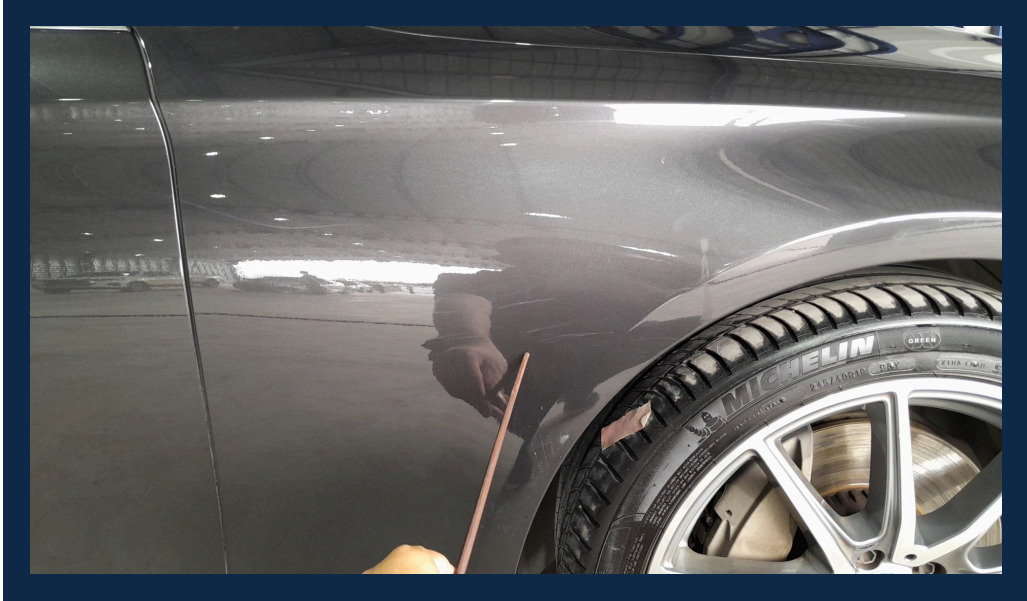
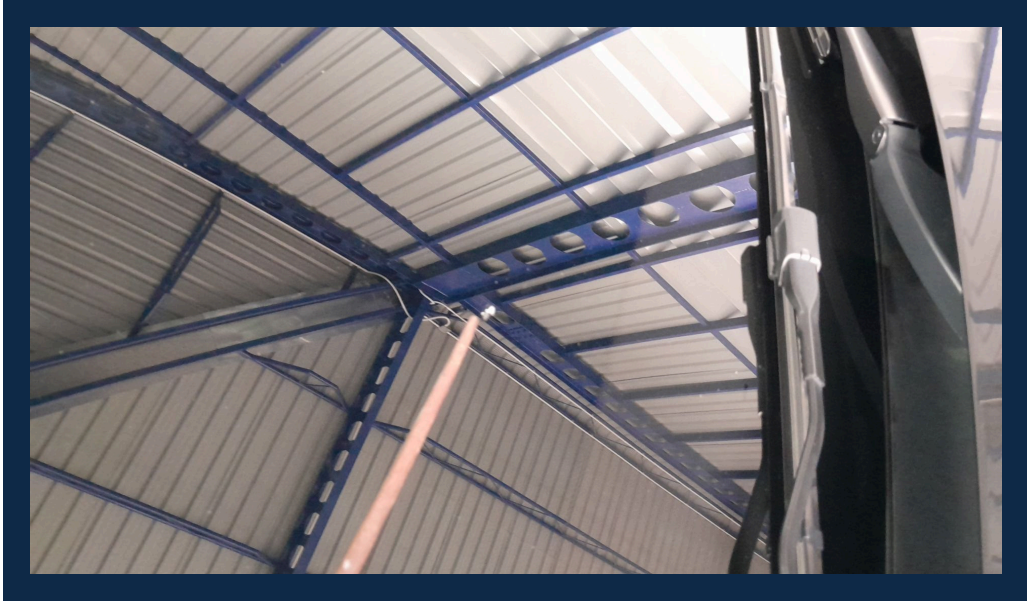
Vehicle Defect Notices

Inspector : ภายนอก(Exterior) : การตรวจสภาพภายนอกโดยรวมไม่พบหลักฐานการซ่อมแซมทำสี มีริ้วรอยถลอก บูด รอยคัน / ก้นชนหน้าและสเกิร์ตเป็นรอยถลอก /สภาพยางปกติทั้ง4เส้น หน้าปี23 หลังปี22 ภายใน(Interior) : ภายในเบาะหน้าขวามีรอยย่นเล็กน้อย สะอาดเรียบร้อย ,อุปกรณ์ไฟฟ้า แอร์ วิทยุFM ใช้งานได้ตามมาตรฐานครบปกติ
