# Preowned Vehicle Inspection Report

Premium Inspection Analysis

**Vehicle :** MERCEDES BENZ E300

**Chassis number :** W1K2130536L042696

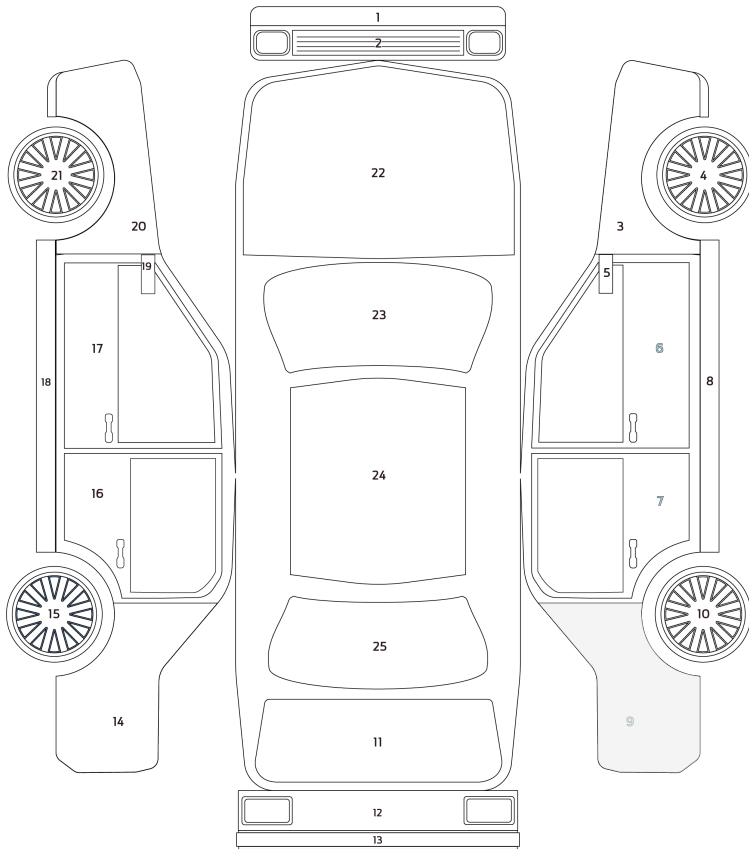
### Exterior Inspection Points

1. Front Skirt	O	14. Left Skirt	O
2. Front Bumper	O	15. Left Wing Mirror	O
3. Front Right Fender	O	16. Front Windshield	O
4. Front Right Wheel	O	17. Roof	O
5. Front Left Fender	O	18. Rear right fender	O (S1)
6. Front Left Wheel	O	19. Rear Bonnet	O
7. Front Bonnet	O	20. Back Right Wheel	O
8. Right Wing Mirror	O	21. Rear Bumper	O
9. Front Right Door	O	22. Rear Skirt	O
10. Rear Right Door	O	23. Rear Left Fender	O
11. Right Skirt	O	24. Back Left Wheel	O
12. Rear Left Door	O	25. Back Windshield	O
13. Front Left Door	O

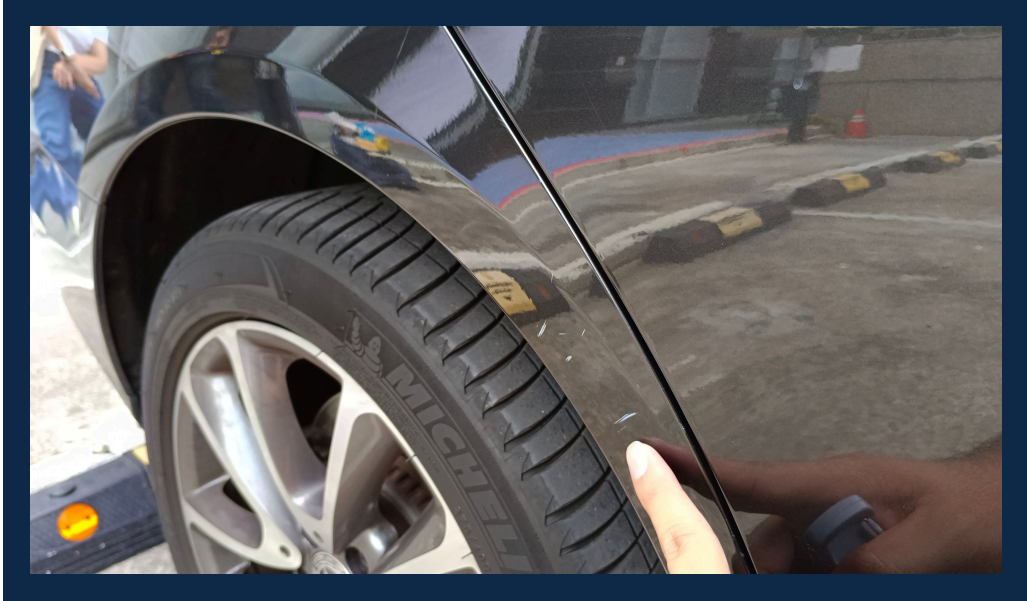
**Vehicle Defect Notices**

**Inspector :** ภายนอก(Exterior) : การตรวจสภาพภายนอกโดยรวมไม่พบหลักฐานการซ่อมแซมทำสี/รถมีรอยบุบและรอยถลอกที่บังโคลนหลังขวา รอยถลอกประตูหน้าซ้าย/ สภาพยางปกติทั้ง4เส้น ปี21 ภายใน(Interior) : ภายในปกติ สะอาดเรียบร้อย ,อุปกรณ์ไฟฟ้า แอร์ วิทยุFM ใช้งานได้สมบูรณ์ครบปกติ เครื่องยนต์(Engine) : เครื่องยนต์ทำงานได้ปกติ ,วิเคราะห์ปัญหาด้วยเครื่อง OBDII พบสิ่งผิดปกติ ขึ้นโค้ดบ015902(ไม่ได้ทดสอบขับชี้) โครงสร้าง(Frame) : อุบัติเหตุไม่มี ,โครงสร้างหลักปกติ ไม่มีการซ่อมแซมโครงสร้างหรือมีการชนถึงโครงสร้าง

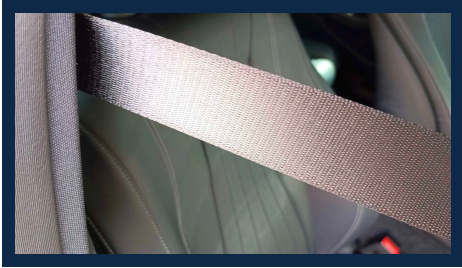
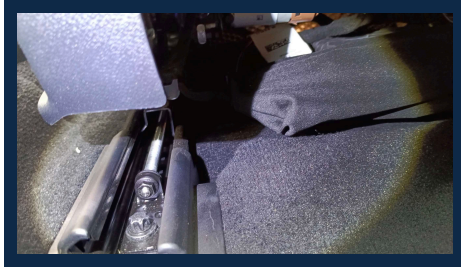
**Flood Report**

Evidence of Flood	No
-------------------	----

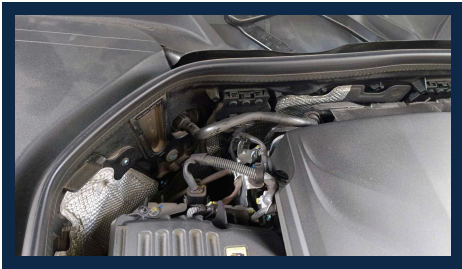
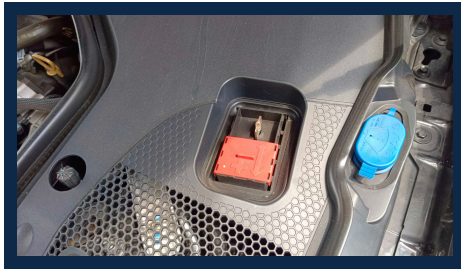
**Fire Report**

Evidence of Fire	No
------------------	----
