# Preowned Vehicle Inspection Report

Premium Inspection Analysis

Customer Name	: MERCEDES-BENZ MOBILITY (THAILAND) CO., LTD.	Inspection Date	: 2024-09-13
Tel.	:	Lemon Inspection ID	: LEMON24090117
Inspector	: ไชยมงคล ไพร์เลี้ยง	Approved By	: Sakulpong S

Brand	MERCEDES BENZ	Model year	2021
Model	E300	Engine Code - No.	27492031981614
Sub-model	e AMG Dynamic	Registration year	2023-11-28
License Plate		Chassis No.	W1K2130536L037431
Current Mileage(km.)	65781	Engine Capacity(cc.)	2000

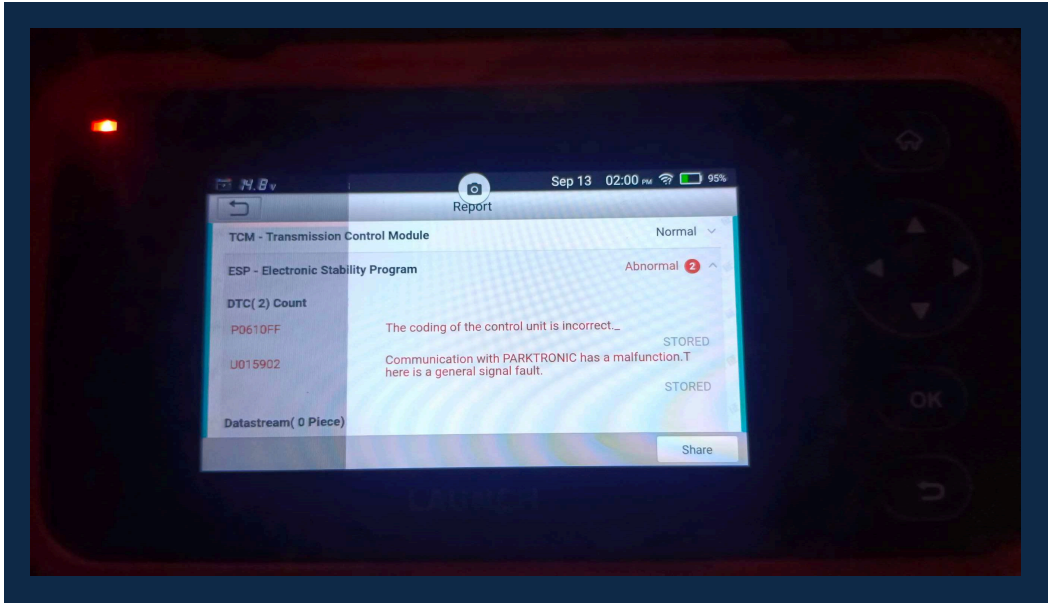
**OBD Vehicle Health Analysis**

**Inspector :** ภายนอก(Exterior) : ตรวจสอบพบบริเวณ กันชนหน้าถลอก ประตูหลังฝั่งขวาถลอก บังโคลนหลังขวาบุบ ประตูหลังขวามุมถลอก ประตูหน้าซ้ายถลอก ภายใน(Interior) : ภายในปกติสะอาดเรียบร้อย ,อุปกรณ์ไฟฟ้าแอร์ วิทยุ ใช้งานได้ตามมาตรฐานครบปกติ เครื่องยนต์(Engine) : วิเคราะห์ปัญหาด้วยเครื่อง OBDII พบสิ่งผิดปกติ P0610FF กล้องควบคุมสัญญาณเข้ารหัสผิดพลาด (เคยเกิดขึ้น) U015902 ระบบสัญญาณช่วยจอดทำงานผิดปกติ (เคยเกิดขึ้น) แนะนำตรวจเช็คโดยละเอียดกับทางศูนย์บริการ (ไม่ได้ทดสอบขับขี) โครงสร้าง(Frame) : โครงสร้างหลักปกติ ไม่มีการซ่อมแซมโครงสร้างหรือมีการชนถึงโครงสร้าง

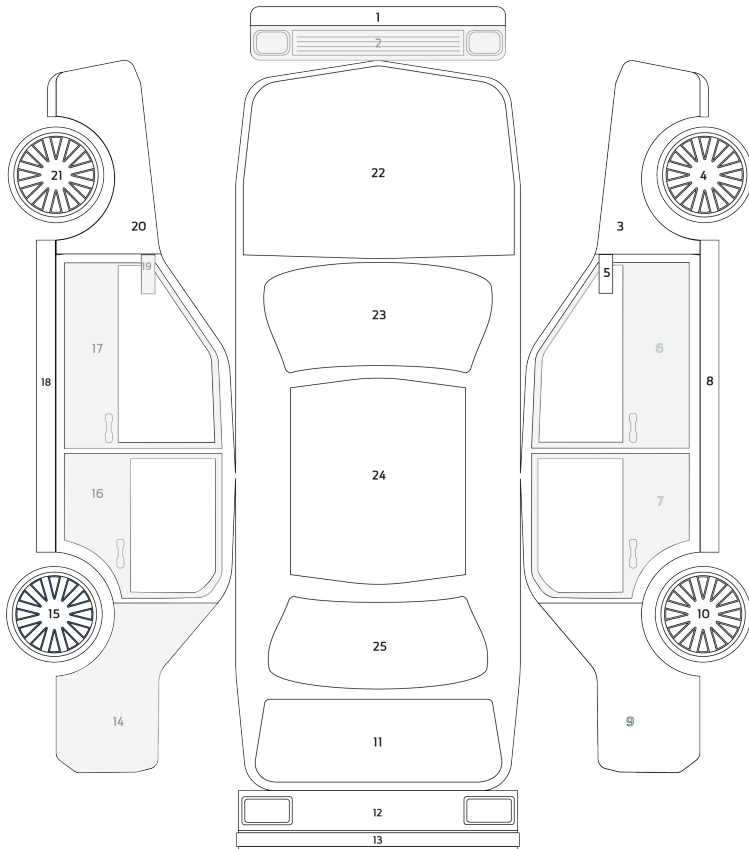
### Exterior Inspection Points

1. Front Skirt	O	14. Left Skirt	O
2. Front Bumper	O (S2)	15. Left wing mirror	O (S1)
3. Front Right Fender	O	16. Front Windshield	O
4. Front Right Wheel	O	17. Roof	O
5. Front Left Fender	O	18. Rear Right Fender	O
6. Front Left Wheel	O	19. Rear Bonnet	O
7. Front Bonnet	O	20. Back Right Wheel	O
8. Right Wing Mirror	O	21. Rear Bumper	O
9. Front right door	O (S1)	22. Rear Skirt	O
10. Rear right door	O (S1)	23. Rear left fender	O (D2)
11. Right Skirt	O	24. Back Left Wheel	O
12. Rear Left door	O (S1,D1)	25. Back Windshield	O
13. Front left door	O (S1)

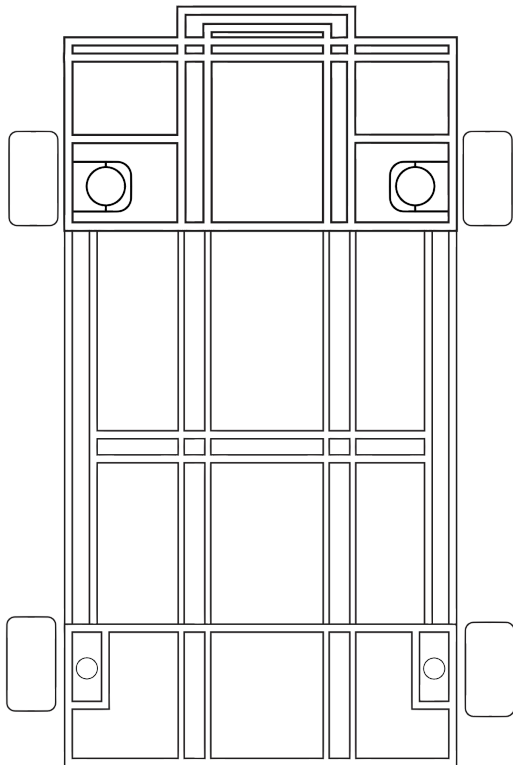
## Chassis Report

No dent in the under carriage	PASS
No deform chassis or chassis frame	PASS
No visible corrosion on the chassis or chassis frame	PASS
No missing part on the chassis frame	PASS
Half cut Analysis	PASS

Chassis Damage Level	No Damage
----------------------	-----------
