# Preowned Vehicle Inspection Report

Premium Inspection Analysis

Customer Name	: MERCEDES-BENZ MOBILITY (THAILAND) CO., LTD.	Inspection Date	: 2024-09-16
Tel.	:	Lemon Inspection ID	: LEMON24090141
Inspector	: แทนรัก ทิพย์อินทร์	Approved By	: Sakulpong S

Brand	MERCEDES BENZ	Model year	2022
Model	EQS	Engine Code - No.	78060020019220 78030010066211
Sub-model	500 4MATIC AMG Premium	Registration year	2023-12-06
License Plate		Chassis No.	W1K2971346L000324
Current Mileage(km.)	37029	Engine Capacity(cc.)	0

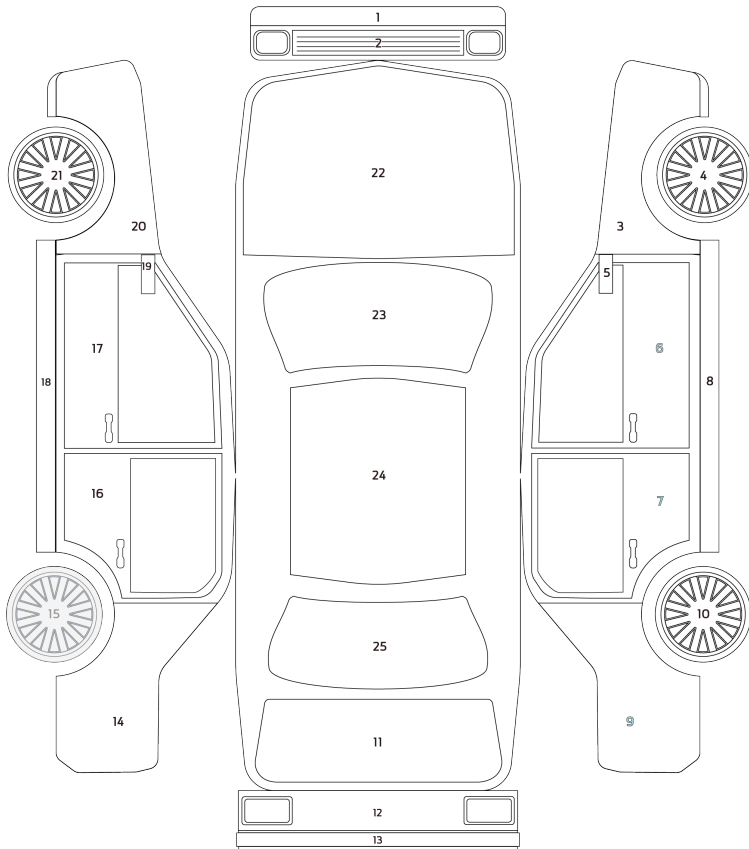
### Exterior Inspection Points

1. Front Skirt	O	14. Left Skirt	O
2. Front Bumper	O	15. Left Wing Mirror	O
3. Front Right Fender	O	16. Front Windshield	O
4. Front Right Wheel	O	17. Roof	O
5. Front Left Fender	O	18. Rear Right Fender	O
6. Front Left Wheel	O	19. Rear Bonnet	O
7. Front Bonnet	O	20. Back Right Wheel	O
8. Right Wing Mirror	O	21. Rear Bumper	O
9. Front Right Door	O	22. Rear Skirt	O
10. Rear Right Door	O	23. Rear Left Fender	O
11. Right Skirt	O	24. Back left wheel	O (S1)
12. Rear Left Door	O	25. Back Windshield	O
13. Front Left Door	O

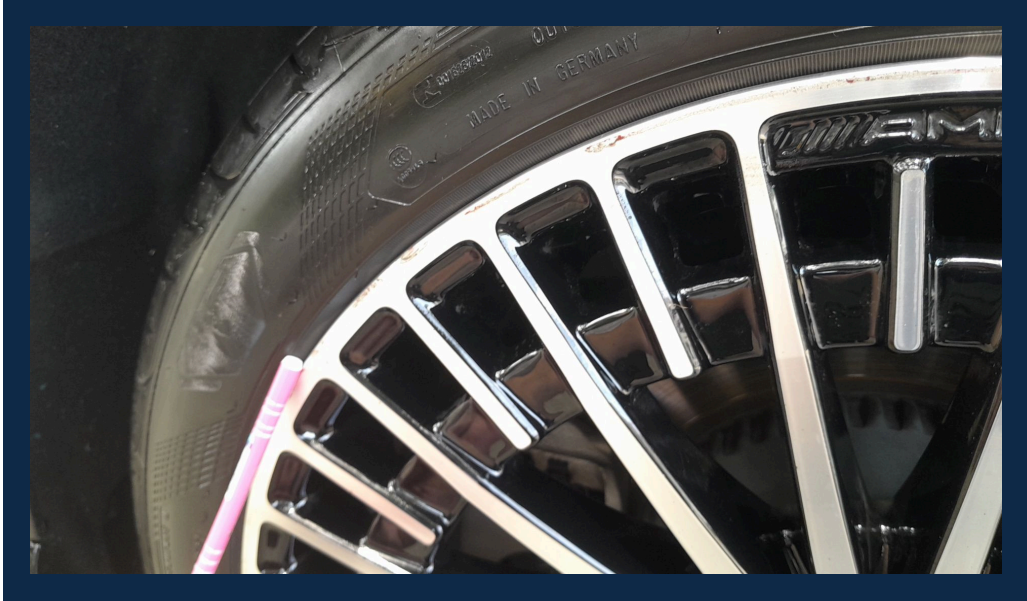
**Vehicle Defect Notices**

**Inspector :** ภายนอก(Exterior) : ล้อแม็กเป็นรอยถลอก / รถรีปสตีกเกอร์มารอบคัน ภายใน(Interior) : อุปกรณ์ไฟฟ้า แอร์ วิทยุ ใช้งานได้ตามมาตรฐานครบปกติ เครื่องยนต์(Engine) : เครื่องยนต์ทำงานได้ปกติ ,วิเคราะห์ปัญหาด้วยเครื่อง OBDII ไม่พบสิ่งผิดปกติ (ไม่ได้ทดสอบขับขี) โครงสร้าง(Frame) : โครงสร้างหลักปกติ ไม่มีการซ่อมแซมโครงสร้างหรือมีการชนถึงโครงสร้าง
