# Preowned Vehicle Inspection Report

Premium Inspection Analysis

Customer Name : MERCEDES-BENZ MOBILITY (THAILAND) CO., LTD. Inspection Date : 2024-09-17  
 Tel. : \_\_\_\_\_ Lemon Inspection ID : LEMON24090143  
 Inspector : แทนรัก ทิพย์อินทร์ Approved By : Yoskongsak B

Brand	MERCEDES BENZ	Model year	2019
Model	E350	Engine Code - No.	27492031673878
Sub-model	e Exclusive	Registration year	2019-12-02
License Plate		Chassis No.	WDD2130506L022175
Current Mileage(km.)	89385	Engine Capacity(cc.)	1991

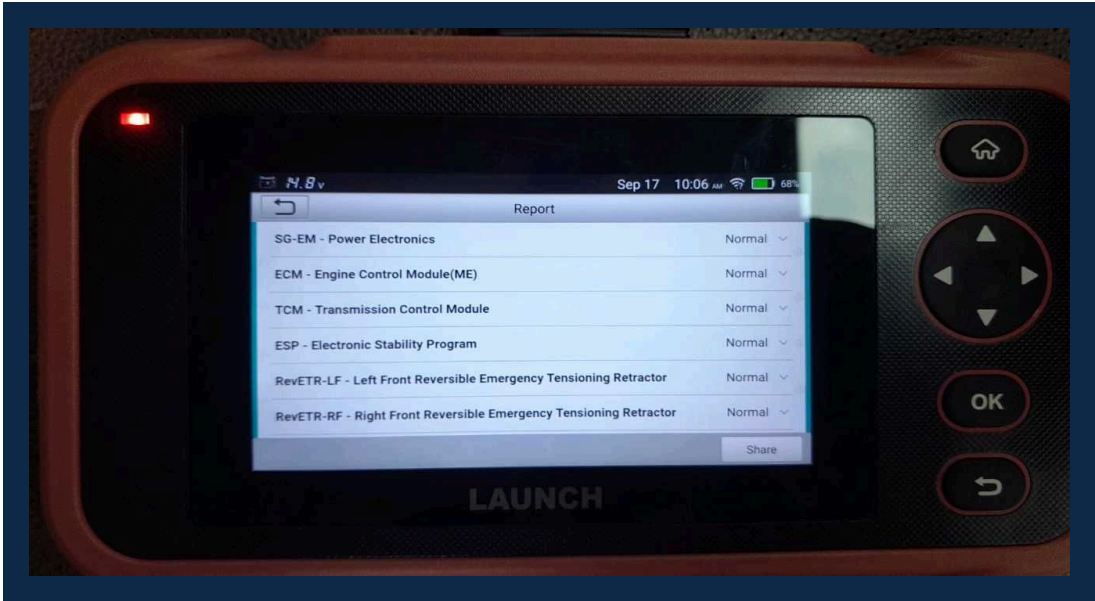
**OBD Vehicle Health Analysis**

1. Vehicle Engine Number Analysis	PASS	14. Air Conditioning and Heating System	PASS
2. Vehicle Chassis Number Analysis	PASS	15. Front and Rear Suspension	PASS
3. Vehicle Original OEM Color Analysis	PASS	16. Drive Axle	PASS
4. Engine System	PASS	17. High Tech	PASS
5. Transmission System	PASS	18. Passenger Comfort	PASS
6. Electrical System	PASS	19. Security System	PASS
7. Brake System	PASS	20. Safety Active	PASS
8. Steering System	PASS	21. Safety Passive	PASS
9. Fuel System	PASS	22. Original Mileage Analysis	PASS
10. Four-wheel Drive	PASS	23. Overall Chassis Analysis	PASS
11. Turbocharger/Supercharger	PASS	24. Overall Exterior Analysis	PASS
12. Fuel Injection and Engine Management System	PASS	25. Overall Interior Analysis	PASS
13. Engine Cooling System	PASS

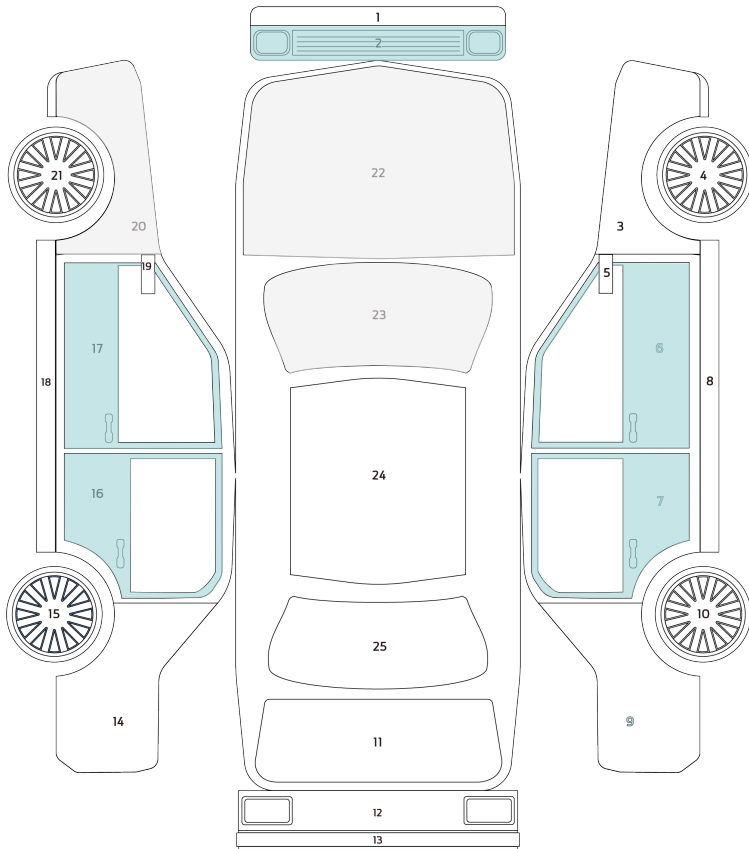
### Exterior Inspection Points

1. Front Skirt	O	14. Left Skirt	O
2. Front Bumper	BP (S1)	15. Left Wing Mirror	O
3. Front Right Fender	O	16. Front windshield	O (S1)
4. Front Right Wheel	O	17. Roof	O
5. Front Left Fender	O (S1)	18. Rear Right Fender	O
6. Front Left Wheel	O	19. Rear Bonnet	O
7. Front bonnet	O (S1)	20. Back Right Wheel	O
8. Right Wing Mirror	O	21. Rear Bumper	O
9. Front right door	BP (S1)	22. Rear Skirt	O
10. Rear right door	BP	23. Rear Left Fender	O
11. Right Skirt	O	24. Back Left Wheel	O
12. Rear Left door	BP	25. Back Windshield	O
13. Front left door	BP
