# Preowned Vehicle Inspection Report

Premium Inspection Analysis

**Vehicle :** MERCEDES BENZ CLS 300

**Chassis number :** WDD2573186L000337

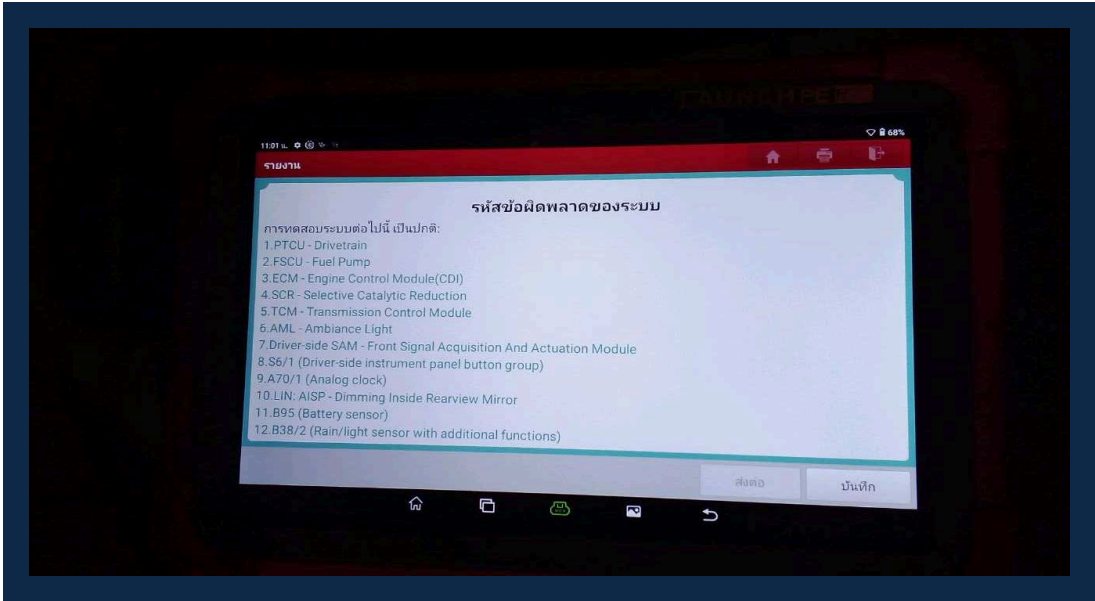
**OBD Vehicle Health Analysis**

ภายใน(Interior) : - เครื่องยนต์(Engine) : วิเคราะห์ปัญหาด้วยเครื่อง OBDII ไม่พบสิ่งผิดปกติ (ไม่ได้ทดสอบขับขี)

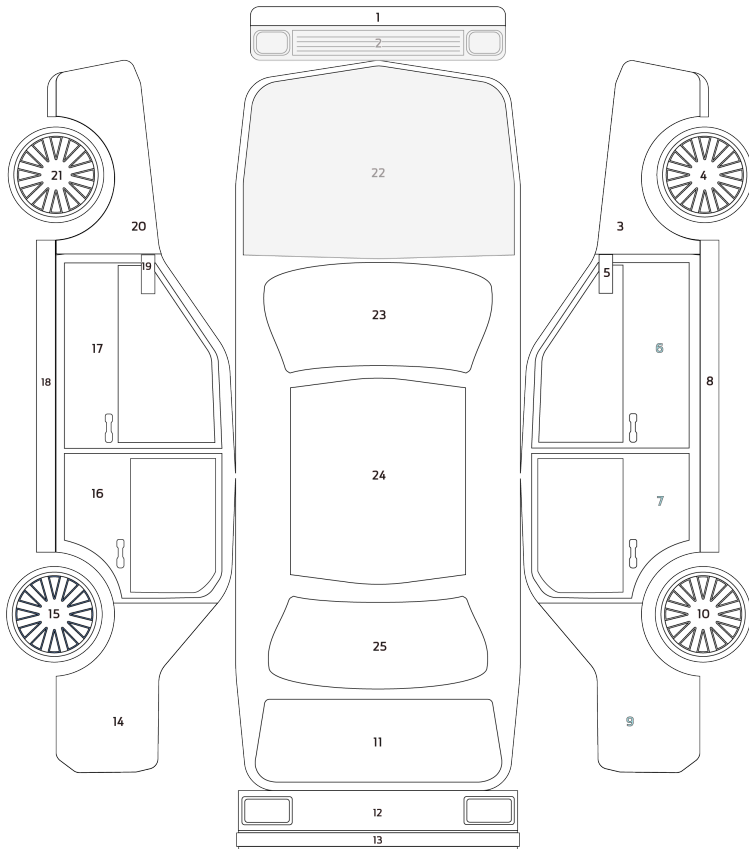
### Exterior Inspection Points

1. Front Skirt	O	14. Left Skirt	O
2. Front Bumper	O (S3)	15. Left Wing Mirror	O
3. Front Right Fender	O	16. Front Windshield	O
4. Front Right Wheel	O	17. Roof	O
5. Front Left Fender	O	18. Rear Right Fender	O
6. Front Left Wheel	O	19. Rear Bonnet	O
7. Front bonnet	O (S1)	20. Back Right Wheel	O
8. Right Wing Mirror	O	21. Rear Bumper	O
9. Front Right Door	O	22. Rear Skirt	O
10. Rear Right Door	O	23. Rear Left Fender	O
11. Right Skirt	O	24. Back Left Wheel	O
12. Rear Left Door	O	25. Back Windshield	O
13. Front Left Door	O

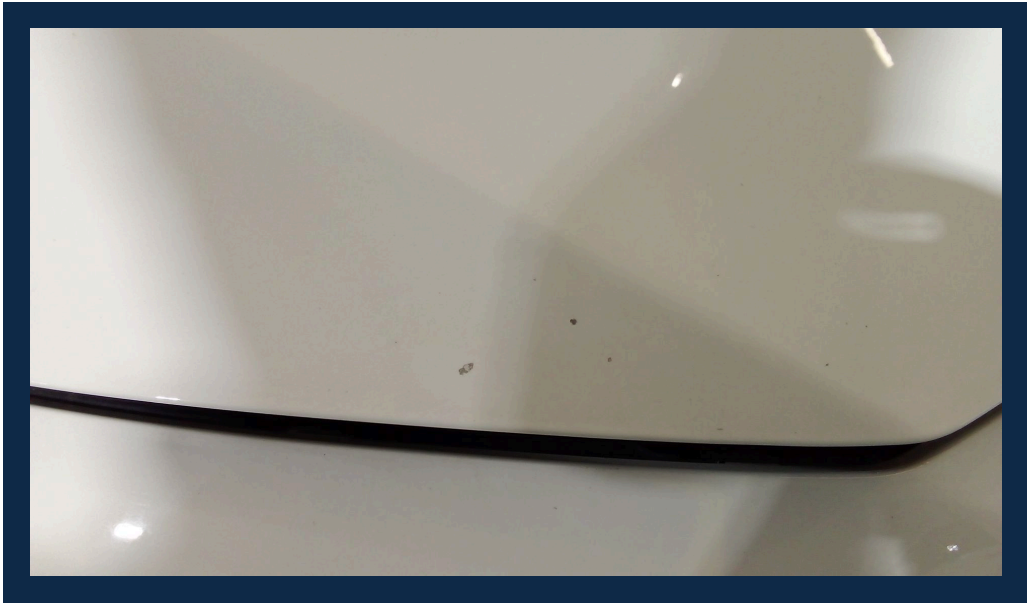
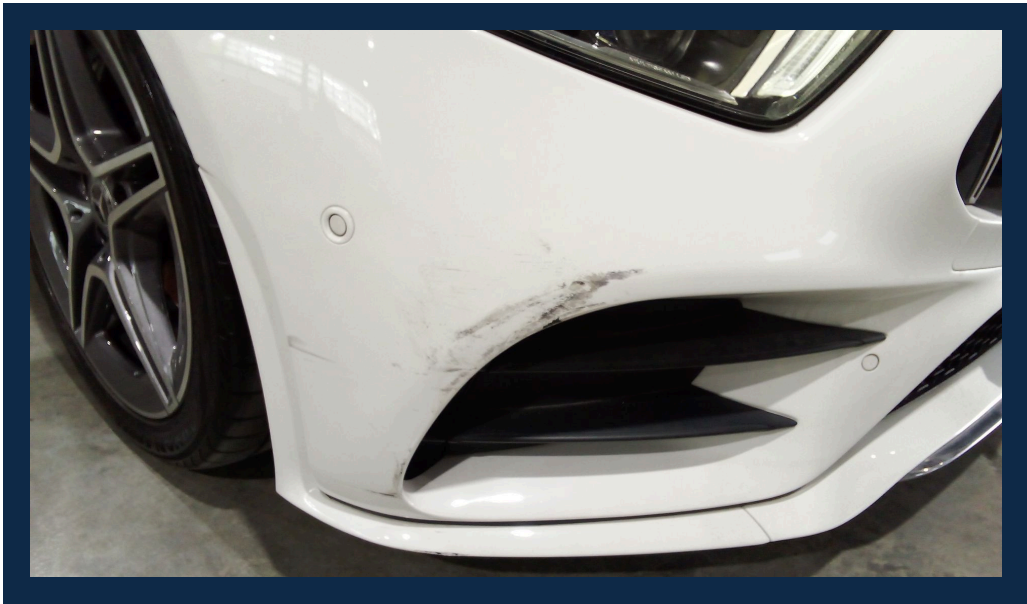
**Vehicle Defect Notices**

**Inspector :** ภายนอก(Exterior) : กันชนหน้าถลอก/ฝากระโปรงหน้ามีรอยสีกระเทาะ/ใช้คอปคู่หน้ารั้วซึม
