# Preowned Vehicle Inspection Report

Premium Inspection Analysis

Tel. : Lemon Inspection ID : LEMON24090167

Brand	MERCEDES BENZ	Model year	2021
Model	GLE	Engine Code - No.	65492080814998
Sub-model	300d 4MATIC AMG Dynamic	Registration year	2022-01-12
License Plate		Chassis No.	W1N1671196M002231
Current Mileage(km.)	130901	Engine Capacity(cc.)	2000

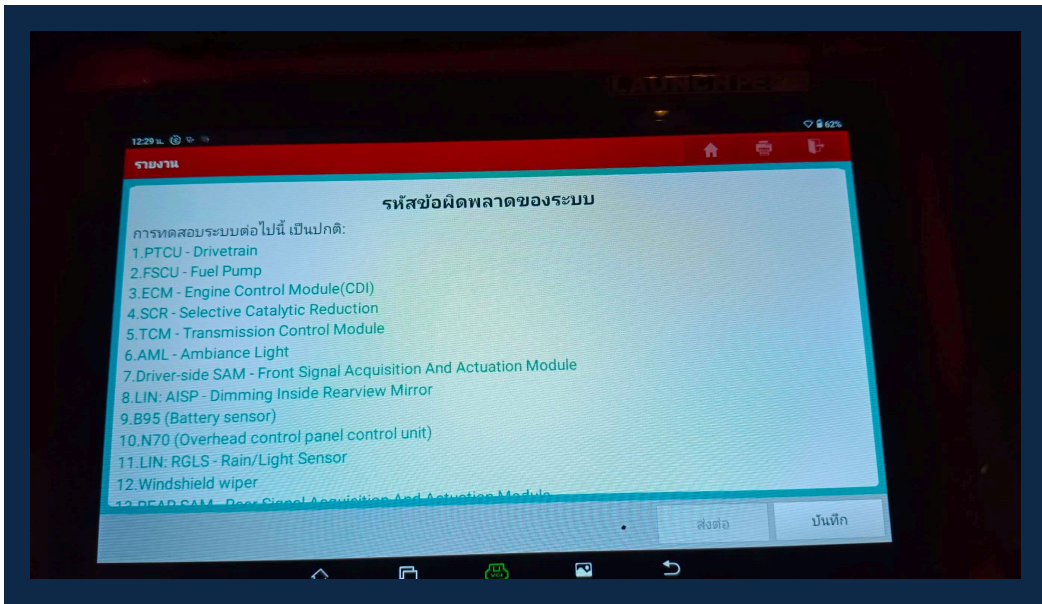
OBD Vehicle Health Analysis

**Inspector :** ภายนอก(Exterior) : - ภายใน(Interior) : - เครื่องยนต์(Engine) : วิเคราะห์ปัญหาด้วยเครื่อง OBDII ไม่พบสิ่งผิดปกติ (ไม่ได้ทดสอบขับเคลื่อน) โครงสร้าง(Frame) : -

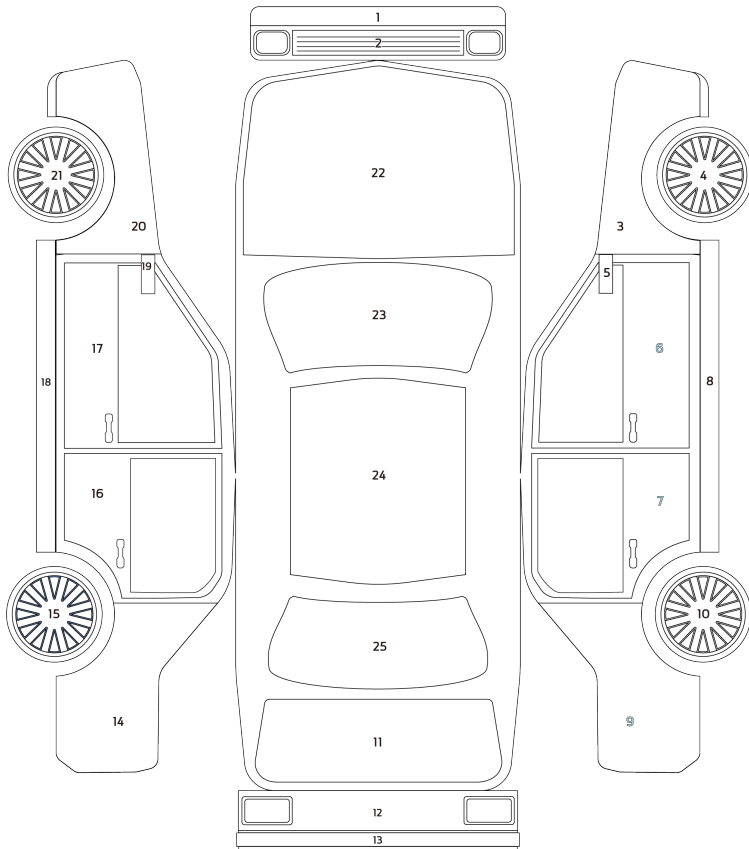
### Exterior Inspection Points

1. Front Skirt	O	14. Left Skirt	O
2. Front Bumper	O	15. Left Wing Mirror	O
3. Front Right Fender	O	16. Front Windshield	O
4. Front Right Wheel	O	17. Roof	O
5. Front Left Fender	O	18. Rear Right Fender	O
6. Front Left Wheel	O	19. Rear Bonnet	O
7. Front Bonnet	O	20. Back Right Wheel	O
8. Right Wing Mirror	O	21. Rear Bumper	O
9. Front Right Door	O	22. Rear Skirt	O
10. Rear Right Door	O	23. Rear Left Fender	O
11. Right Skirt	O	24. Back Left Wheel	O
12. Rear Left Door	O	25. Back Windshield	O
13. Front Left Door	O

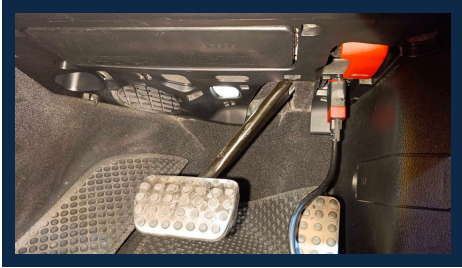
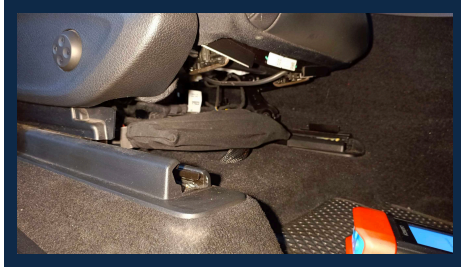
**Flood Report**

Evidence of Flood	No
-------------------	----

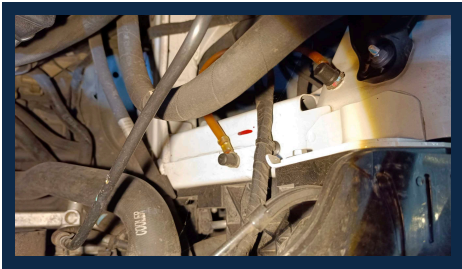
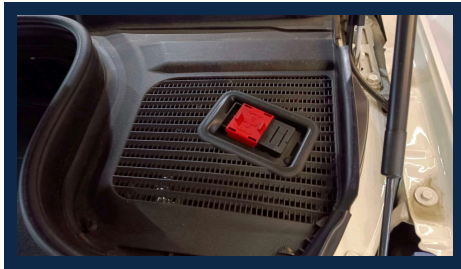
**Fire Report**

Evidence of Fire	No
------------------	----
