Preowned Vehicle Inspection Report

Premium Inspection Analysis

Customer Name	: MERCEDES-BENZ MOBILITY (THAILAND) CO., LTD.	Inspection Date	: 2024-09-18
Tel.	:	Lemon Inspection ID	: LEMON24090171
Inspector	: ไชยมงคล ไพโรเลี้ยง	Approved By	: Sakulpong S

Brand	MERCEDES BENZ	Model year	2022
Model	C220	Engine Code - No.	65482080041496
Sub-model	d Avantgarde	Registration year	2023-06-28
License Plate		Chassis No.	W1K2060046L002615
Current Mileage(km.)	24497	Engine Capacity(cc.)	2000

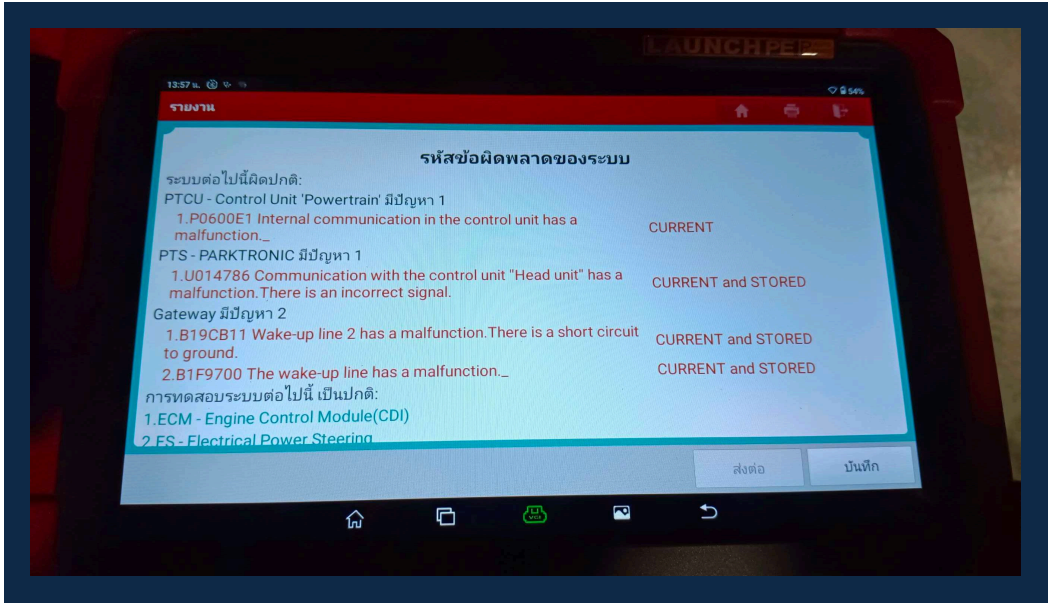
OBD Vehicle Health Analysis

เครื่องยนต์(Engine) : เครื่องยนต์ทำงานได้ปกติ ,วิเคราะห์ปัญหาด้วยเครื่อง OBDII พบสิ่งผิดปกติ P0600E1 ,U014786 ,B19CB 11,B1F9700 โค้ดเกี่ยวกับ ระบบสัญญาณของหน่วยควบคุมมีปัญหา (ไม่ได้ทดสอบขั้วชี้)

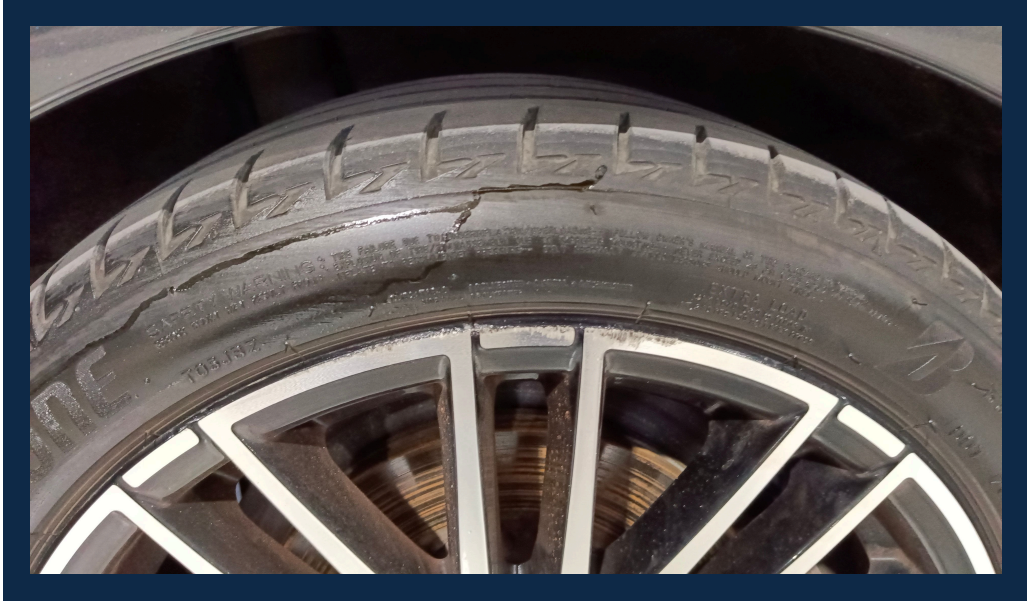
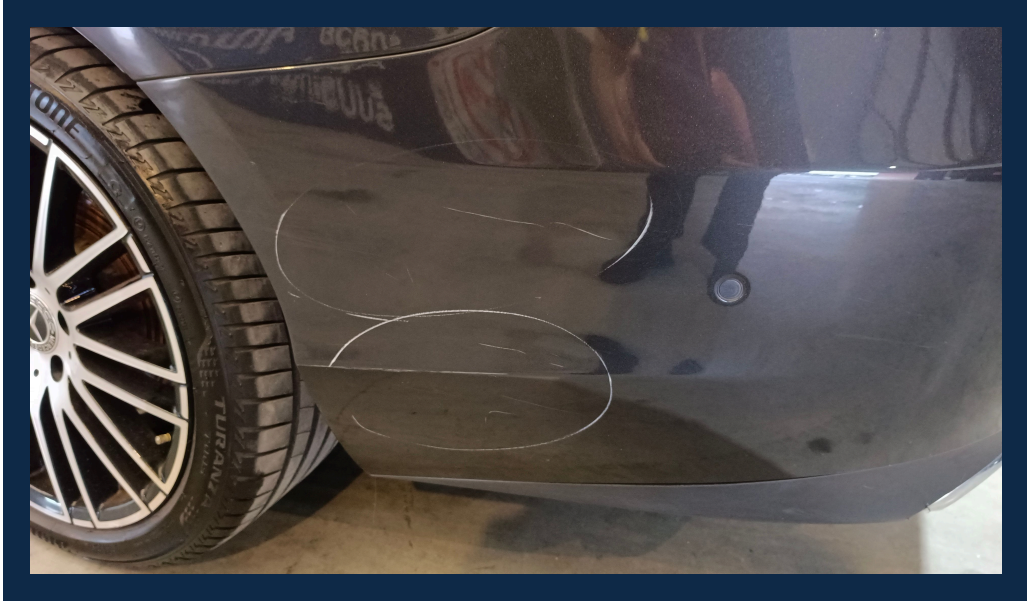
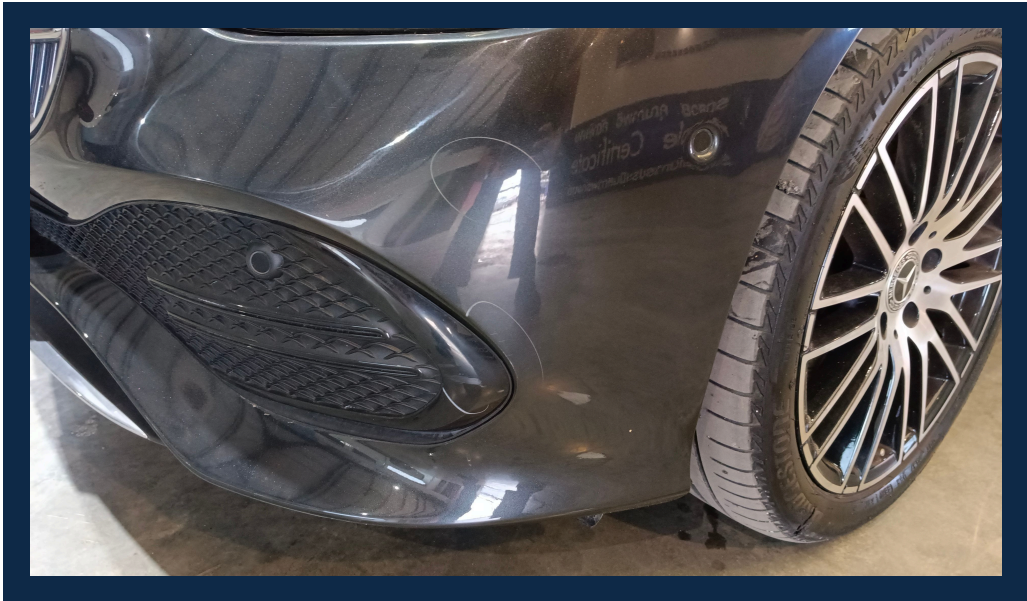
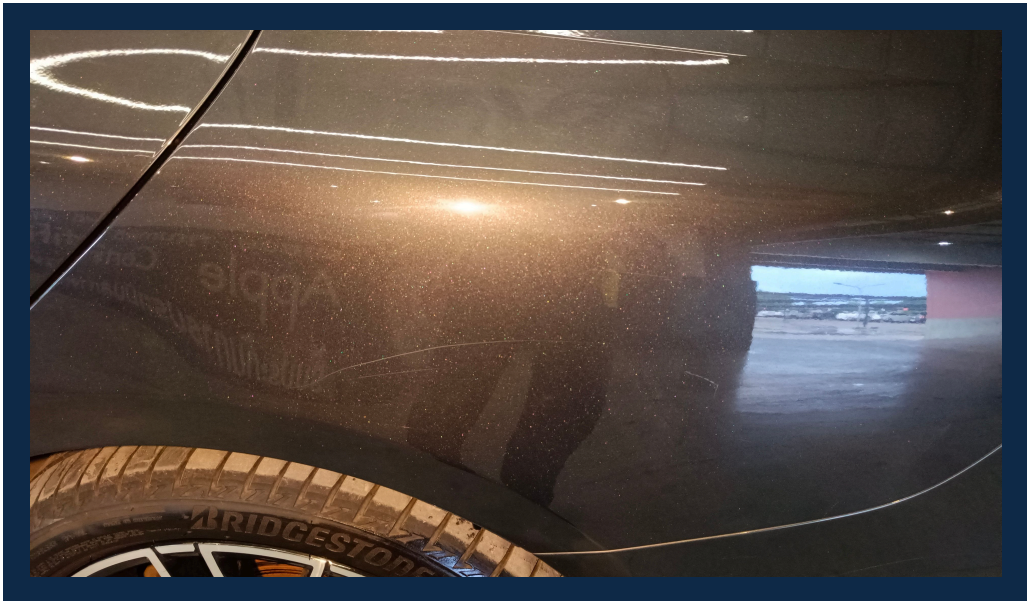
Vehicle Defect Notices

1. Front Skirt	O	14. Left Skirt	O
2. Front Bumper	O (S1)	15. Left Wing Mirror	O
3. Front Right Fender	O	16. Front Windshield	O
4. Front Right Wheel	O	17. Roof	O
5. Front Left Fender	O	18. Rear Right Fender	O
6. Front Left Wheel	O	19. Rear Bonnet	O
7. Front Bonnet	O	20. Back right wheel	O (S2)
8. Right Wing Mirror	O	21. Rear Bumper	O (S2)
9. Front Right Door	O	22. Rear Skirt	O
10. Rear Right Door	O	23. Rear left fender	O (S2)
11. Right Skirt	O	24. Back Left Wheel	O
12. Rear Left Door	O	25. Back Windshield	O
13. Front Left Door	O

Inspector : ภายนอก(Exterior) : ตรวจสอบสภาพภายนอกโดยรวมไม่พบหลักฐานการซ่อมแซมทำสี / กั้นชนหน้ารถ / ล้อแม็กหลังขวารถ / กั้นชนหลังรถ / บังโคลนหลังซ้ายรถ สภาพยางปกติทั้ง4เส้น หน้าปี21 หลังปี22
