# Preowned Vehicle Inspection Report

Customer Name	: MERCEDES-BENZ MOBILITY (THAILAND) CO., LTD.	Inspection Date	: 2024-09-17
Tel.		Lemon Inspection ID	: LEMON24090151
Inspector	: ไซยมงคล ไพโรเสียง	Approved By	: แทนรัก ทิพย์อินทร์

Brand	MERCEDES BENZ	Model year	2019
Model	GLA200	Engine Code - No.	27091031892481
Sub-model	Urban	Registration year	2023-01-27
License Plate		Chassis No.	WDC1569436L013339
Current Mileage(km.)	21643	Engine Capacity(cc.)	1600

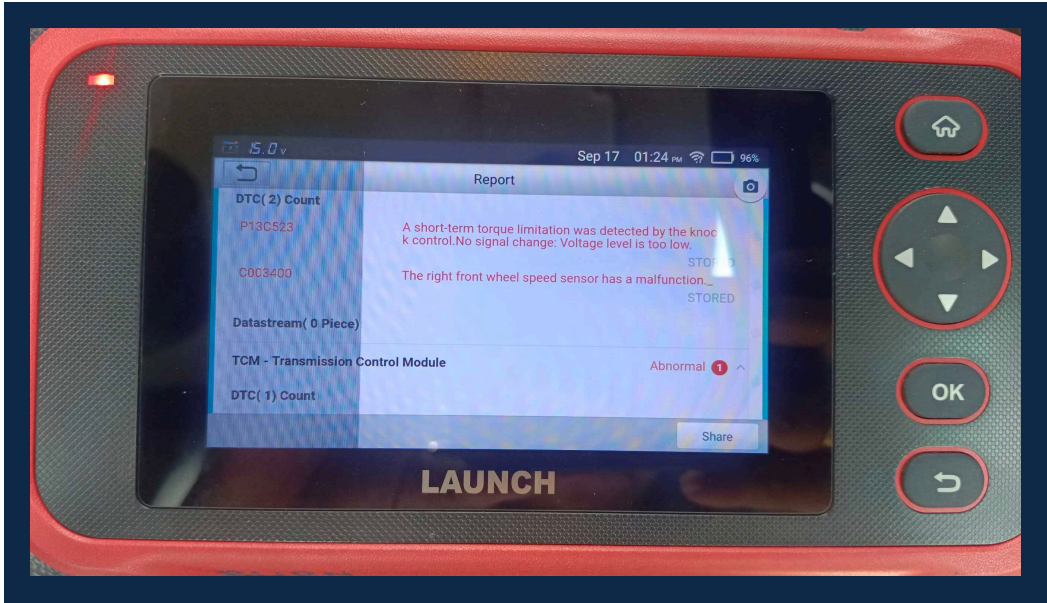
**OBD Vehicle Health Analysis**

**Inspector :** ภายนอก(Exterior) : ยางเสื่อมสภาพ 4 เส้นปี 19 ภายใน(Interior) : - เครื่องยนต์(Engine) : วิเคราะห์  
ปัญหาด้วยเครื่อง OBDII พบสิ่งผิดปกติ P13C523,C003400,D40A00 แนะนำตรวจเช็ค ไฟเครื่องยนต์หน้าปิดโชว์ (ไม่ได้  
ทดสอบขั้วขี้) โครงสร้าง(Frame) : -

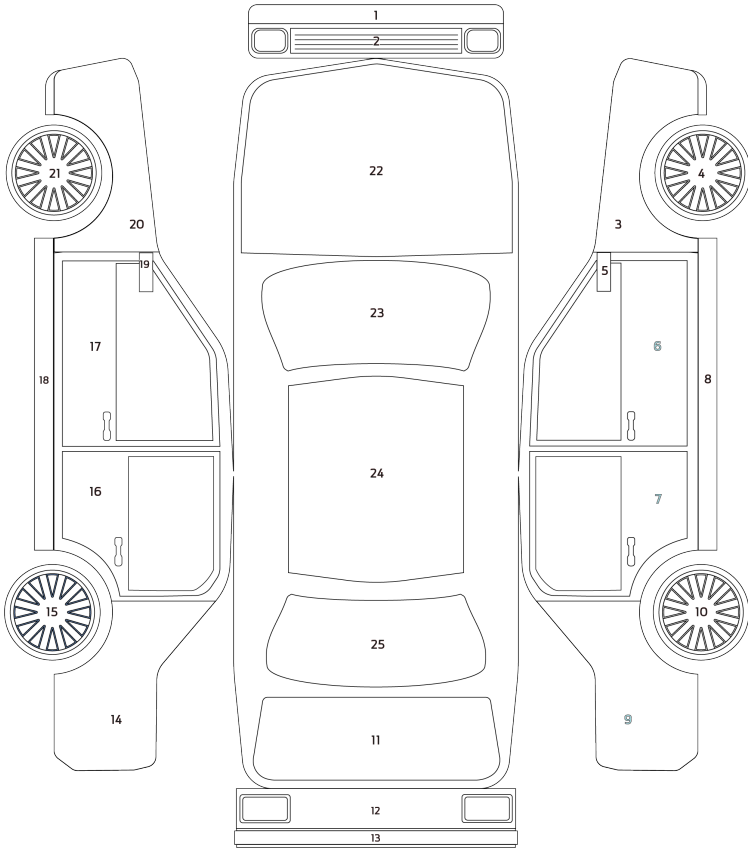
### Exterior Inspection Points

1. Front Skirt	O	14. Left Skirt	O
2. Front Bumper	O	15. Left Wing Mirror	O
3. Front Right Fender	O	16. Front Windshield	O
4. Front Right Wheel	O	17. Roof	O
5. Front Left Fender	O	18. Rear Right Fender	O
6. Front Left Wheel	O	19. Rear Bonnet	O
7. Front Bonnet	O	20. Back Right Wheel	O
8. Right Wing Mirror	O	21. Rear Bumper	O
9. Front Right Door	O	22. Rear Skirt	O
10. Rear Right Door	O	23. Rear Left Fender	O
11. Right Skirt	O	24. Back Left Wheel	O
12. Rear Left Door	O	25. Back Windshield	O
13. Front Left Door	O

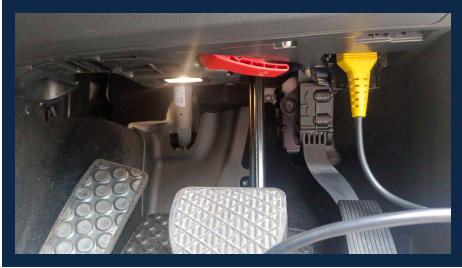
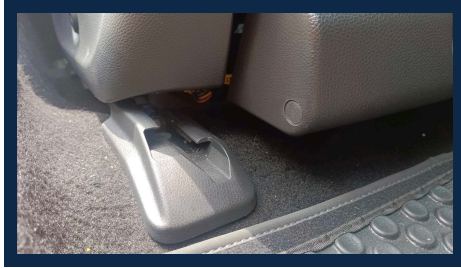
**Flood Report**

Evidence of Flood	No
-------------------	----

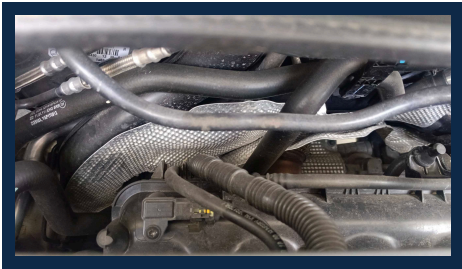
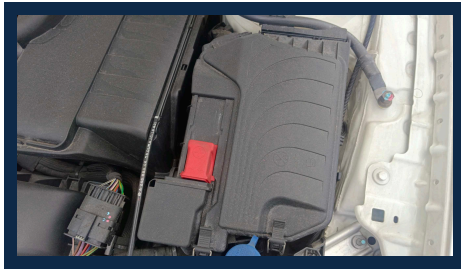
**Fire Report**

Evidence of Fire	No
------------------	----
