# Preowned Vehicle Inspection Report

Premium Inspection Analysis

Customer Name : MERCEDES-BENZ MOBILITY (THAILAND) CO., LTD. Inspection Date : 2024-09-02  
 Tel. : Lemon Inspection ID : LEMON24090008  
 Inspector : ไซยมงคล ไพโรเลี้ยง Approved By : ไซยมงคล ไพโรเลี้ยง

Brand	MERCEDES BENZ	Model year	2022
Model	GLA35	Engine Code - No.	26092030365996
Sub-model	AMG 4MATIC SPEEDSHIFT	Registration year	2022-11-11
License Plate		Chassis No.	W1N2477516L004814
Current Mileage(km.)	15906	Engine Capacity(cc.)	2000

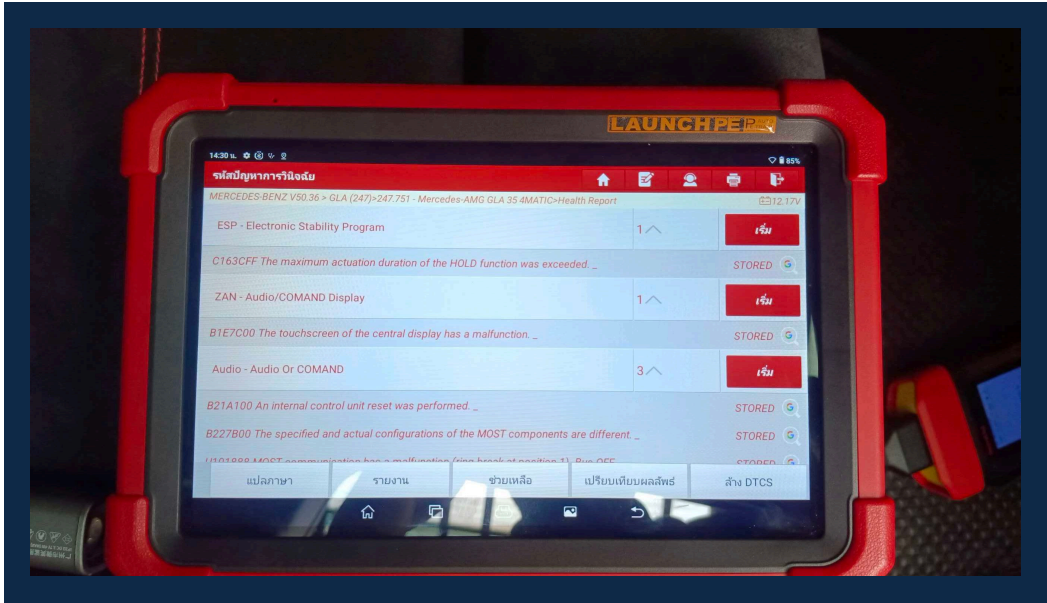
**OBD Vehicle Health Analysis**

**Inspector :** ภายนอก(Exterior) : การตรวจสอบสภาพภายนอกโดยรวมไม่พบหลักฐานการซ่อมแซมทำสี กันชนหน้ามีรอยถลอก บังโคลนหลังขวามีรอยบุบ ล้อหลังขวามีรอยถลอก ภายใน(Interior) : - เครื่องยนต์(Engine) : วิเคราะห์ปัญหาด้วยเครื่อง OBDII พบสิ่งผิดปกติ code C163CFF // B1E7C00 // B21A100 // B227B00 // U101888 // U106887 (ไม่ได้ทดสอบขับเคลื่อน) โครงสร้าง(Frame) : -

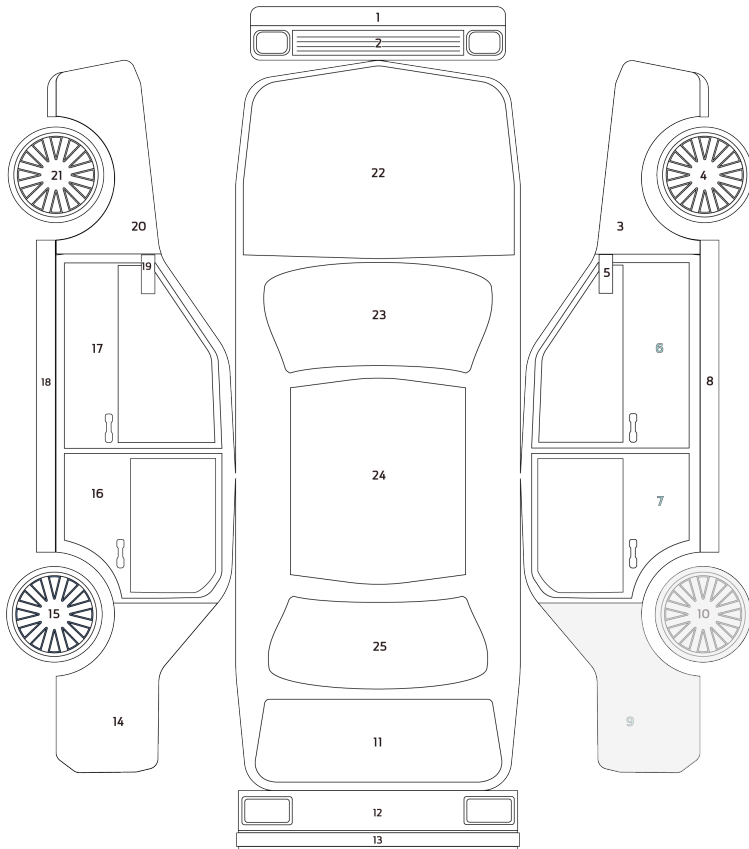
### Exterior Inspection Points

1. Front Skirt	O	14. Left Skirt	O
2. Front Bumper	O	15. Left Wing Mirror	O
3. Front Right Fender	O	16. Front Windshield	O
4. Front Right Wheel	O	17. Roof	O
5. Front Left Fender	O	18. Rear right fender	O (D1)
6. Front Left Wheel	O	19. Rear Bonnet	O
7. Front Bonnet	O	20. Back right wheel	O (S1)
8. Right Wing Mirror	O	21. Rear Bumper	O
9. Front Right Door	O	22. Rear Skirt	O
10. Rear Right Door	O	23. Rear Left Fender	O
11. Right Skirt	O	24. Back Left Wheel	O
12. Rear Left Door	O	25. Back Windshield	O
13. Front Left Door	O
