Preowned Vehicle Inspection Report

Premium Inspection Analysis

Vehicle : MERCEDES BENZ GLC250

Inspection date : 2024-09-19

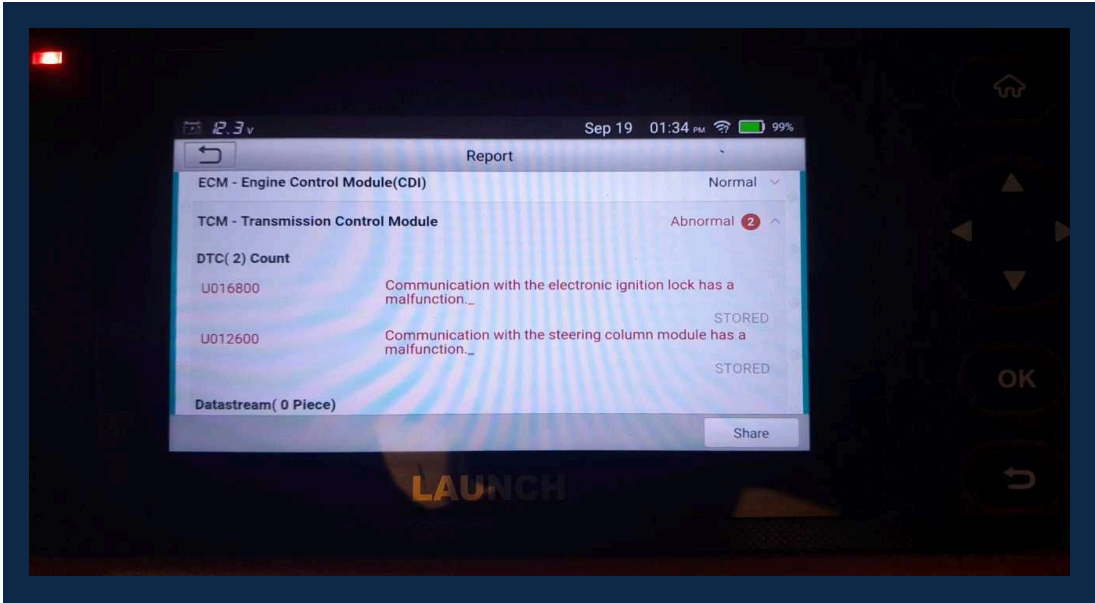
OBD Vehicle Health Analysis

Inspector : ภายนอก(Exterior) : รถเก็บสีมาแถมหน้าขวา / รั้วรอยขีดข่วนบุรอบคัน / ยางเสื่อมสภาพทั้ง 4 เส้น / ล้อแม็กเป็นรอยถลอก / ก้านปิดน้ำฝนหลังไม่มีมา / ไฟหน้าซ้ายเหลืองหมอง ภายใน(Interior) : เบาะหน้าขวาเป็นรอยขาด / แอร์มีกลิ่น เครื่องยนต์(Engine) : วิเคราะห์ปัญหาด้วยเครื่อง OBDII พบสิ่งผิดปกติ U016800 / U012600 = เกี่ยวกับระบบสื่อสารพวงมาลัยและจุดระเบิดทำงานบกพร่อง (ไม่ได้ทดสอบขับขี) โครงสร้าง(Frame) : -

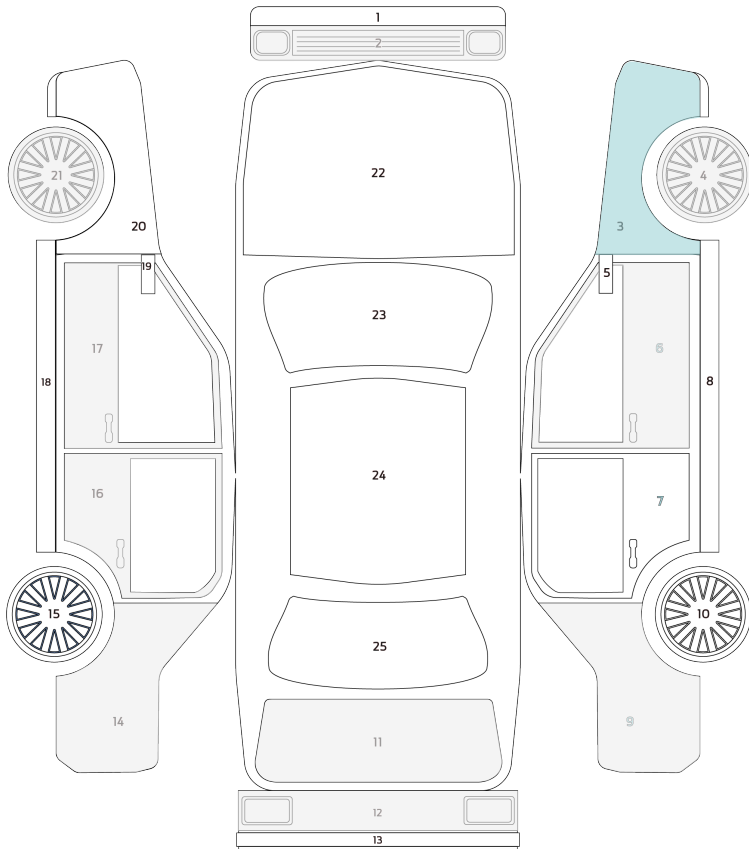
Exterior Inspection Points

1. Front Skirt	O	14. Left Skirt	O
2. Front Bumper	O (S1)	15. Left Wing Mirror	O
3. Front Right Fender	BP	16. Front Windshield	O
4. Front Right Wheel	O (S1)	17. Roof	O
5. Front Left Fender	O	18. Rear right fender	O (D1)
6. Front Left Wheel	O (S1)	19. Rear Bonnet	O (S1)
7. Front Bonnet	O	20. Back Right Wheel	O
8. Right Wing Mirror	O	21. Rear Bumper	O (S1)
9. Front right door	O (D1)	22. Rear Skirt	O
10. Rear Right Door	O	23. Rear left fender	O (D1)
11. Right Skirt	O	24. Back Left Wheel	O
12. Rear Left door	O (D1)	25. Back Windshield	O
13. Front left door	O (S1)
