Preowned Vehicle Inspection Report

Premium Inspection Analysis

Customer Name : MERCEDES-BENZ MOBILITY (THAILAND) CO., LTD. Inspection Date : 2024-09-04
Tel. : Lemon Inspection ID : LEMON24090024
Inspector : ไชยมงคล ไพโรเลี้ยง Approved By : Tanrak T

Brand	MERCEDES BENZ	Model year	2023
Model	GLC350	Engine Code - No.	254920V0216390
Sub-model	e AMG Dynamic	Registration year	2024-03-08
License Plate		Chassis No.	W1N2546566L000413
Current Mileage(km.)	18377	Engine Capacity(cc.)	2000

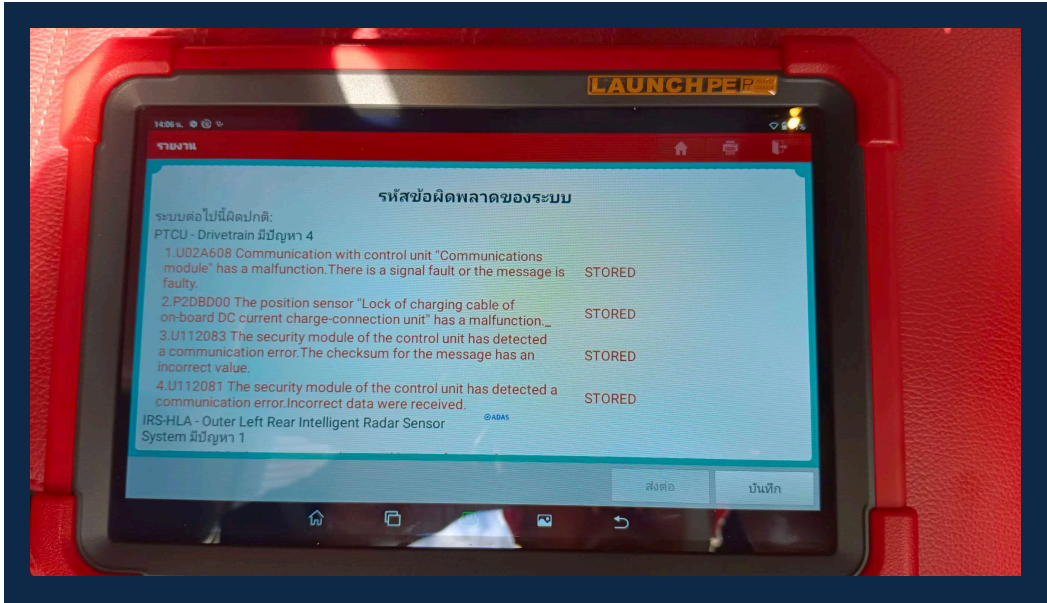
OBD Vehicle Health Analysis

U02A608,P2DBD00,U112083,C111A00,B223231,B229676,U016887,B185A00,U112083,B1F9700,U116

แหล่งกำเนิดไฟฟ้าทำงานบกพร่อง , ระบบจุดระเบิดทำงานผิดพลาด , ระบบส่งสัญญาณภายนอกทำงานผิดปกติ (ไม่
ได้ทดสอบขั้วชี้) โครงสร้าง(Frame) : -

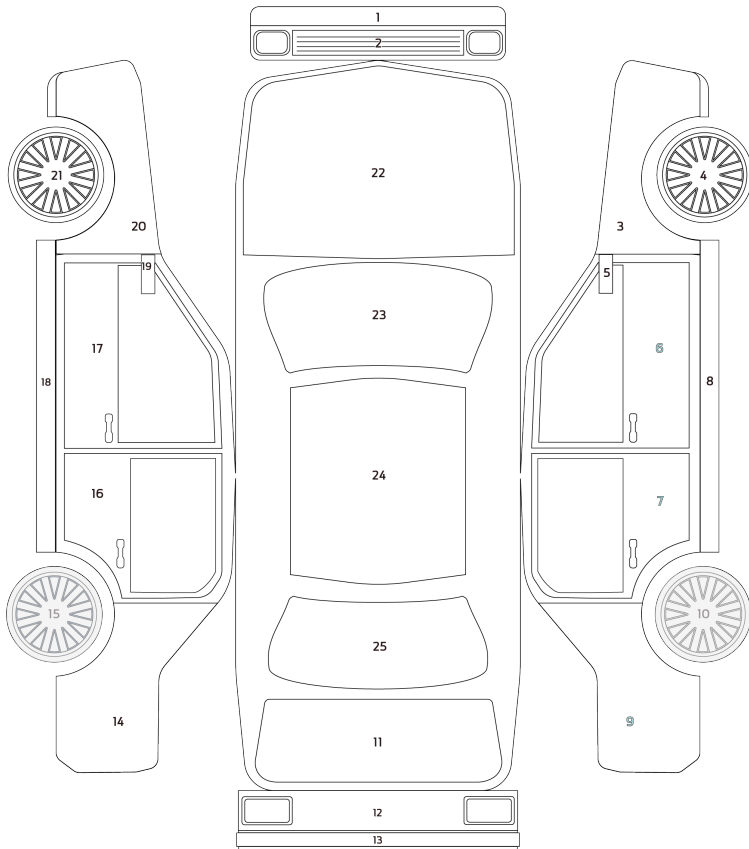
Exterior Inspection Points

1. Front Skirt	O	14. Left Skirt	O
2. Front Bumper	O	15. Left Wing Mirror	O
3. Front Right Fender	O	16. Front Windshield	O
4. Front Right Wheel	O	17. Roof	O
5. Front Left Fender	O	18. Rear Right Fender	O
6. Front Left Wheel	O	19. Rear Bonnet	O
7. Front Bonnet	O	20. Back right wheel	O (S1)
8. Right Wing Mirror	O	21. Rear Bumper	O
9. Front Right Door	O	22. Rear Skirt	O
10. Rear Right Door	O	23. Rear Left Fender	O
11. Right Skirt	O	24. Back left wheel	O (S1)
12. Rear Left Door	O	25. Back Windshield	O
13. Front Left Door	O

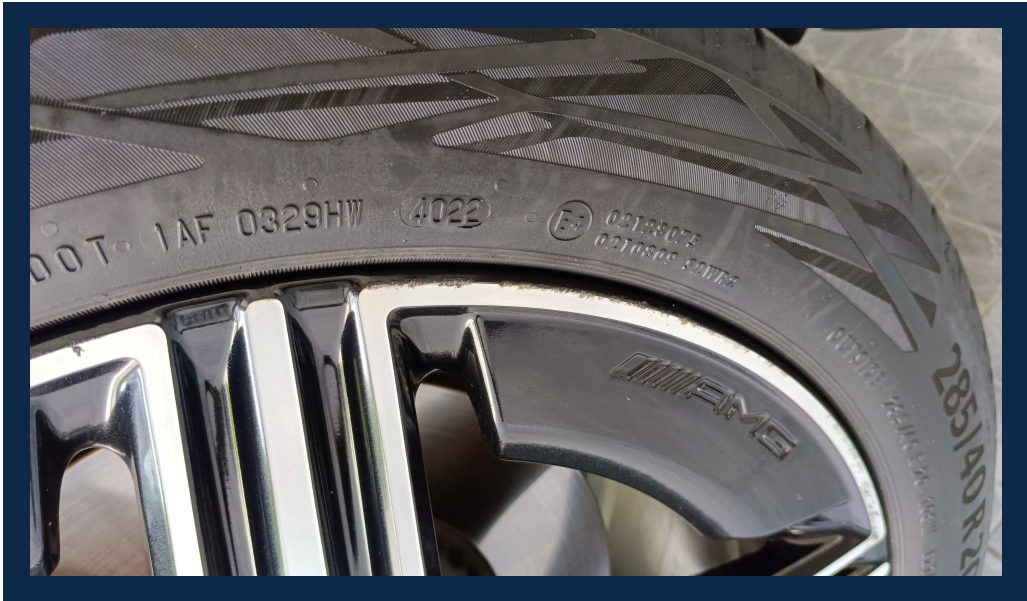
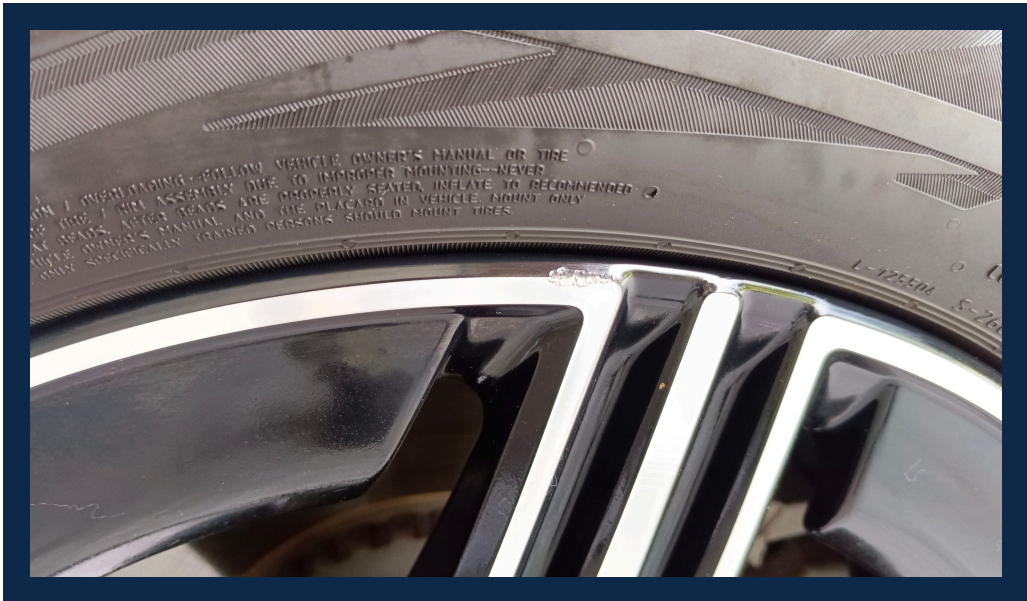
Vehicle Defect Notices

Inspector : ภายนอก(Exterior) : ล้อแม็กหลังขวาหน้าซ้ายเป็นรอยถลอก ภายใน(Interior) : - เครื่องยนต์(Engine) :
วิเคราะห์ปัญหาด้วยเครื่อง OBDII พบสิ่งผิดปกติ
