# Preowned Vehicle Inspection Report

Premium Inspection Analysis

**Vehicle :** MERCEDES BENZ GLC300

**Inspection date :** 2024-09-19

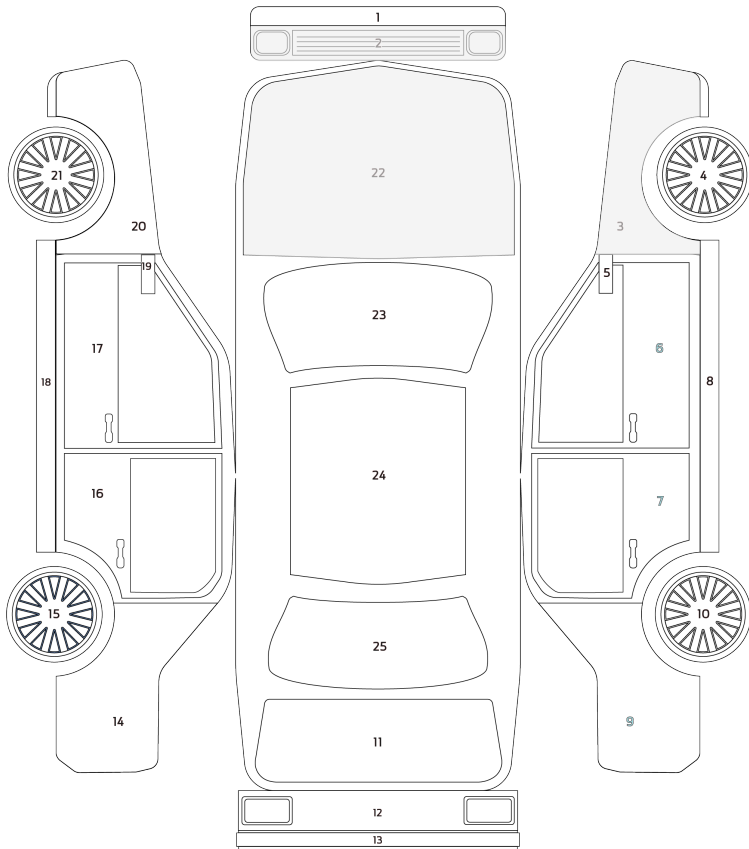
### Exterior Inspection Points

1. Front Skirt	O	14. Left Skirt	O
2. Front Bumper	O (S1)	15. Left Wing Mirror	O
3. Front Right Fender	O (G1)	16. Front Windshield	O
4. Front Right Wheel	O	17. Roof	O
5. Front Left Fender	O	18. Rear Right Fender	O
6. Front Left Wheel	O	19. Rear Bonnet	O
7. Front bonnet	O	20. Back Right Wheel	O
8. Right Wing Mirror	O	21. Rear Bumper	O
9. Front Right Door	O	22. Rear Skirt	O
10. Rear Right Door	O	23. Rear Left Fender	O
11. Right Skirt	O	24. Back Left Wheel	O
12. Rear Left Door	O	25. Back Windshield	O
13. Front Left Door	O

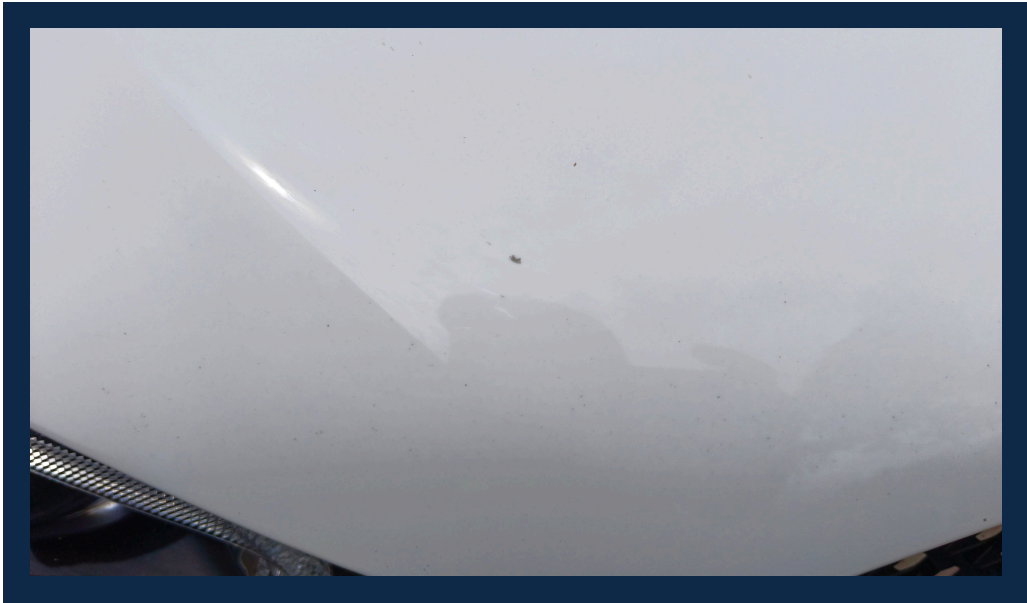
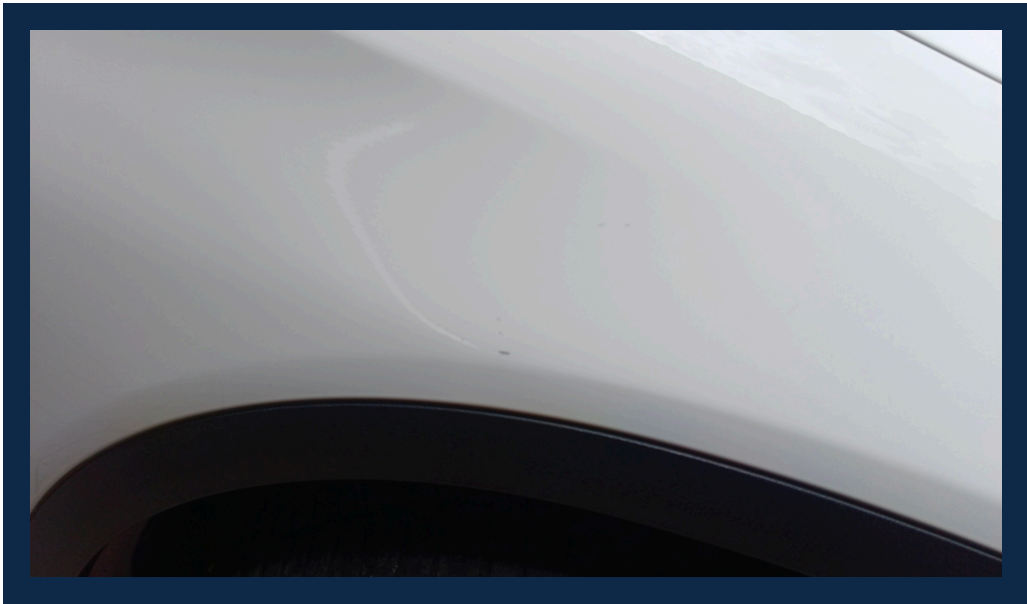
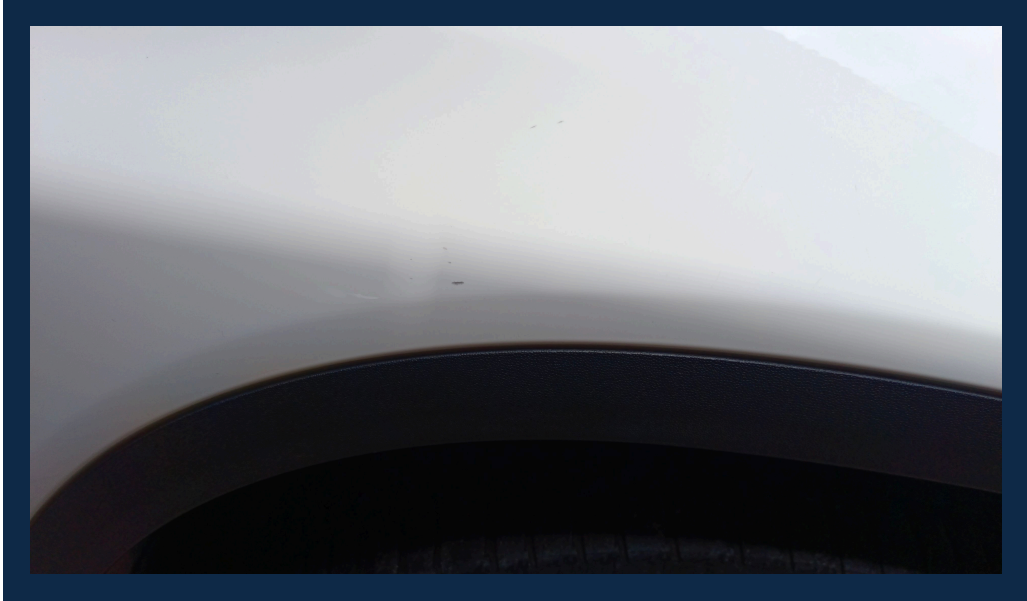
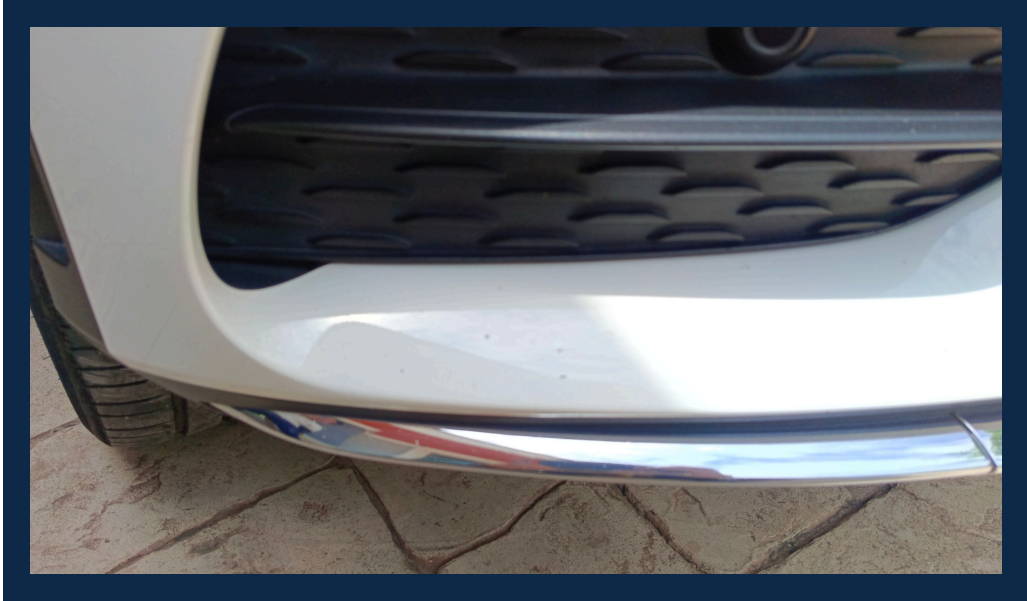
**Vehicle Defect Notices**

**Inspector :** ภายนอก(Exterior) : การตรวจสภาพภายนอกโดยรวมไม่พบหลักฐานการซ่อมแซมทำสี /พบรอยสะเก็ดหิน/กั้นชนหน้าฝากระโปรงหน้า/บังโคลนหน้าซ้ายขวา/ สภาพยางปกติทั้ง4เส้น ปี22 ภายใน(Interior) : ภายในปกติ สะอาดเรียบร้อย ,อุปกรณ์ไฟฟ้า แอร์ วิทยุFM ใช้งานได้สมบูรณ์ครบปกติ เครื่องยนต์(Engine) : เครื่องยนต์ทำงานได้ปกติ ,วิเคราะห์ปัญหาด้วยเครื่อง OBDII ไม่พบสิ่งผิดปกติ (ไม่ได้ทดสอบขับขี่) โครงสร้าง(Frame) : อุบัติเหตุไม่มี ,โครงสร้างหลักปกติ ไม่มีการซ่อมแซมโครงสร้างหรือมีการชนถึงโครงสร้าง

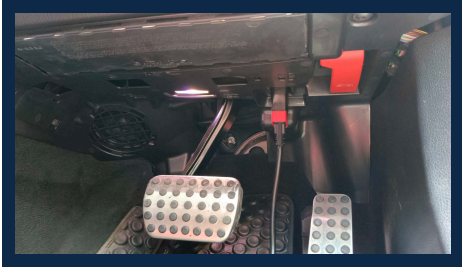
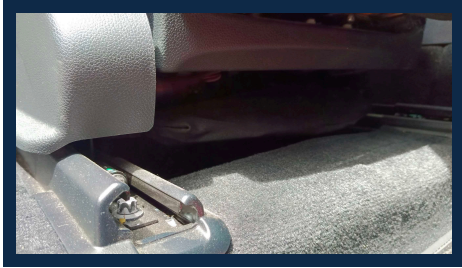
**Flood Report**

Evidence of Flood	No
-------------------	----

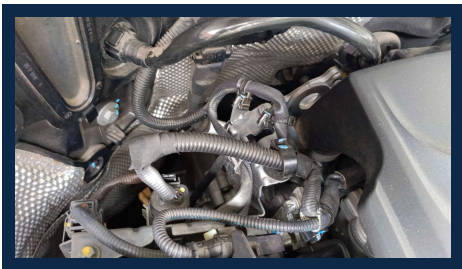
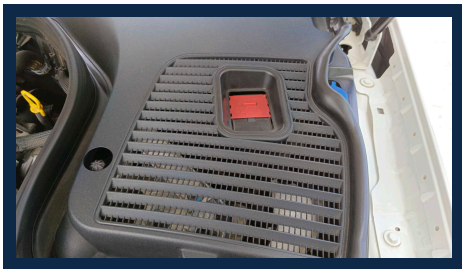
**Fire Report**

Evidence of Fire	No
------------------	----
