Preowned Vehicle Inspection Report

Premium Inspection Analysis

Customer Name	: MERCEDES-BENZ MOBILITY (THAILAND) CO., LTD.	Inspection Date	: 2024-09-17
Tel.	:	Lemon Inspection ID	: LEMON24090156
Inspector	: เอกวิทย์ อุตสาหกรรม	Approved By	: Tanrak T

Brand	MERCEDES BENZ	Model year	2023
Model	C350	Engine Code - No.	254920V0150774
Sub-model	e AMG Dynamic	Registration year	2023-04-10
License Plate		Chassis No.	W1K2060546L008552
Current Mileage(km.)	12344	Engine Capacity(cc.)	2000

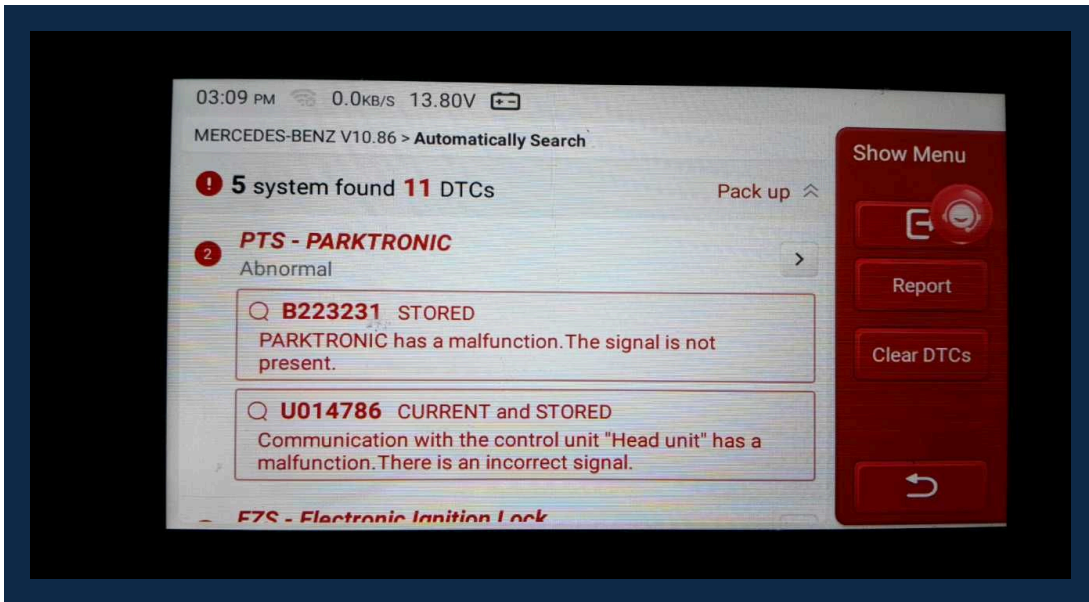
OBD Vehicle Health Analysis

Inspector : ภายนอก : ประตูลังขวาขีดข่วน แก้มหลังซ้ายขีดข่วน ประตูหน้าซ้ายรอยขีดข่วน ภายใน : - เครื่องยนต์ : เครื่องยนต์สามารถทำงานได้ครบปกติไม่พบคราบน้ำมันรั่วซึม ไฟเครื่องโชว์ ตรวจสอบด้วย OBD พว Code B223231 // U014786 = เกี่ยวกับระบบการส่งสัญญาณเบรกจอดทำงานบกพร่อง B182700 // B185A00 // B1F8E51 // B1FCB97 // B210509 // U100814 //U112083 //U119887 = เกี่ยวกับระบบแรงดันไฟฟ้าต่ำในการจุดระเบิด B1F9700 = ระบบส่งสัญญาณสื่อสารทำงานบกพร่อง โครงสร้าง : -

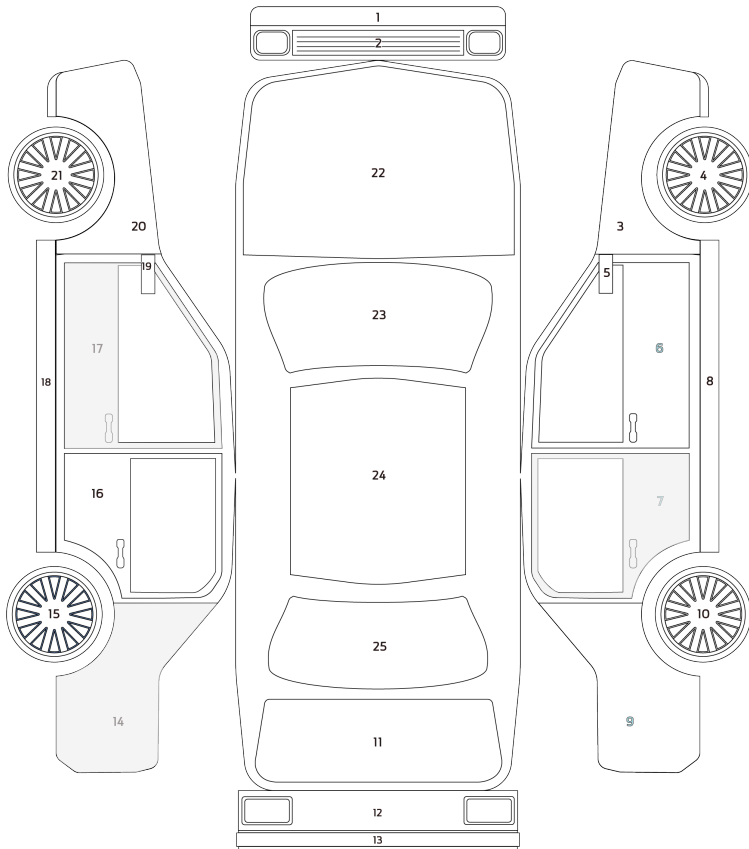
Exterior Inspection Points

1. Front Skirt	O	14. Left Skirt	O
2. Front Bumper	O	15. Left Wing Mirror	O
3. Front Right Fender	O	16. Front Windshield	O
4. Front Right Wheel	O	17. Roof	O
5. Front Left Fender	O	18. Rear Right Fender	O
6. Front Left Wheel	O	19. Rear Bonnet	O
7. Front Bonnet	O	20. Back Right Wheel	O
8. Right Wing Mirror	O	21. Rear Bumper	O
9. Front Right Door	O	22. Rear Skirt	O
10. Rear right door	O (S1)	23. Rear left fender	O (S2)
11. Right Skirt	O	24. Back Left Wheel	O
12. Rear Left Door	O	25. Back Windshield	O
13. Front left door	O (S1)

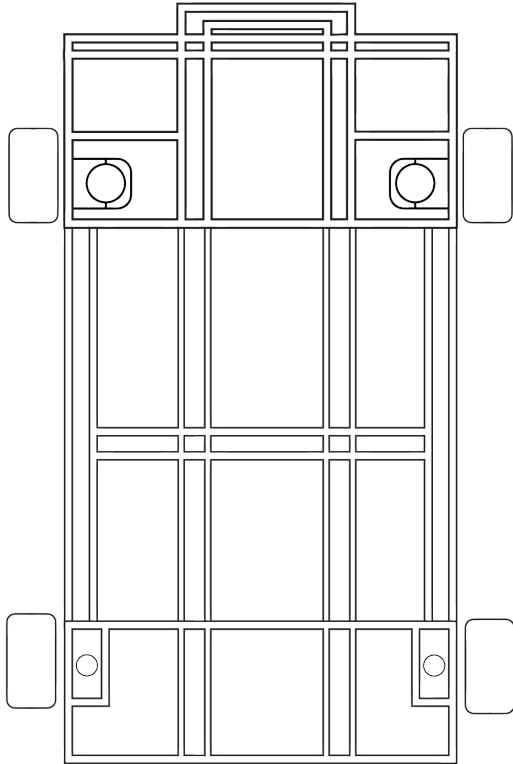
Chassis Report

No dent in the under carriage (th)	PASS
No deform chassis or chassis frame (th)	PASS
No visible corrosion on the chassis or chassis frame (th)	PASS
No missing part on the chassis frame (th)	PASS
Half cut Analysis (th)	PASS

Chassis Damage Level	no-damage
----------------------	-----------
