# Pre-owned Car Certificate

VIN: W1K1771876L007750  
Inspection Report No.: 135  
Inspection Date: 13/12/2024  
KM Status: 22932

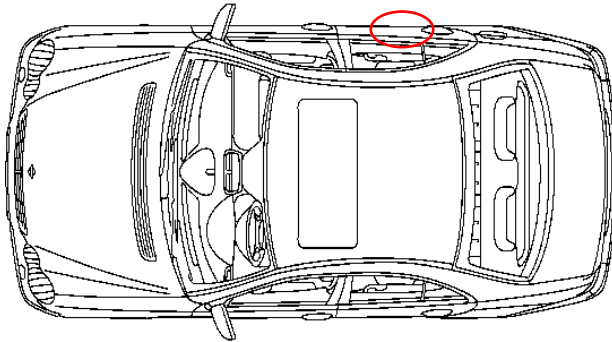
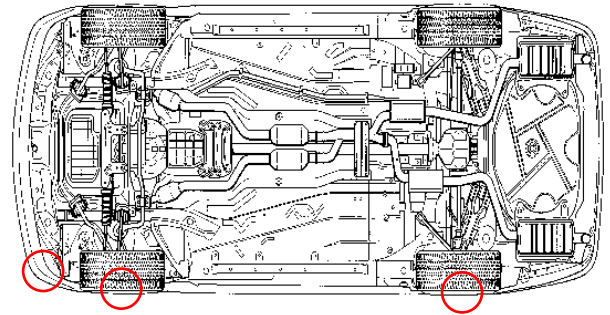
### Damage areas

- Front Left Bumper - Scratch
- Rear Right Door - Dent
- Front Left Wheel - Scratch
- Rear Left Wheel - Scratch

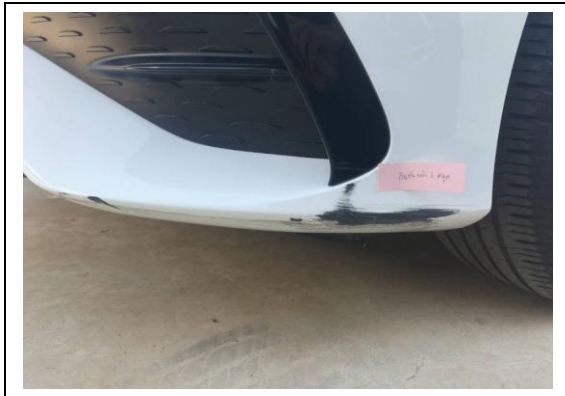
Front Left Bumper - Scratch

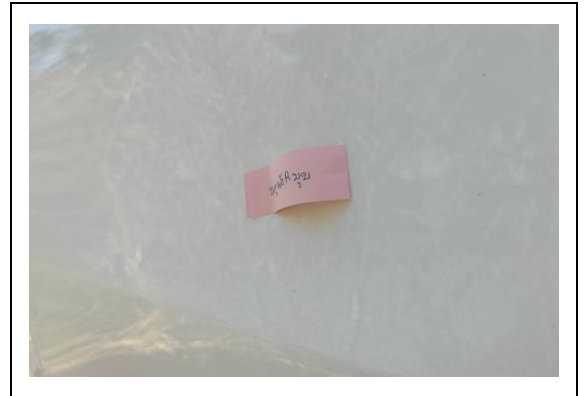
Rear Right Door - Dent

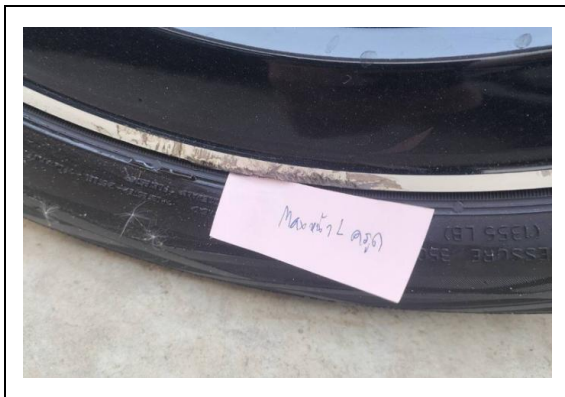
Front Left Wheel - Scratch

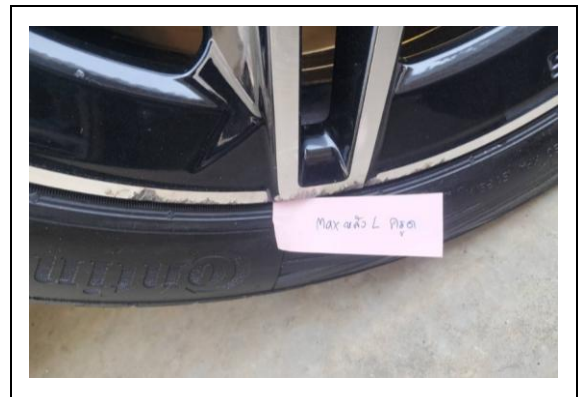
Rear Left Wheel - Scratch
