Pre-owned Car Certificate

Mercedes-Benz vehicle are checked comply to Mercedes-Benz Thailand requirements

VIN: W1K2130046L052249
Inspection Report No.: 134
Inspection Date: 13/12/2024
KM Status: 14542

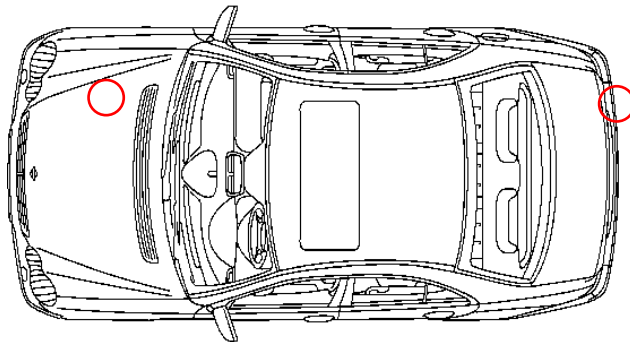
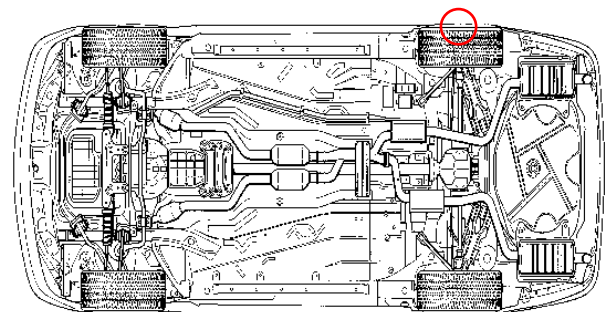
Damage areas

| M = Medium damage | <input checked="" type="checkbox"/> |

- Engine Hood - Paint Etching
- Rear Right Bumper - Scratch
- Rear Right Wheel - Scratch

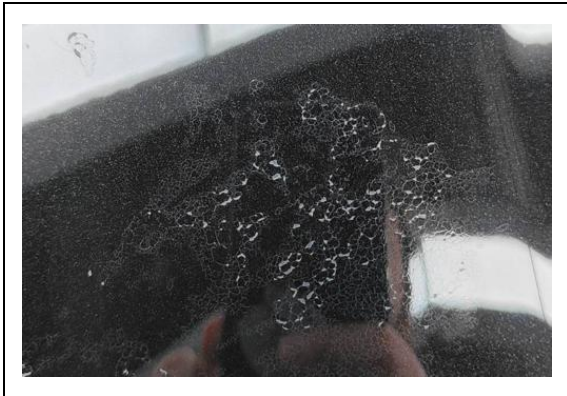
Engine Hood - Paint Etching

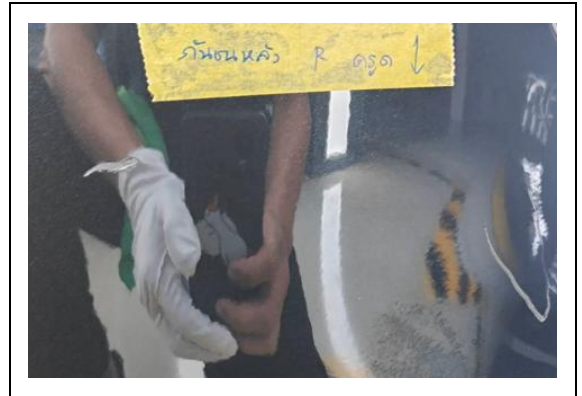
Rear Right Bumper - Scratch

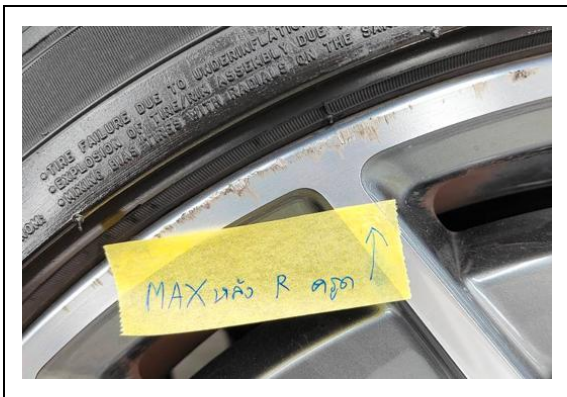
Rear Right Wheel - Scratch
