# Pre-owned Car Certificate

VIN: W1K2130536L056039  
Inspection Report No.: 136  
Inspection Date: 13/12/2024  
KM Status: 17546

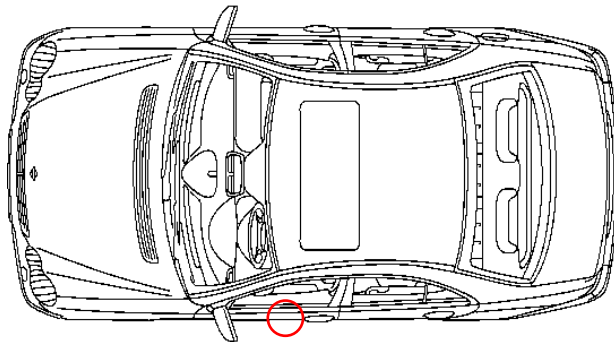
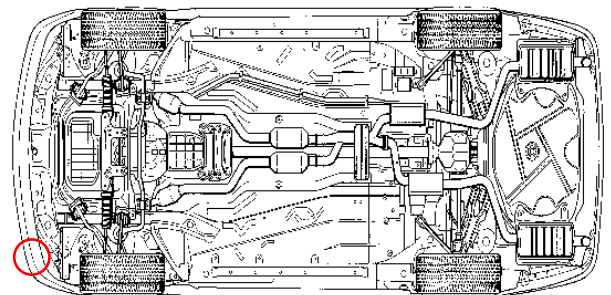
### Damage areas

- Front Left Bumper – Scratch
- Front Left Door – Dent & Scratch

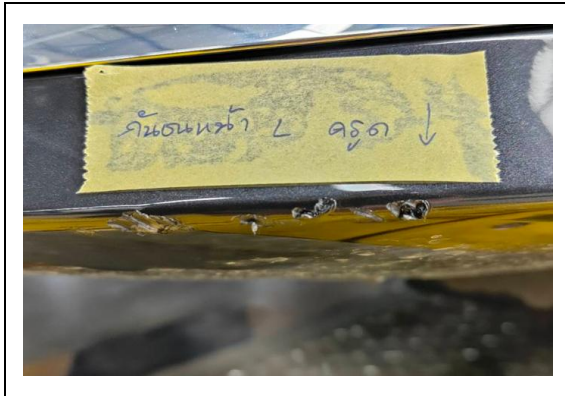
Front Left Bumper - Scratch

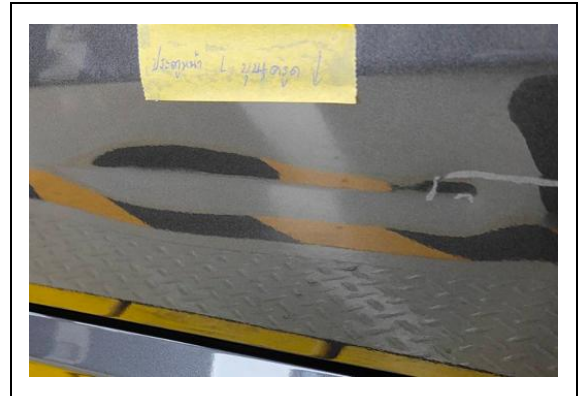
Front Left Door - Dent & Scratch
