Preowned Vehicle Inspection Report

Premium Inspection Analysis

Brand	MERCEDES BENZ	Model year	2021
Model	A 200	Engine Code - No.	28291430687714
Sub-model	AMG Dynamic	Registration year	2022-03-03
Registration No.	2ขม9907	Chassis No.	W1K1771876L003762
Current Mileage(km.)	40171	Engine Capacity(cc.)	1300

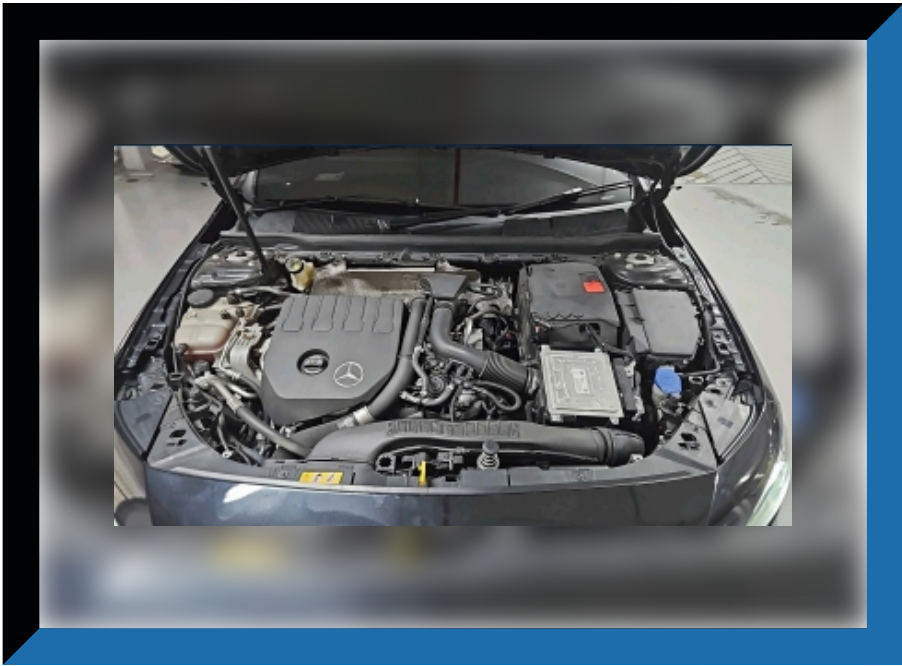
Vehicle Engine Image

เครื่องยนต์(Electric) : เครื่องยนต์ทำงานได้ปกติ ,ไม่พบคราบน้ำมันรั่วซึม ,วิเคราะห์ปัญหาด้วยเครื่อง OBDII ไม่พบสิ่งผิดปกติ (ไม่ได้ทดสอบขับขี)

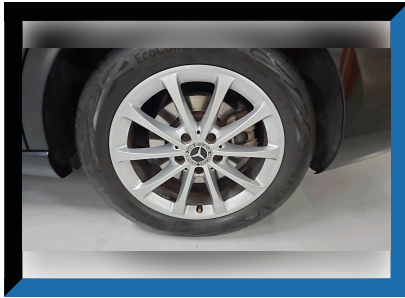
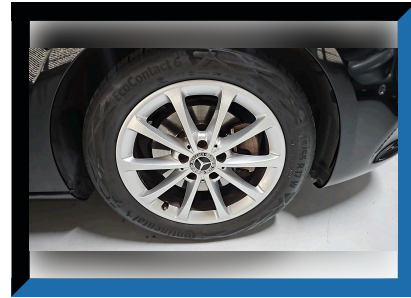
Tire Condition Report

Conditions Report	Tire Status	Date Code	Tire Depth(mm)
1. Front Left Tire Condition	ᵿᵿ	1522	4
2. Front Right Tire Condition	ᵿᵿ	1522	4
3. Back Left Tire Condition	ᵿᵿ	1522	4
4. Back Right Tire Condition	ᵿᵿ	1522	4

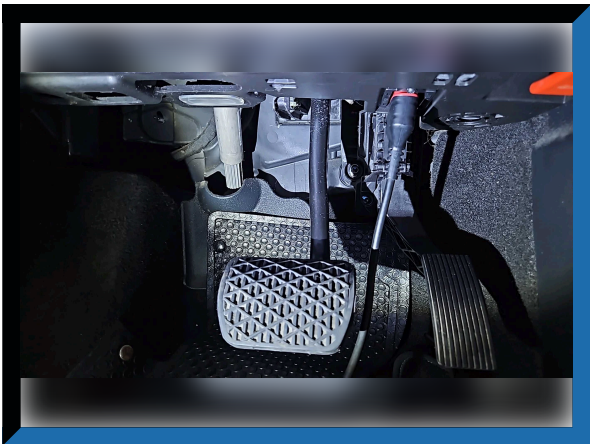
Flood Report

Evidence fo Flood	No
-------------------	----

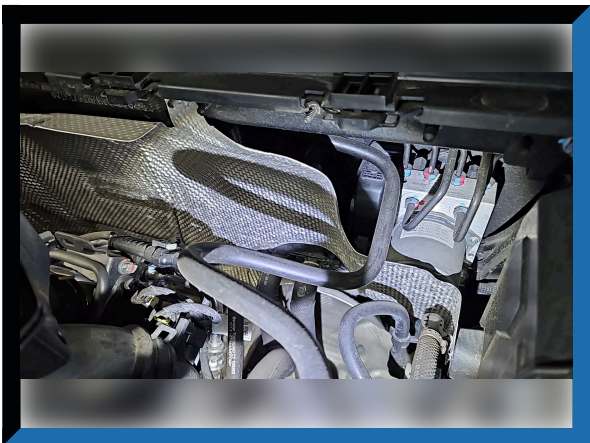
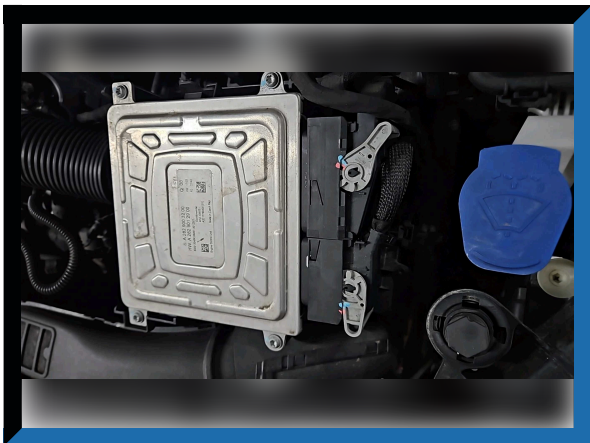
Fire Report

Evidence fo Fire	No
------------------	----
