Preowned Vehicle Inspection Report

Premium Inspection Analysis

Brand	MERCEDES BENZ	Model year	2022
Model	A 200	Engine Code - No.	28291430575163
Sub-model	AMG Dynamic	Registration year	2022-08-22
Registration No.	3บญ4007	Chassis No.	W1K1771876L002111
Current Mileage(km.)	24711	Engine Capacity(cc.)	1300

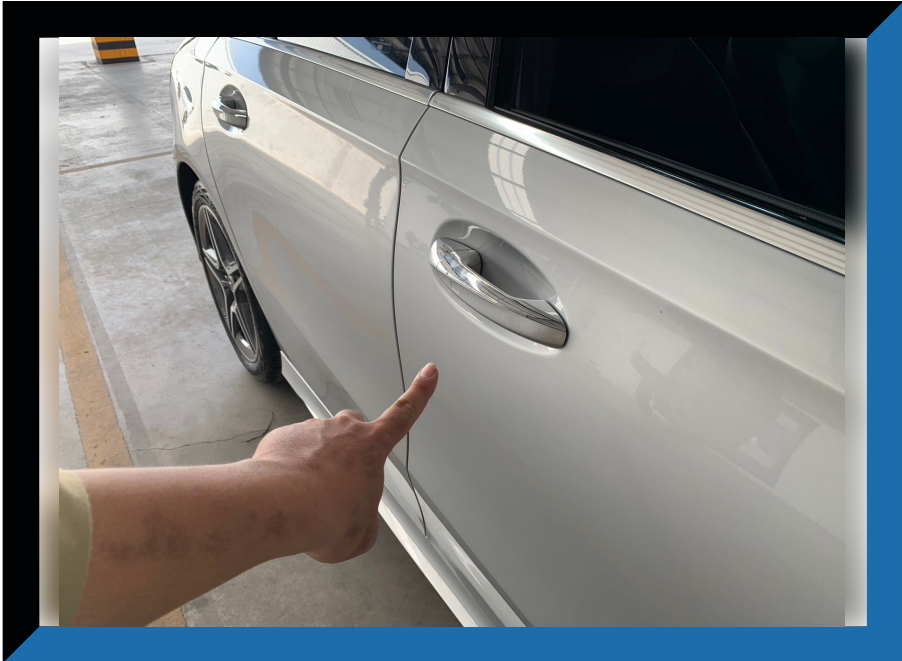
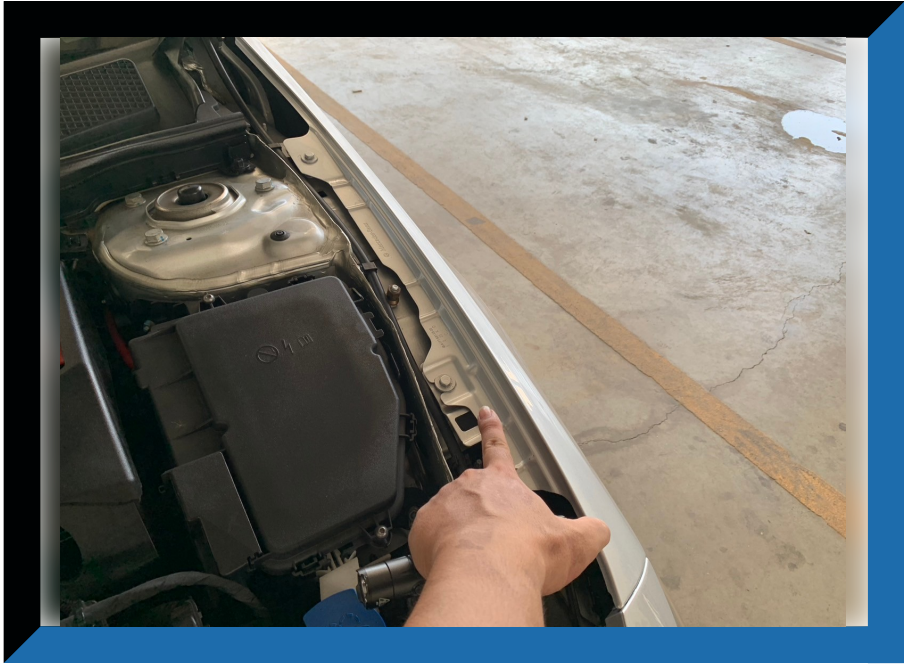
Vehicle defect notices

ภายนอก(Exterior) : การตรวจสภาพภายนอกโดยรวมพบหลักฐานการซ่อมแซมทำสีมารอบคัน แก้มหน้าซ้ายมีการถอดซ่อมทำสี ประตูหลังซ้ายเปลี่ยนชิ้นทำสี ประตูหน้าหลังซ้ายเป็นรอยบุบเล็กน้อย ฝาท้ายเป็นรอยขีดข่วน ไฟท้ายขวาเป็นรอยถลอก กันชนท้ายเป็นรอยขีดข่วน ประตูหน้าหลังขวาเป็นรอยขีดข่วน / สภาพยางปกติทั้ง4เส้น ปี 21 เสื่อมสภาพ

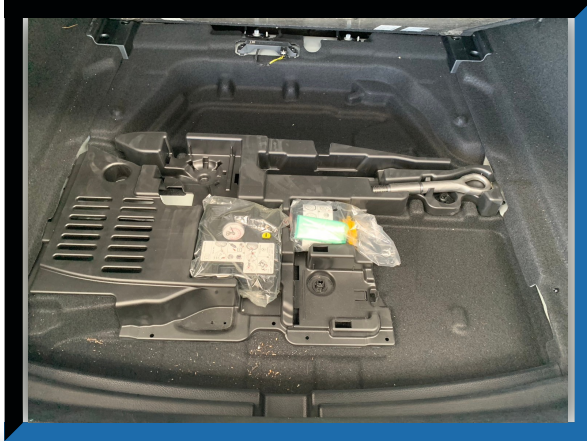
Flood Report

Evidence fo Flood	No
-------------------	----

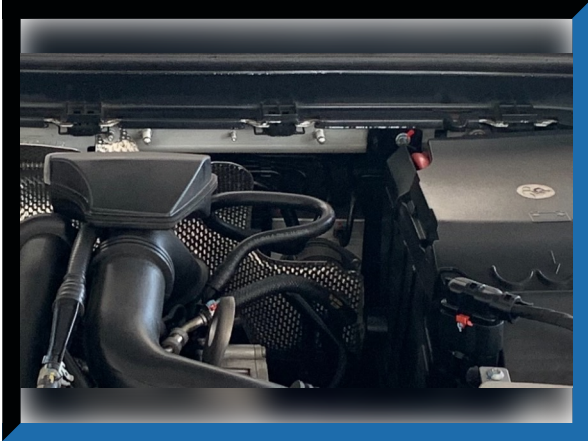
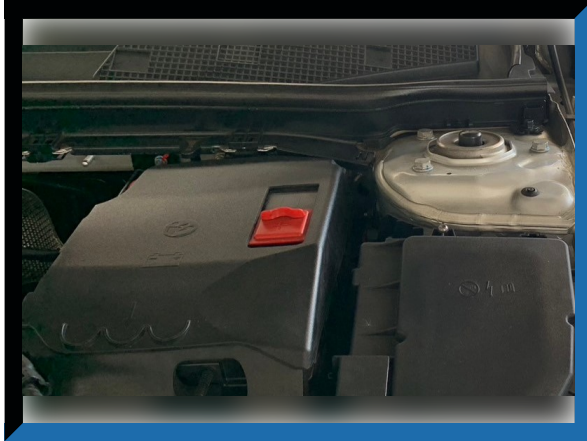
Fire Report

Evidence fo Fire	No
------------------	----
