# Preowned Vehicle Inspection Report

Premium Inspection Analysis

| Brand | MERCEDES BENZ | Model year | 2022 |
| Model | A 200 | Engine Code - No. | 28291430575163 |

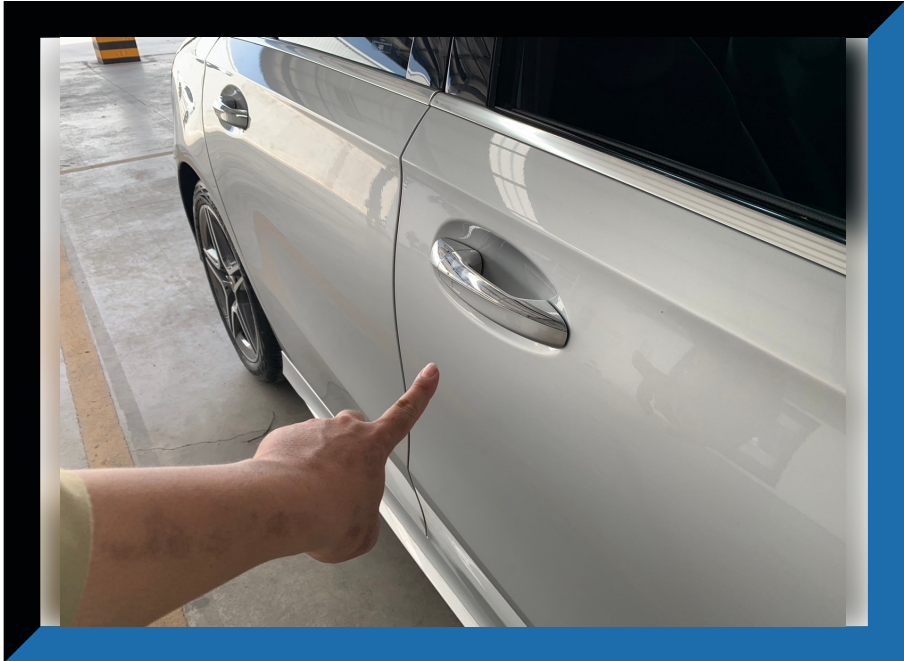
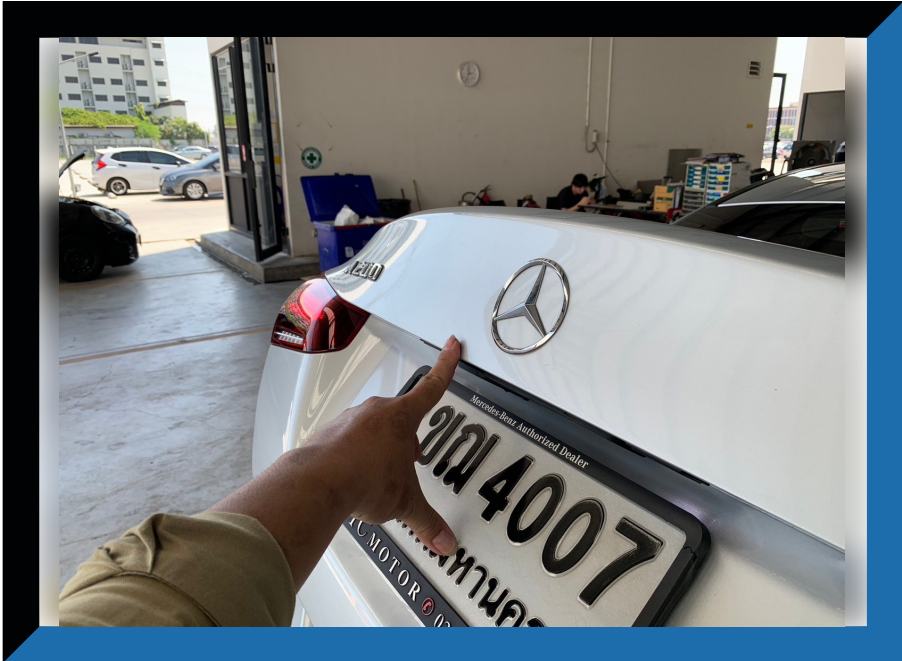
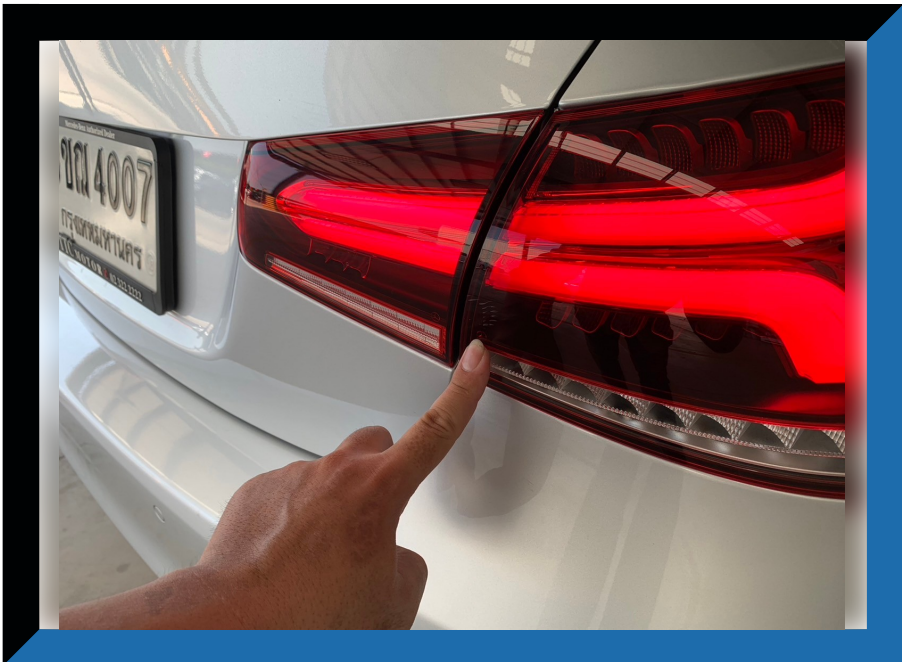
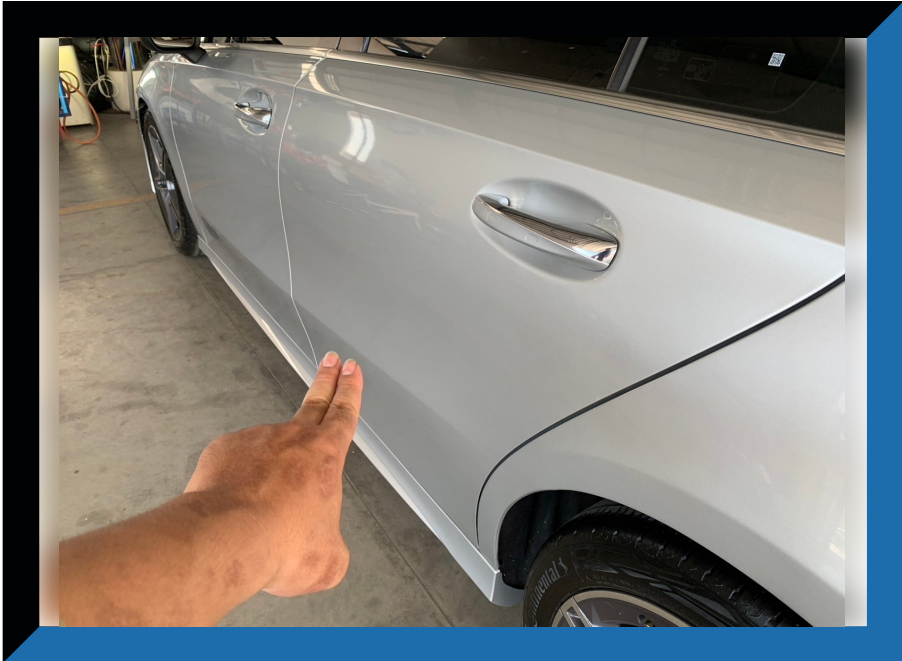
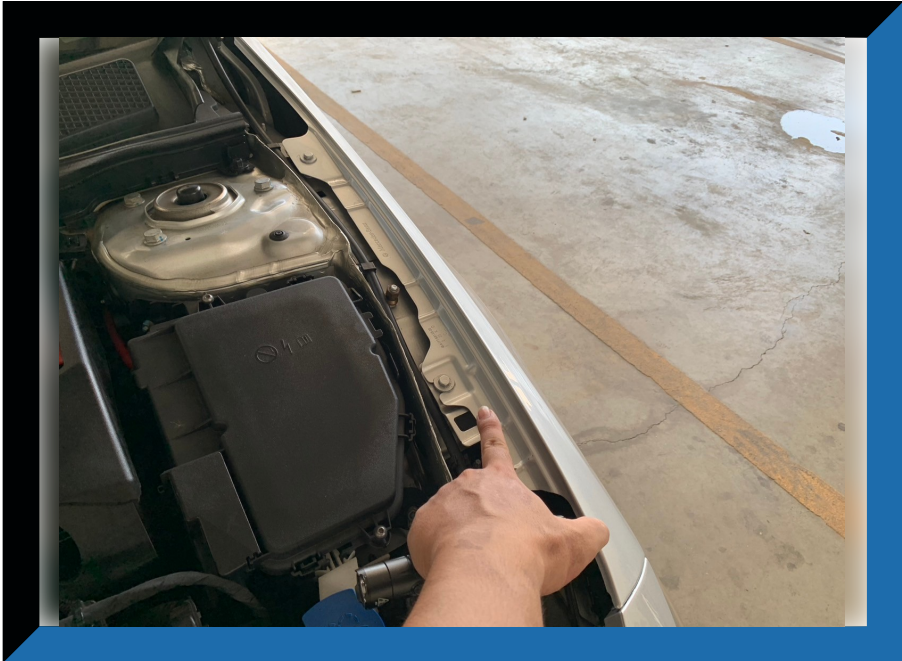
**Vehicle defect notices**

**ภายนอก(Exterior) :** การตรวจสภาพภายนอกโดยรวมพบหลักฐานการซ่อมแซมทำสีมารอบคัน แก้มหน้าซ้ายมีการถอดซ่อมทำสี ประตูหลังซ้ายเปลี่ยนชิ้นทำสี ประตูหน้าหลังซ้ายเป็นรอยบุบเล็กน้อย ฝาท้ายเป็นรอยขีดข่วน ไฟท้ายขวาเป็นรอยถลอก กันชนท้ายเป็นรอยขีดข่วน ประตูหน้าหลังขวาเป็นรอยขีดข่วน / สภาพยางปกติทั้ง4เส้น ปี 21 เสื่อมสภาพ

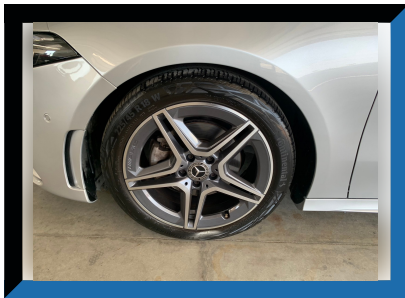
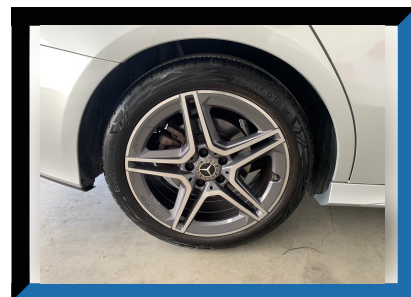
**Tire Condition Report**

| Conditions Report | Tire Status | Date Code | Tire Depth(mm) |
|---|---|---|---|
| 1. Front Left Tire Condition | ยางเสื่อมสภาพ | 2021 | 4 |
| 2. Front Right Tire Condition | ยางเสื่อมสภาพ | 2021 | 4 |
| 3. Back Left Tire Condition | ยางเสื่อมสภาพ | 2021 | 4 |
| 4. Back Right Tire Condition | ยางเสื่อมสภาพ | 2021 | 4 |

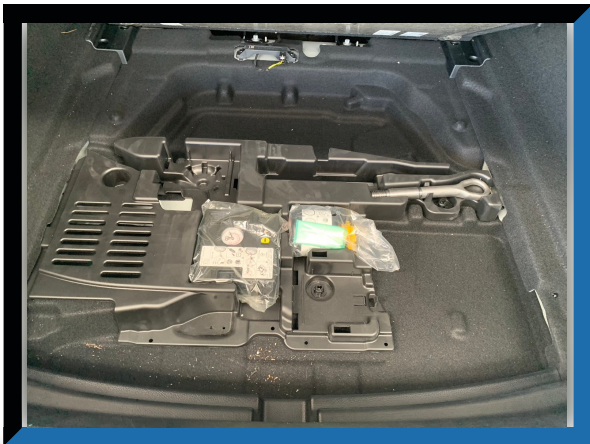
**Flood Report**

| Evidence fo Flood | No |

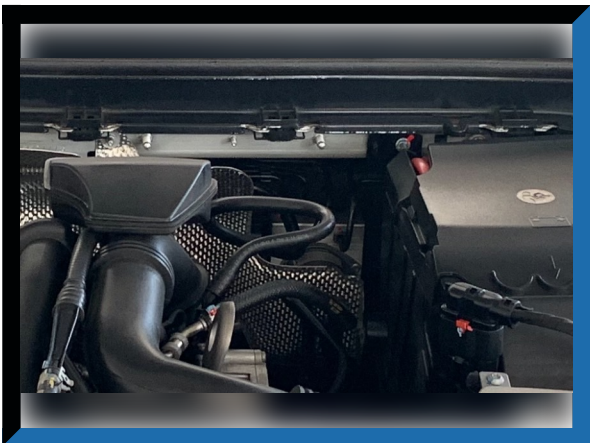
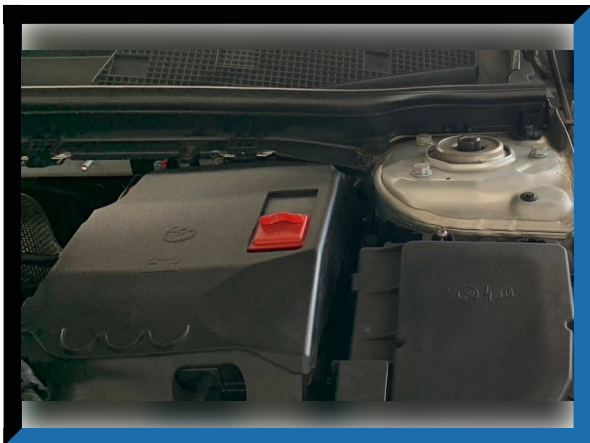
**Fire Report**

| Evidence fo Fire | No |
