Preowned Vehicle Inspection Report

Premium Inspection Analysis

Brand	MERCEDES BENZ	Model year	2019
Model	GLA200	Engine Code - No.	27091031911518
Sub-model	Urban	Registration year	2023-03-20
Registration No.		Chassis No.	WDC1569436L013567
Current Mileage(km.)	104309	Engine Capacity(cc.)	1600

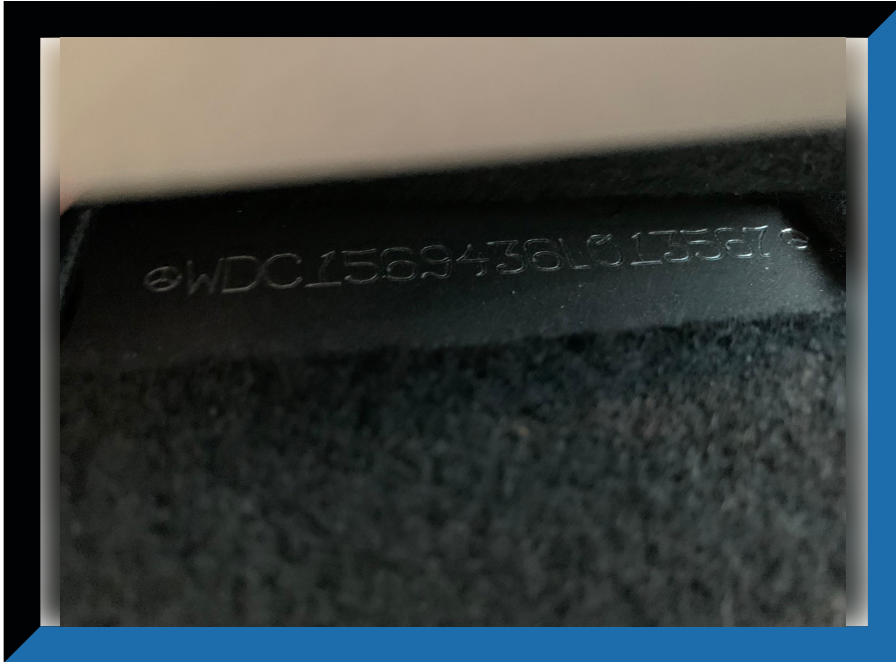
Vehicle Chassis Image

No dent in the under carriage	Pass
No deform chassis or chassis frame	Pass
No visible corrosion on the chassis or chassis frame	Pass
No missing part on the chassis frame	Pass
Half cut Analysis	Pass
Chassis Damage Level	No Damage

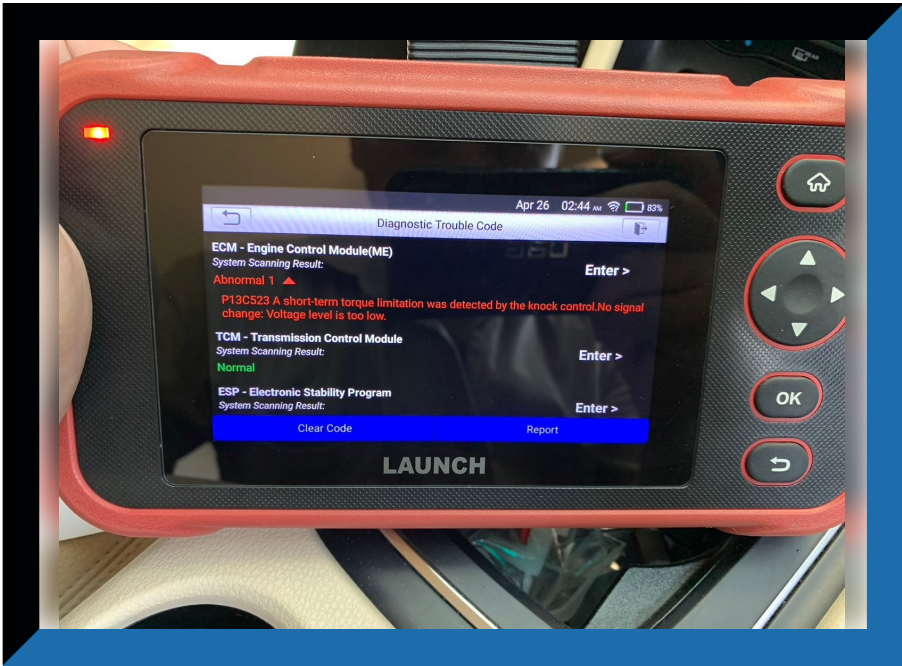
OBD Vehicle Health Analysis

เครื่องยนต์(Engine) : ไฟเครื่องโชว์ เครื่องยนต์ทำงานได้ปกติ ,วิเคราะห์ปัญหาด้วยเครื่อง OBDII พบสิ่งผิดปกติ รหัส P13C523 / แบตเตอรี่เสื่อมสภาพ (ไม่ได้ทดสอบขั้วขี้)

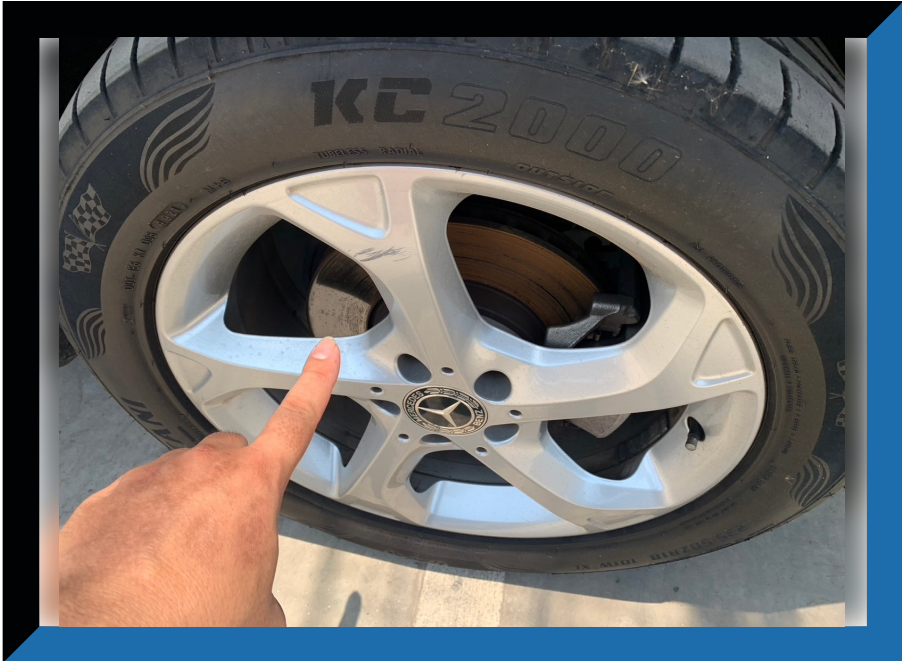
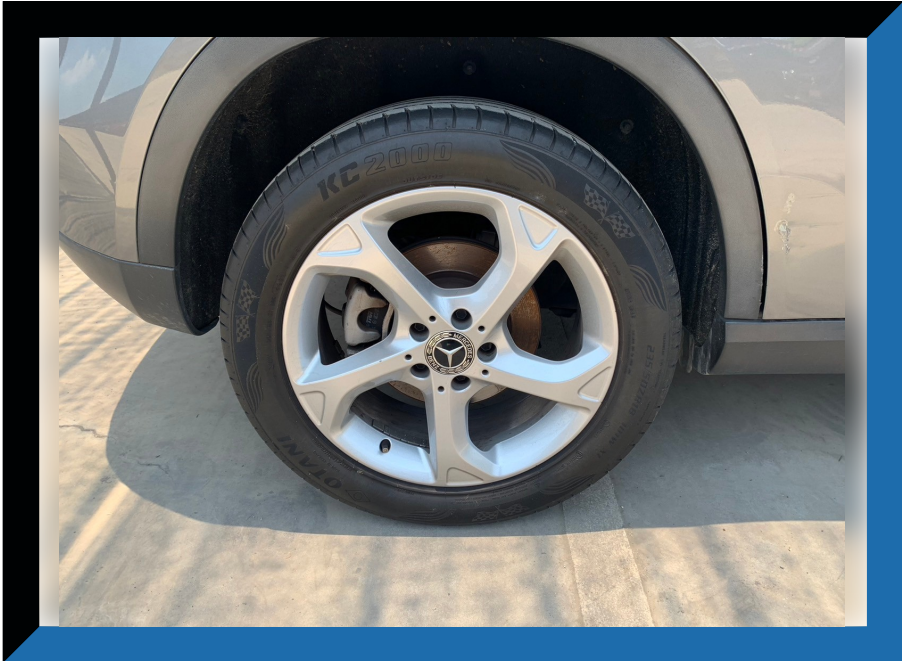
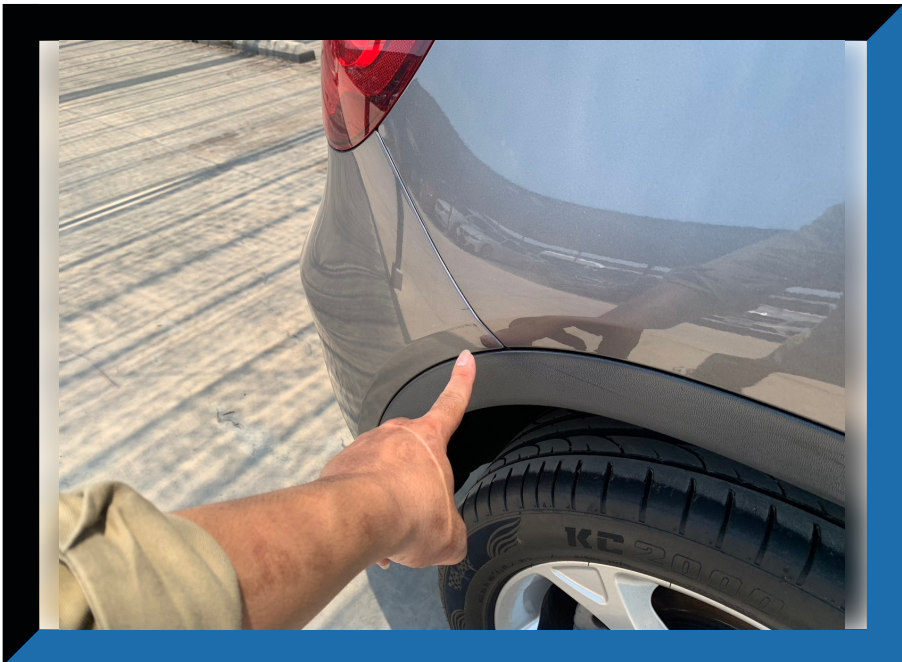
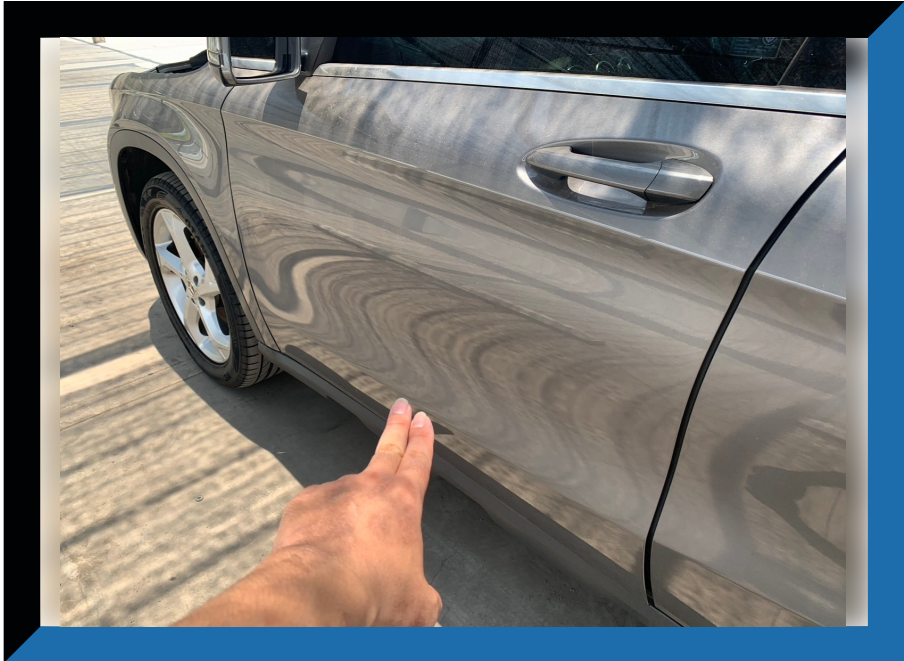
Vehicle defect notices

ภายนอก(Exterior) : การตรวจสภาพภายนอกโดยรวมไม่พบหลักฐานการซ่อมแซมทำสี กั้นชนท้ายเป็นรอยถลอก ประตูหลังขวาเป็นรอยถลอก ประตูหน้าซ้ายเป็นรอยบุบ ล้อแม็กเป็นรอยถลอก /ยางทั้ง 4 เส้นเสื่อมสภาพ ปี 21

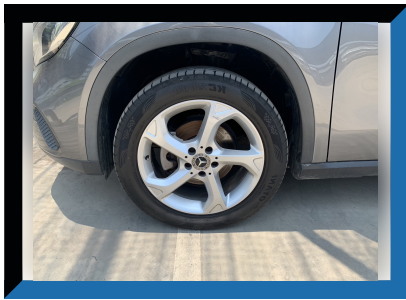
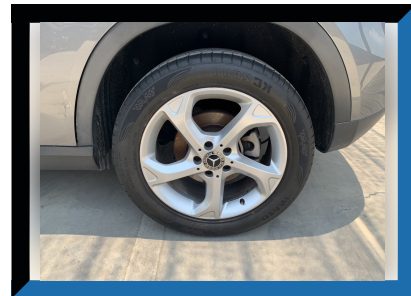
Tire Condition Report

Conditions Report	Tire Status	Date Code	Tire Depth(mm)
1. Front Left Tire Condition	ยางเสื่อมสภาพ	2021	4
2. Front Right Tire Condition	ยางเสื่อมสภาพ	2021	4
3. Back Left Tire Condition	ยางเสื่อมสภาพ	2021	4
4. Back Right Tire Condition	ยางเสื่อมสภาพ	2021	4

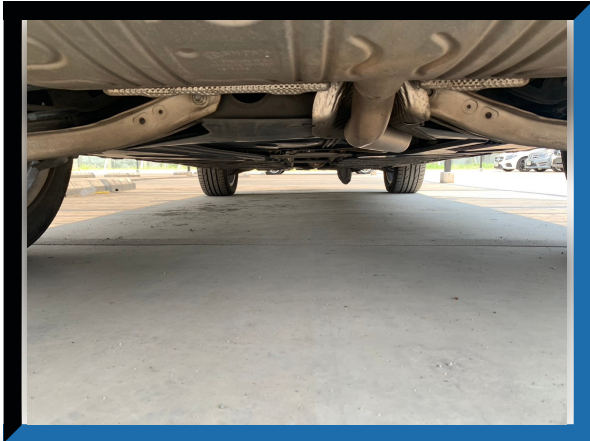
Flood Report

Evidence fo Flood	No
-------------------	----

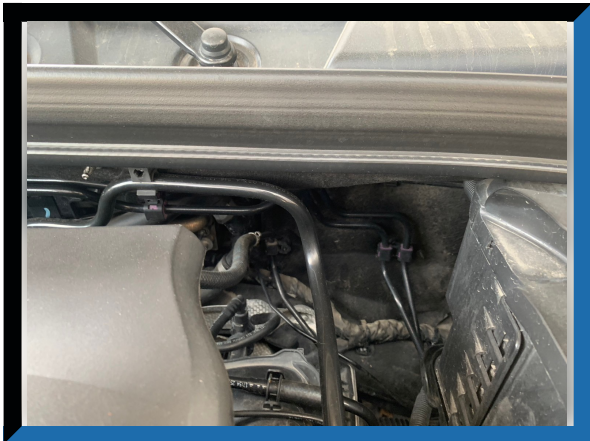
Fire Report

Evidence fo Fire	No
------------------	----
