Premium Inspection Analysis

Customer Name	:			nspec	tion Date	: 2024-04-26
Tel.	:		9	Schic I	nspection II	: ) SCH240028755
Inspector	: Tanruk Tipin			Appro	ved By	: tanruk tipin
Details						
Brand	MERCEDES BENZ	Mode	l year		2020	
Model	V250d	Engin	e Code - No	O.	651950352	81903
Sub-model	Business Plus	Regist	tration yea	r	2020-06-2	26
Registration No.	-	Chass	sis No.		W1V447815	523740150
Current Mileage(km.)	38389	Engin	e Capacity(	cc.)	2100	
Inspection Lists						Grading
1.Exterior				*	****	
2.Chassis				*	****	
3.Interior			****			
4.Engine & Mechanical			****			
Overall				*	****	
This vehicle has been inspected SCHIC INSPECTION BY LEMON-AIDE						
ispector	tanruk tipin	Anr	orove by	t	anut tipin

**Vehicle**: MERCEDES BENZ V250d **Chassis number**: W1V44781523740150

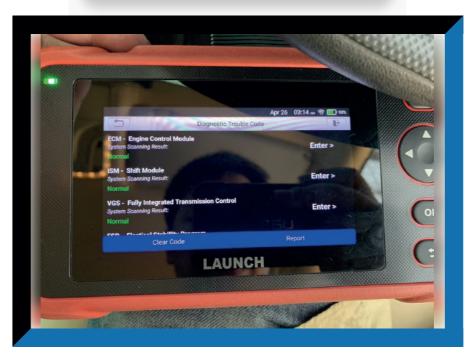
#### OBD Vehicle Health Analysis

เครื่องยนต์(Engine) : เครื่องยนต์ทำงานได้ปกติ ,วิเคราะห์ปัญหาด้วยเครื่อง OBDII พบสิ่งผิดปกติ ขึ้น Nox Sensor (ไม่ได้ทดสอบขับขี่) โครงสร้าง(Frame) : อุบัติเหตุไม่มี ,โครงสร้างหลักปกติ ไม่มีการซ่อมแซมโครงสร้างหรือมีการซนถึงโครงสร้าง

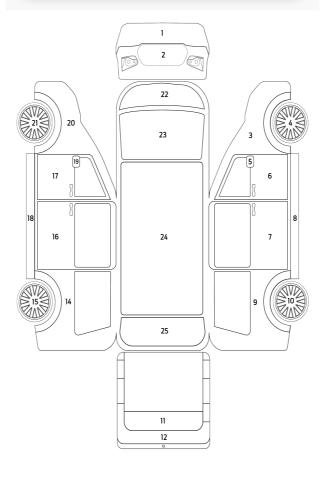
## Exterior Inspection Points

1. Front Skirt	О	14. Rear Left Fender	0
2. Front Bumper	O (C1)	15. Rear Left Wheel	O (S1)
3. Front Right Fender	O (S1)	16. Rear Left Door	O (E1)
4. Front Right Wheel	0	17. Front Left Door	0
5. Right Wing Mirror	0	18. Left Skirt	0
6. Front Right Door	O (E1)	19. Left Wing Mirror	O (S1)
7. Rear Right Door	O (E1)	20. Front Left Fender	0
8. Right Skirt	0	21. Front Left Wheel	0
9. Rear Right Fender	0	22. Front Bonnet	O (E1)
10. Rear Right Wheel	0	23. Front WindShield	0
11. Rear Bonnet	0	24. Roof	0
12. Rear Bumper	0	25. Back WindShield	0
13. Rear Skrit	0	26. Truck Bed	0

ภายนอก(Exterior) : การตรวจสภาพภายนอกโดยรวมไม่พบหลักฐานการช่อมแชมทำสี กันชนหน้าไม่เข้าแนวเป็นรอยถลอก ประตูหน้าหลัง ขวาเป็นรอยบุบ ประตูหลังซ้ายเป็นรอยบุบ ฝากระโปรงหน้าเป็นรอยบุบลักยิ้ม / สภาพยางปกติทั้ง4เส้น หน้าซ้ายขวาปี 20 เสื่อมสภาพ ยาง หลังขวาปี 20 เสื่อมสภาพ ยางซ้ายหลังปี 22 ปกติ

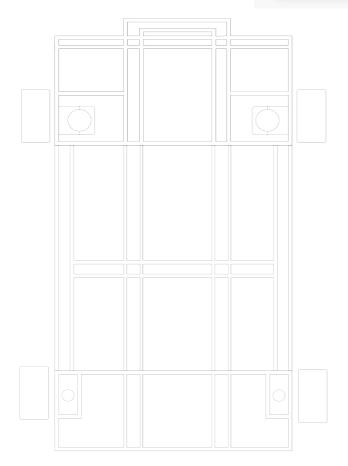
Chassis Report

No dent in the under carriage	Pass
No deform chassis or chassis frame	Pass
No visible corrision on the chassis or chassis frame	Pass
No missing part on the chassis frame	Pass
Half cut Analysis	Pass
	5

Chassis Damage Level	No Damage
	110 = 590

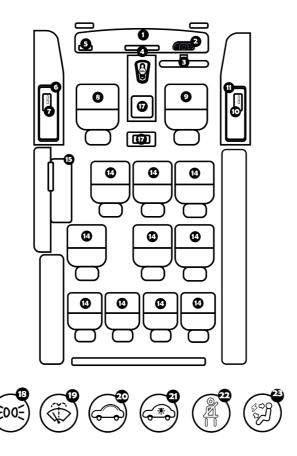
## Interior Inspection Point

ภายใน(Interior) : ภายในปกติ สะอาดเรียบร้อย ,อุปกรณ์ไฟฟ้า แอร์ วิทยุFM ใช้งานได้สมบูรณ์ครบปกติ / ภายในทำชุดแต่งเบาะคอนโซล มา ผ้าบุหลังคาไฟห้องโดยสารหลังไม่เข้าแนว
