# Preowned Vehicle Inspection Report

Premium Inspection Analysis

Customer Name	: MERCEDES-BENZ MOBILITY (THAILAND) CO., LTD.	Inspection Date	: 2024-05-21
Tel.	:	Lemon Inspection ID	: LEMON24050196
Inspector	: tanruk tipin	Approved By	: sakulpong singnarong

Brand	MERCEDES BENZ	Model year	2022
Model	GLA200	Engine Code - No.	28291480835403
Sub-model	AMG Dynamic	Registration year	2023-09-12
Registration No.		Chassis No.	W1N2477876L007595
Current Mileage(km.)	34501	Engine Capacity(cc.)	1332

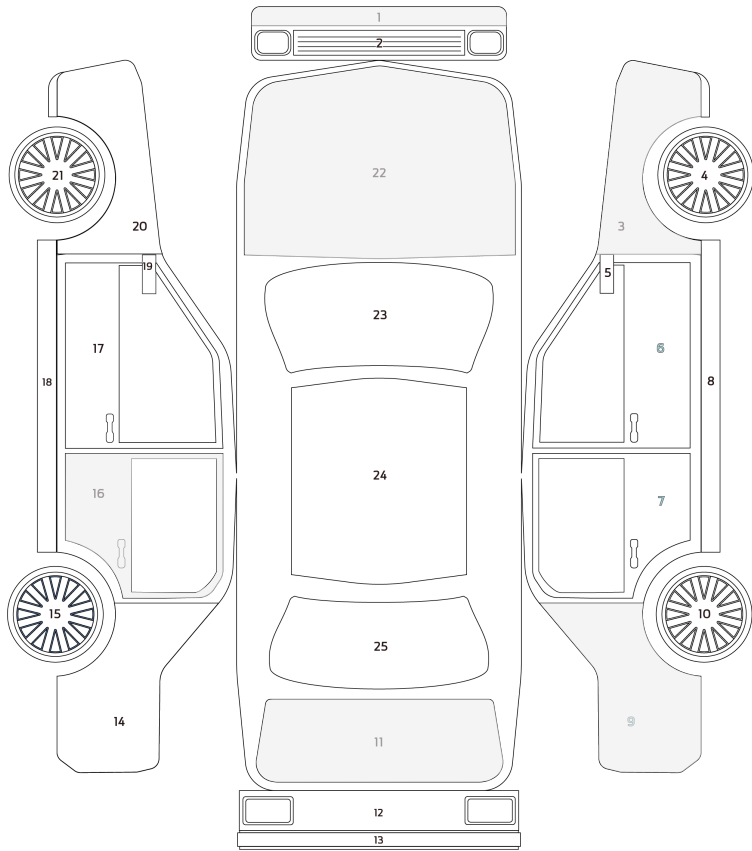
**Exterior Inspection Points**

1. Front Skirt	O (S1)	14. Left Skirt	O
2. Front Bumper	O	15. Left Wing Mirror	O
3. Front Right Fender	O (S1)	16. Front Windshield	O
4. Front Right Wheel	O	17. Roof	O
5. Front Left Fender	O	18. Rear right fender	O (S1)
6. Front Left Wheel	O	19. Rear Bonnet	O (S1)
7. Front bonnet	O (S1)	20. Back Right Wheel	O
8. Right Wing Mirror	O	21. Rear Bumper	O
9. Front Right Door	O	22. Rear Skirt	O
10. Rear Right Door	O	23. Rear Left Fender	O
11. Right Skirt	O	24. Back Left Wheel	O
12. Rear Left door	O	25. Back Windshield	O
13. Front Left Door	O

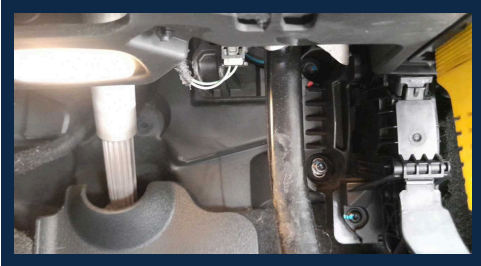
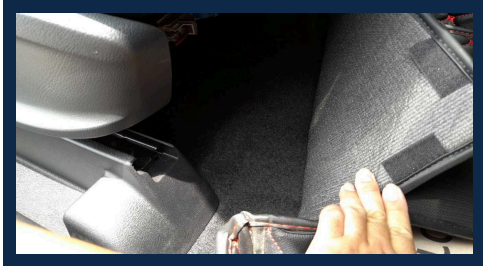
**Flood Report**

Evidence of Flood	No
-------------------	----

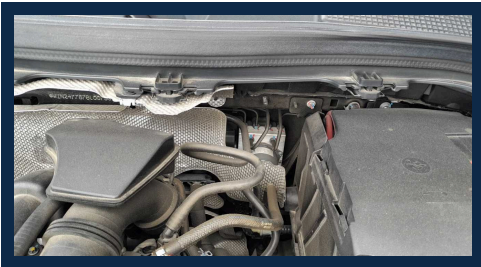
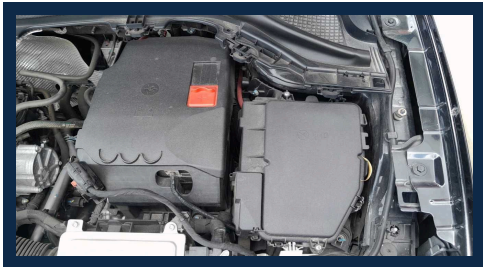
**Fire Report**

Evidence of Fire	No
------------------	----
