Vehicle : MERCEDES BENZ C220

Chassis number : W1K2050146L064084

Inspection date : 2024-07-15

Vehicle Certification : Pass the inspection standard of SCHIC INSPECTION BY LEMON-AIDE

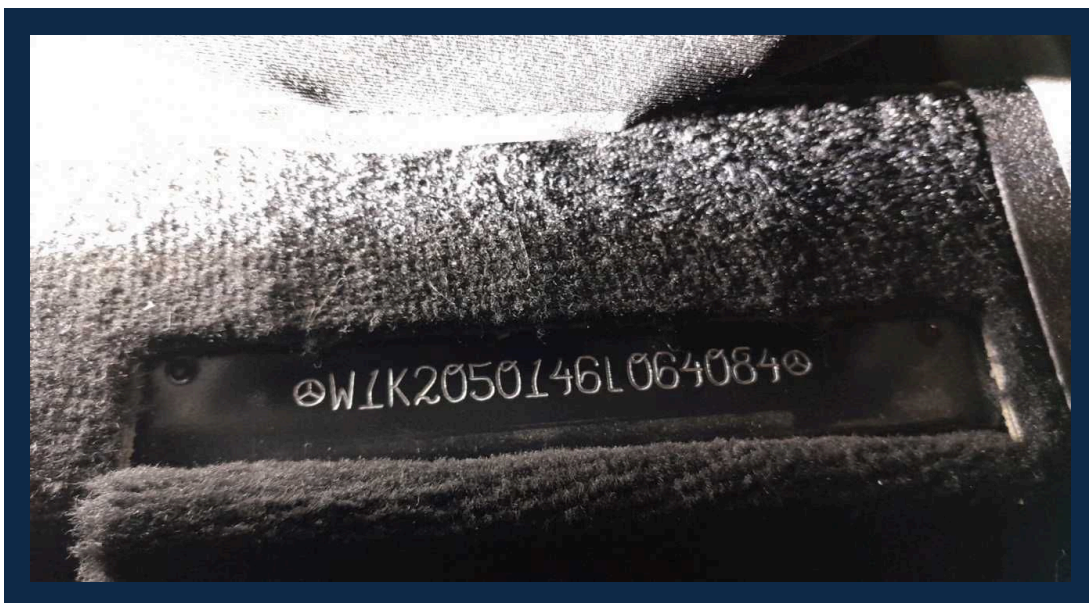
Vehicle Chassis Image

No dent in the under carriage (th)	PASS
No deform chassis or chassis frame (th)	PASS
No visible corrosion on the chassis or chassis frame (th)	PASS
No missing part on the chassis frame (th)	PASS
Half cut Analysis (th)	PASS

Chassis Damage Level	No Damage
----------------------	-----------

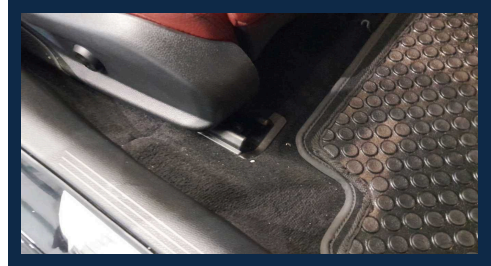
Flood Report

Evidence of Flood	No
-------------------	----

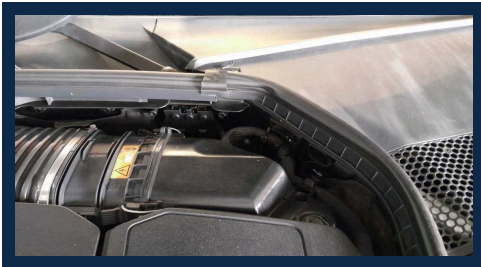
Fire Report

Evidence of Fire	No
------------------	----
