Preowned Vehicle Inspection Report

Premium Inspection Analysis

Vehicle : MERCEDES BENZ A200

Inspection date : 2024-09-09

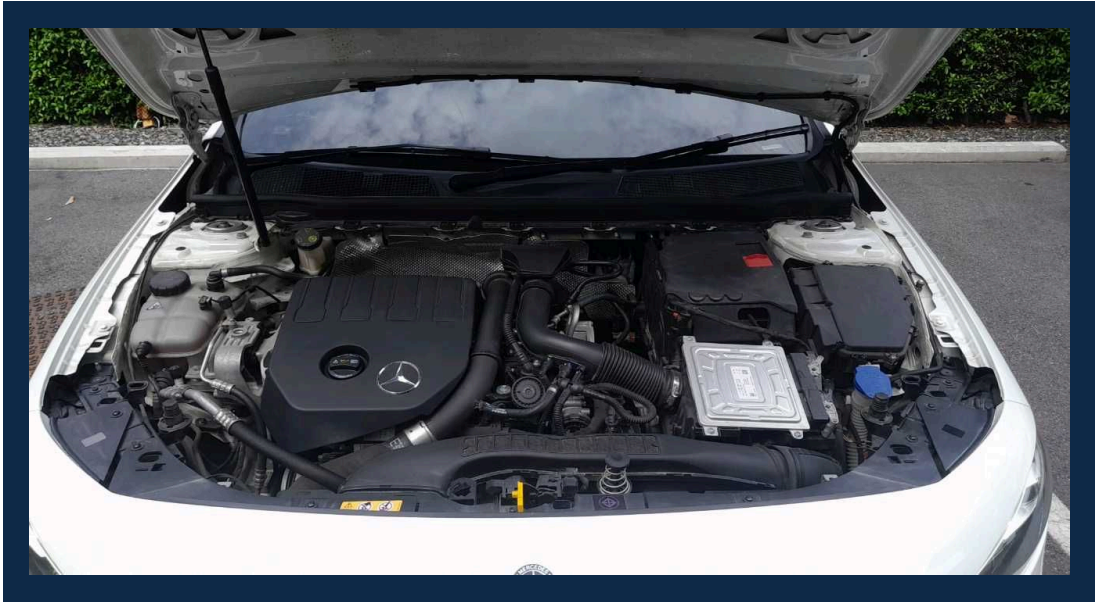
Vehicle Engine Image

เครื่องยนต์(Engine) : วิศวะห์ปัญหาด้วยเครื่อง OBDII ไม่พบสิ่งผิดปกติ (ไม่ได้ทดสอบขับขี้) โครงสร้าง(Frame) : -

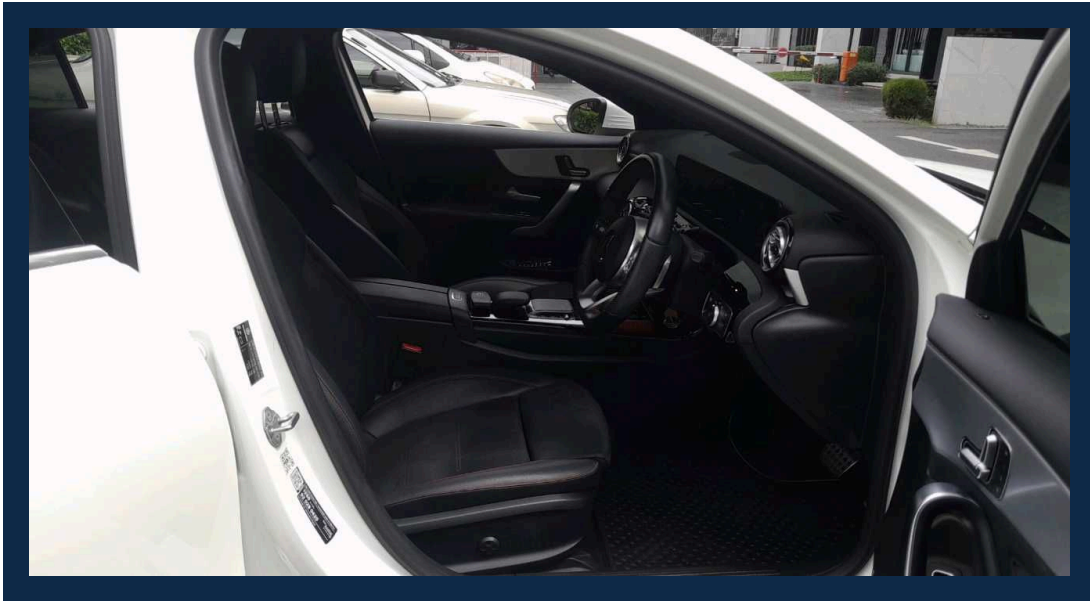
Passenger Front Seat Image

สภาพยางดีปี23 ภายใน(Interior) : เบาะหน้าเป็นคราบเล็กน้อย / แผงประตูหน้าขวาเป็นคราบเล็กน้อย

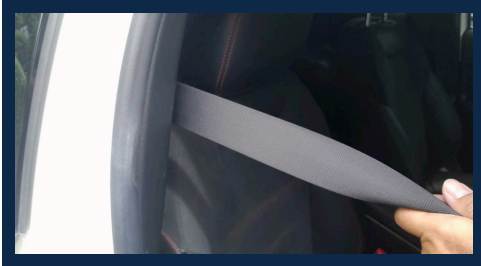
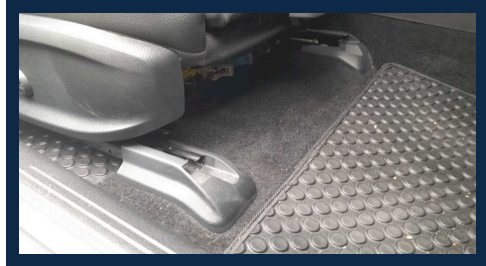
Flood Report

Evidence of Flood	No
-------------------	----

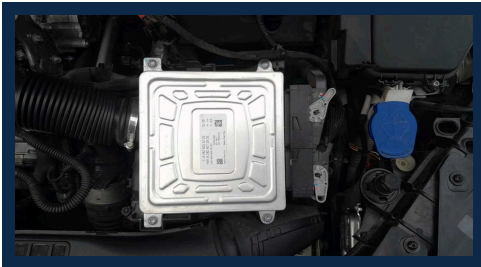
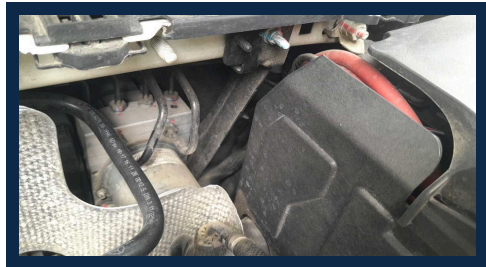
Fire Report

Evidence of Fire	No
------------------	----
