# Preowned Vehicle Inspection Report

Premium Inspection Analysis

**Vehicle :** MERCEDES BENZ S560

**Chassis number :** W1K2221736L013989

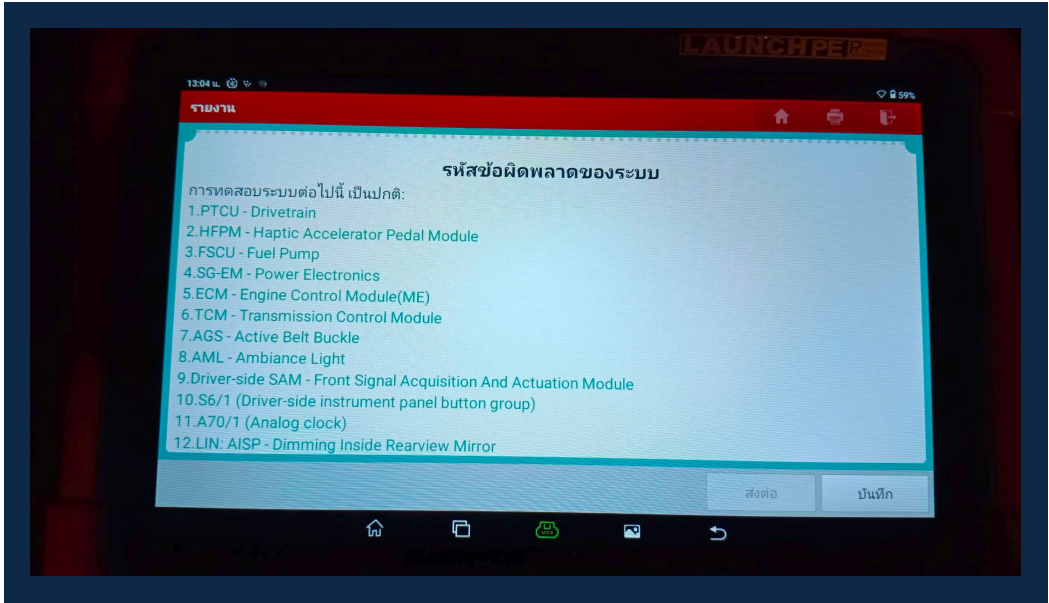
**OBD Vehicle Health Analysis**

**Inspector :** ภายนอก(Exterior) : พบรอยถลอกยาวที่บังโคลนหน้าขวา/ประตูหน้าขวา/ประตูหลังขวา/บังโคลนหลังขวา ภายใน(Interior) : - เครื่องยนต์(Engine) : วิเคราะห์ปัญหาด้วยเครื่อง OBDII ไม่พบสิ่งผิดปกติ (ไม่ได้ทดสอบขับขี่) โครงสร้าง(Frame) : -

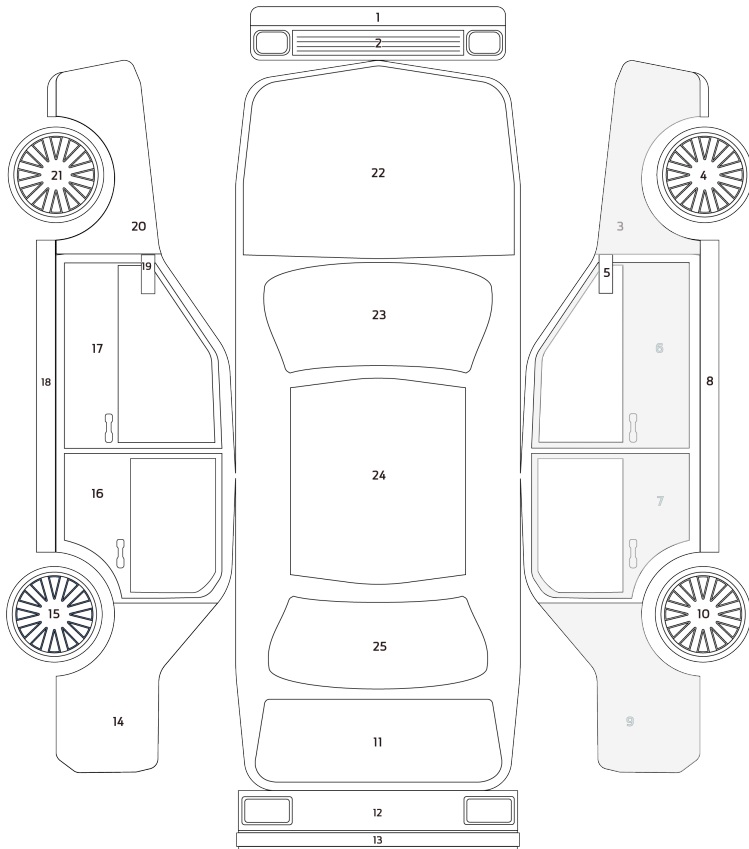
### Exterior Inspection Points

1. Front Skirt	O	14. Left Skirt	O
2. Front Bumper	O	15. Left Wing Mirror	O
3. Front Right Fender	O (S1)	16. Front Windshield	O
4. Front Right Wheel	O	17. Roof	O
5. Front Left Fender	O	18. Rear right fender	O (S1)
6. Front Left Wheel	O	19. Rear Bonnet	O
7. Front Bonnet	O	20. Back Right Wheel	O
8. Right Wing Mirror	O	21. Rear Bumper	O
9. Front right door	O (S1)	22. Rear Skirt	O
10. Rear right door	O (S1)	23. Rear Left Fender	O
11. Right Skirt	O	24. Back Left Wheel	O
12. Rear Left Door	O	25. Back Windshield	O
13. Front Left Door	O

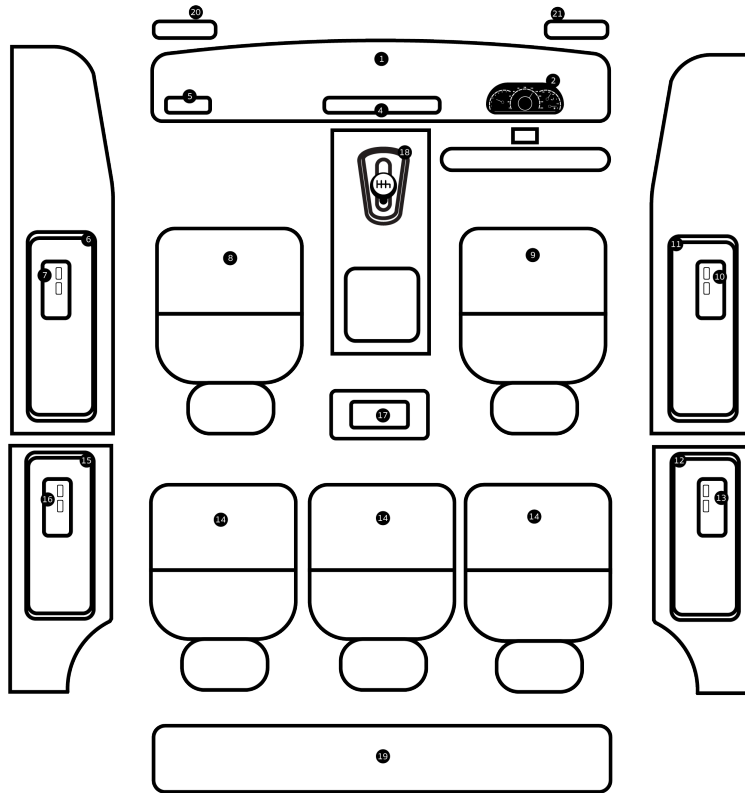
### Interior Inspection Points

Scratched/Faded items	S
Sunken/Sagging car seats	D
Tear/Cracks	Y
Failed Electrical Equipment	E

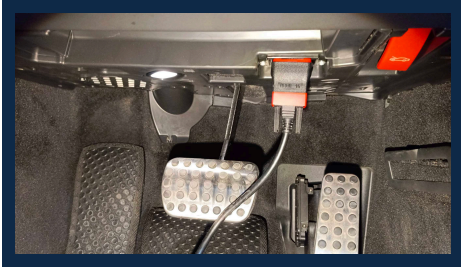
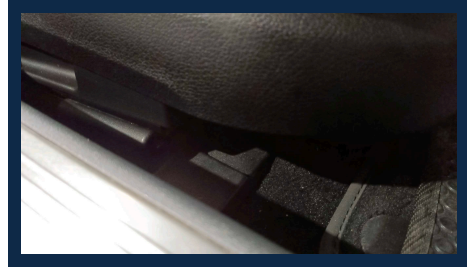
**Flood Report**

Evidence of Flood

No

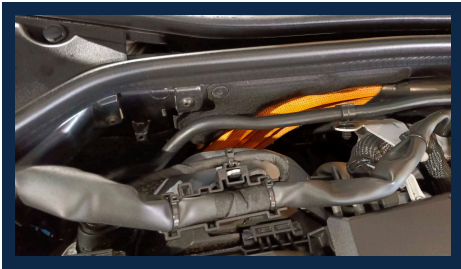
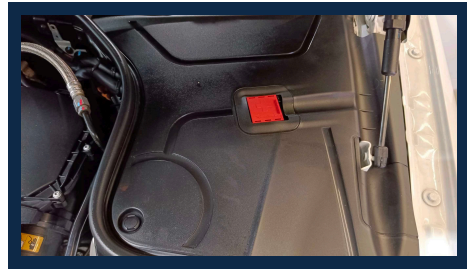
**Fire Report**

Evidence of Fire

No
