# Preowned Vehicle Inspection Report

Customer Name	: MERCEDES-BENZ MOBILITY (THAILAND) CO., LTD.	Inspection Date	: 2024-05-22
Tel.	:	Lemon Inspection ID	: LEMON24050214
Inspector	: tanruk tipin	Approved By	: sakulpong singnarong

Brand	MERCEDES BENZ	Model year	2021
Model	E350E	Engine Code - No.	27492031956187
Sub-model	AMG DYNAMIC	Registration year	2021-04-05
Registration No.		Chassis No.	W1K2130536L035090
Current Mileage(km.)	38895	Engine Capacity(cc.)	2000

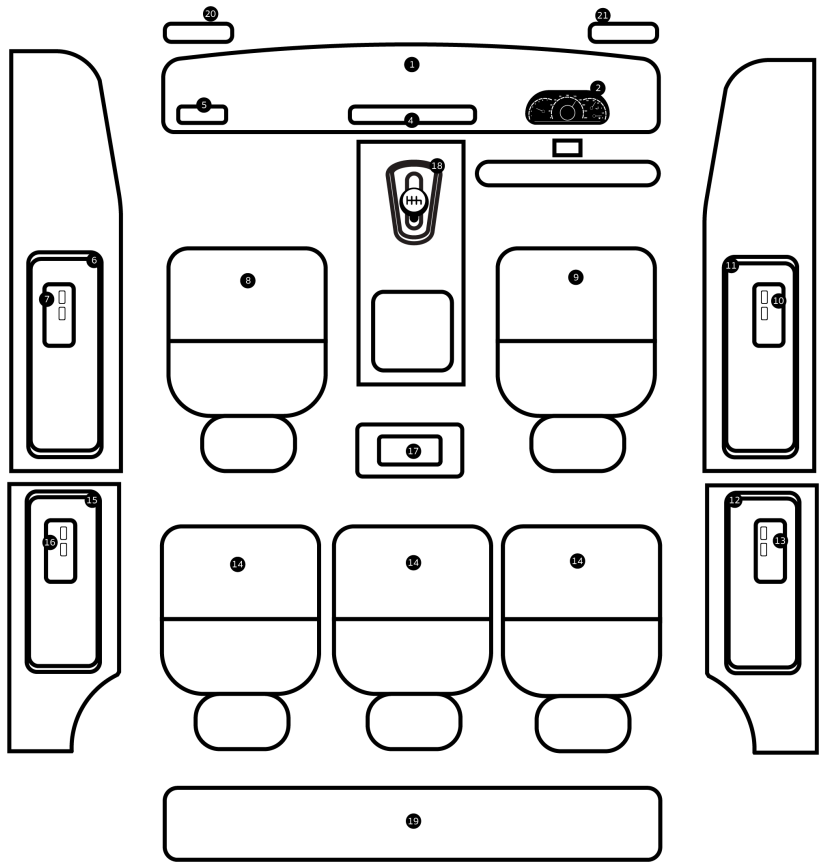
**Interior Inspection Points**

Scratched/Faded items	S
Sunken/Sagging car seats	D
Tear/Cracks	Y
Failed Electrical Equipment	E
