# Preowned Vehicle Inspection Report

Premium Inspection Analysis

Customer Name	: MERCEDES-BENZ MOBILITY (THAILAND) CO., LTD.	Inspection Date	: 2024-05-27
Tel.		Lemon Inspection ID	: LEMON24050273
Inspector	: suwat thongpim	Approved By	: tanruk tipin

Brand	MERCEDES BENZ	Model year	2019
Model	GLA250	Engine Code - No.	27092031823630
Sub-model	AMG DYNAMIC	Registration year	2019-12-18
Registration No.		Chassis No.	WDC1569446L012045
Current Mileage(km.)	109472	Engine Capacity(cc.)	1991

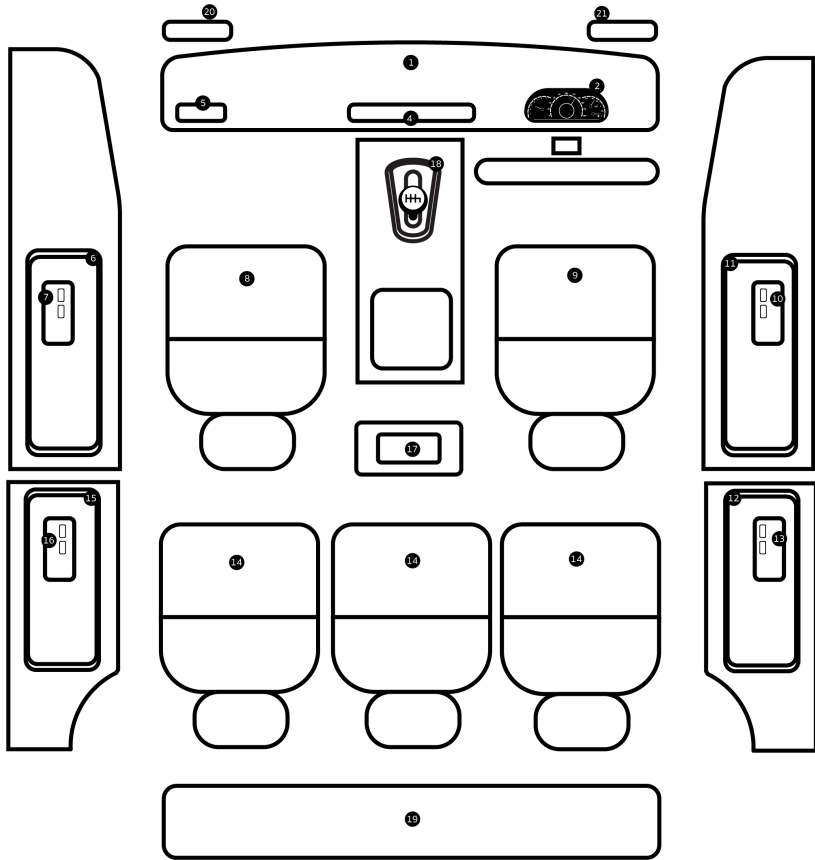
**Interior Inspection Points**

Scratched/Faded items	S
Sunken/Sagging car seats	D
Tear/Cracks	Y
Failed Electrical Equipment	E

**Inspector :** หมายเอก\* ภายนอก(Exterior) : การตรวจสภาพภายนอกโดยรวมพบหลักฐานการซ่อมแซมทำสี กันชนหน้าทำสี ฝากระโปรงหลังซ่อมทำสี บังโคลนหลังขวาซ่อมทำสี ล้อแม็กหน้าหลังขวาครูดลอกเล็กน้อย ฝากระโปรงหน้ารอยสะเก็ดหินเล็กน้อย / สภาพยางปกติทั้ง4เส้น ปี23 ภายใน(Interior) : ปุ่มกดแผงประตูหน้าขวากับแผงสวิตช์เปิดปิดแอร์รอยถลอกพอง ภายในสะอาดเรียบร้อย , อุปกรณ์ไฟฟ้า แอร์ วิทยุFM ใช้งานได้สมบูรณ์ครบปกติ
