Preowned Vehicle Inspection Report

Premium Inspection Analysis

Brand	MERCEDES BENZ	Model year	2019
Model	GLA250	Engine Code - No.	27092031792034
Sub-model	AMG DYNAMIC	Registration year	2019-04-04
Registration No.		Chassis No.	WDC1569446L011351
Current Mileage(km.)	71818	Engine Capacity(cc.)	1991

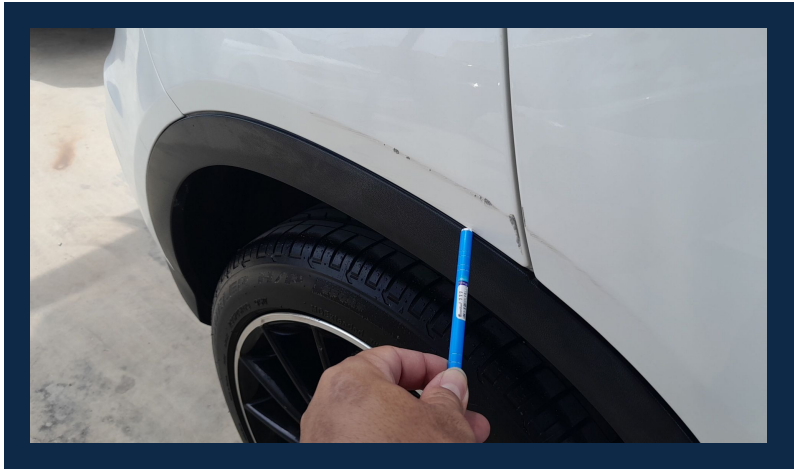
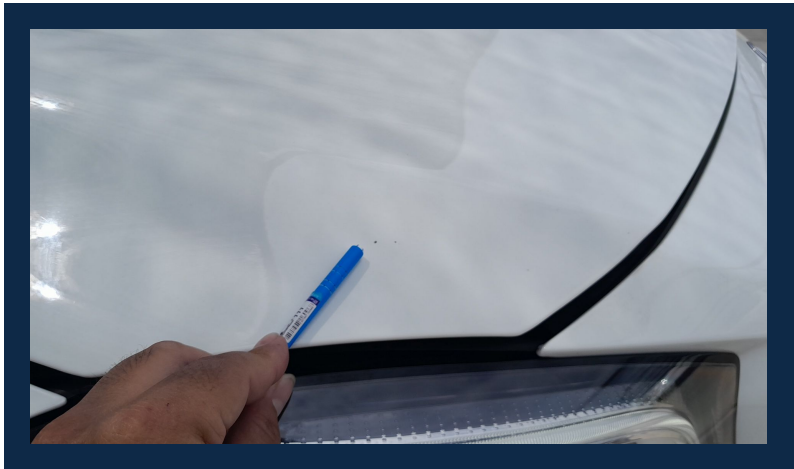
Vehicle Defect Notices

1. Front Skirt	O (S1)	14. Left Skirt	O
2. Front Bumper	O	15. Left Wing Mirror	O
3. Front Right Fender	BP (D1)	16. Front Windshield	O
4. Front Right Wheel	O	17. Roof	O
5. Front Left Fender	BP (S1)	18. Rear right fender	BP (S2)
6. Front Left Wheel	O	19. Rear Bonnet	O
7. Front bonnet	BP (S1)	20. Back Right Wheel	O
8. Right Wing Mirror	O	21. Rear Bumper	O
9. Front right door	O (S1)	22. Rear Skirt	O
10. Rear right door	O (S1)	23. Rear Left Fender	O
11. Right Skirt	O	24. Back left wheel	O (S1)
12. Rear Left door	BP (S1)	25. Back Windshield	O
13. Front left door	O (S1)
