Preowned Vehicle Inspection Report

Premium Inspection Analysis

Customer Name	: MERCEDES-BENZ MOBILITY (THAILAND) CO., LTD.	Inspection Date	: 2024-06-06
Tel.	:	Lemon Inspection ID	: LEMON24060055
Inspector	: tanruk tipin	Approved By	: Sakulpong Singnarong

Brand	MERCEDES BENZ	Model year	2019
Model	S350	Engine Code - No.	65692980032448
Sub-model	CDI BLUEEFFICIENCY EXCLUSIVE	Registration year	2019-08-22
Registration No.		Chassis No.	WDD2221206L012322
Current Mileage(km.)	86463	Engine Capacity(cc.)	3000

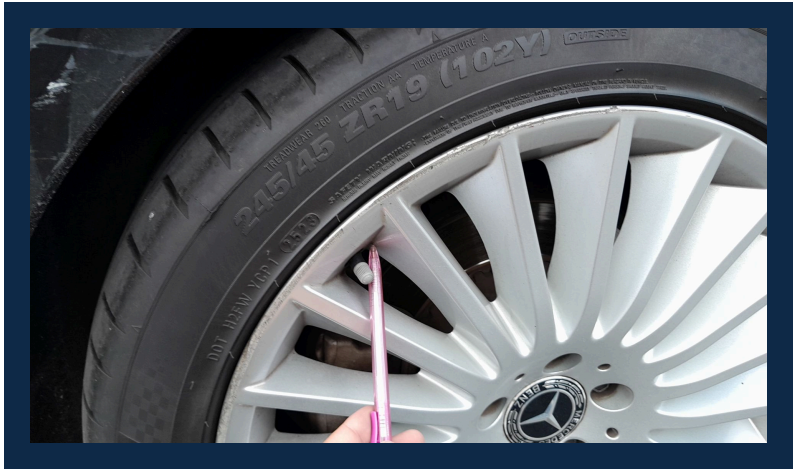
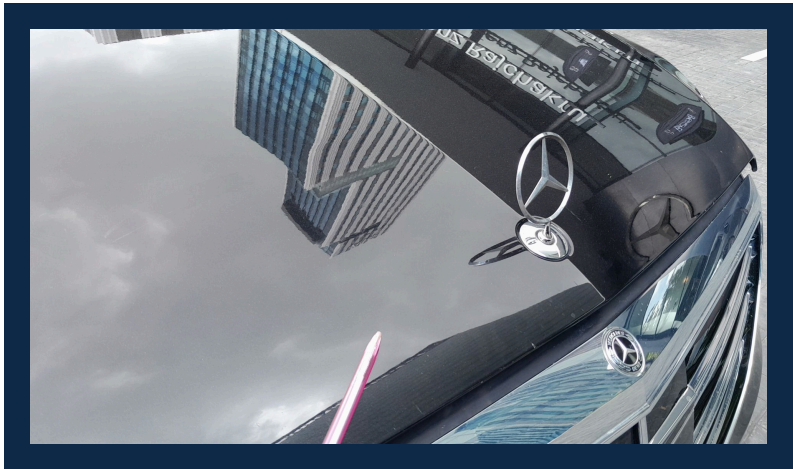
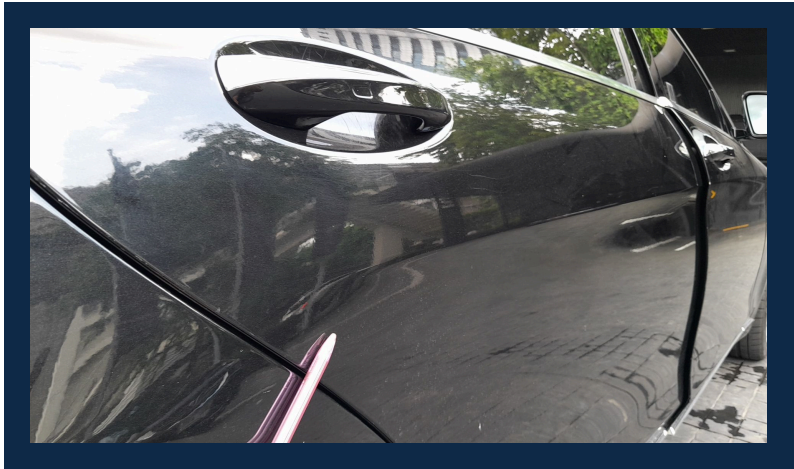
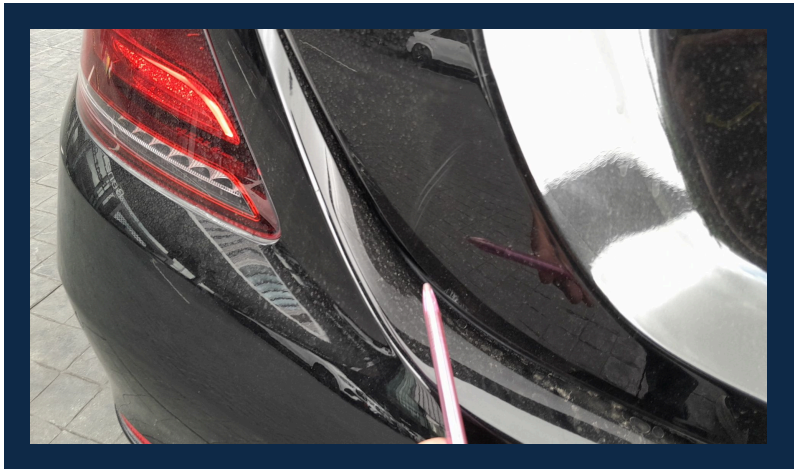
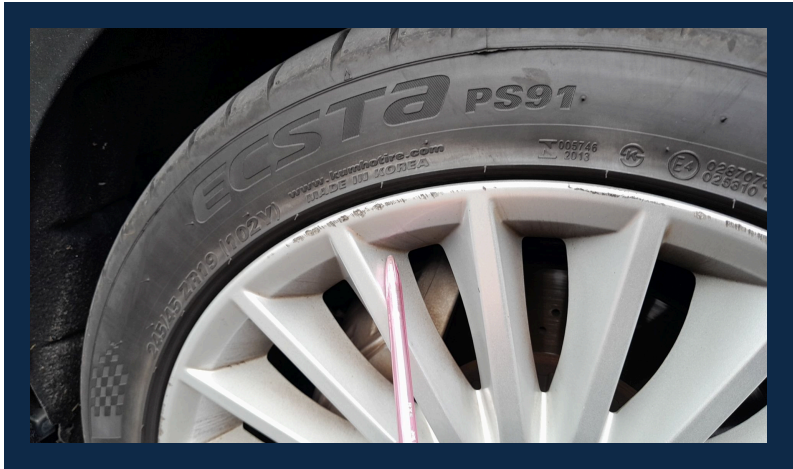
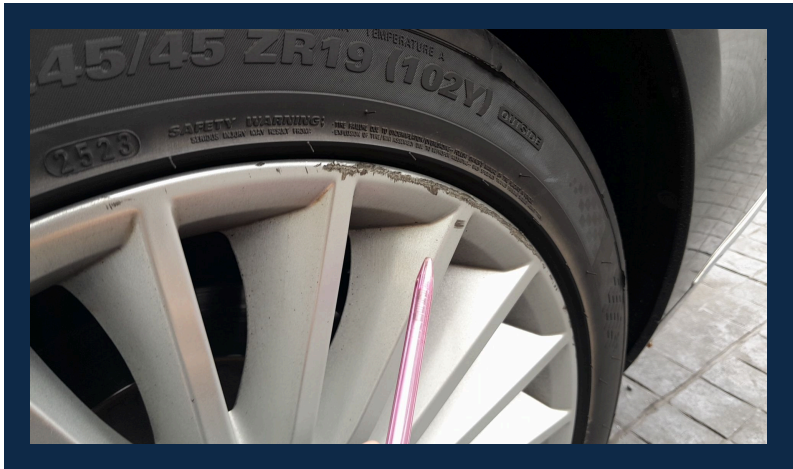
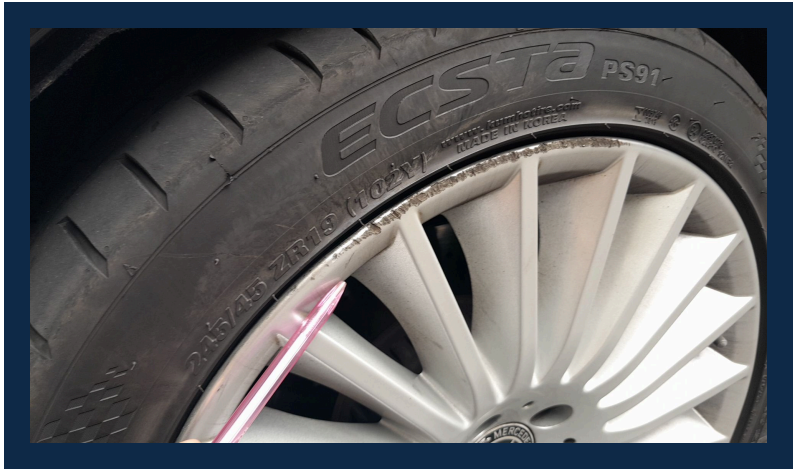
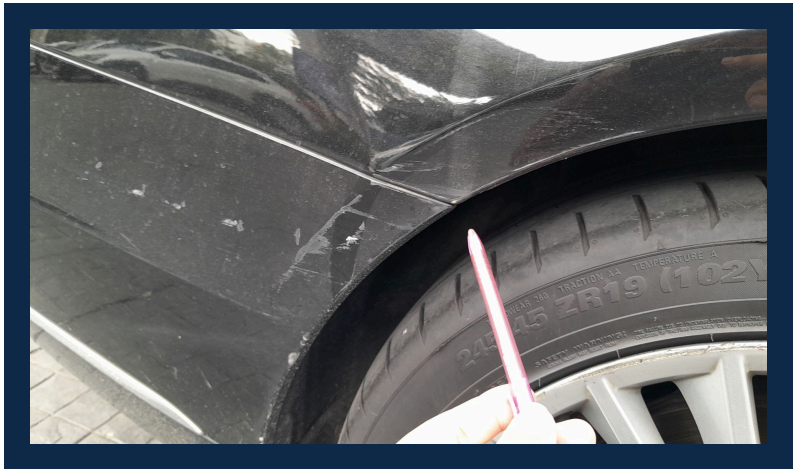
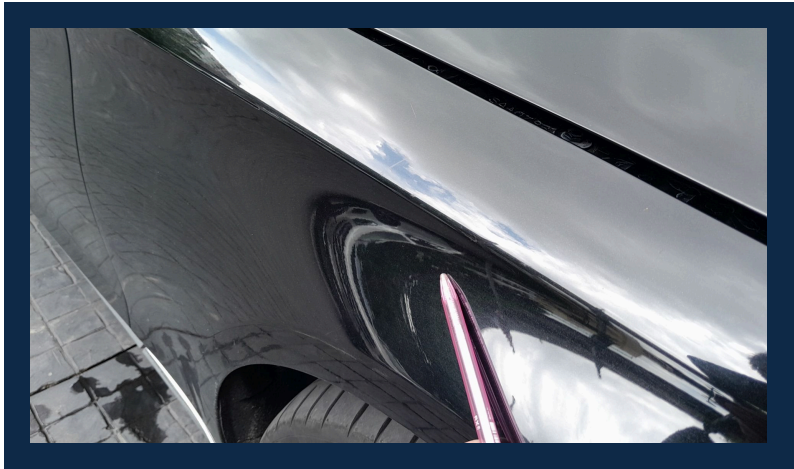
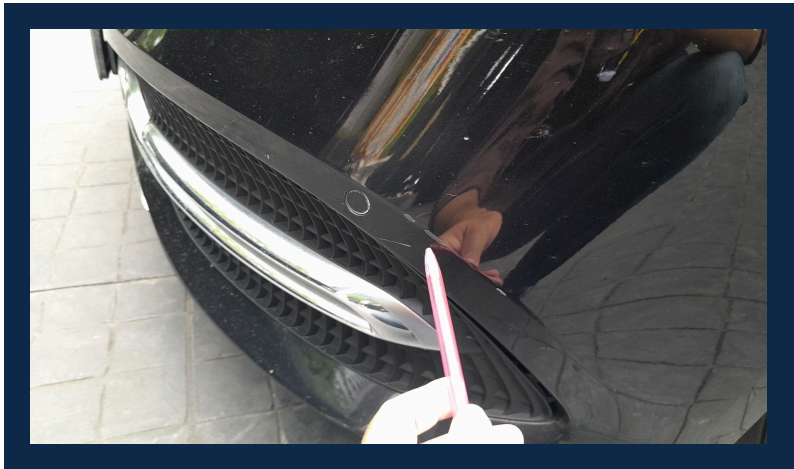
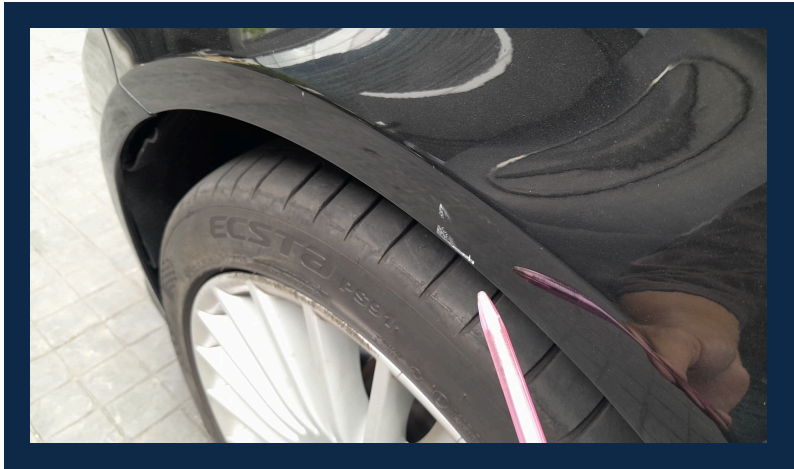
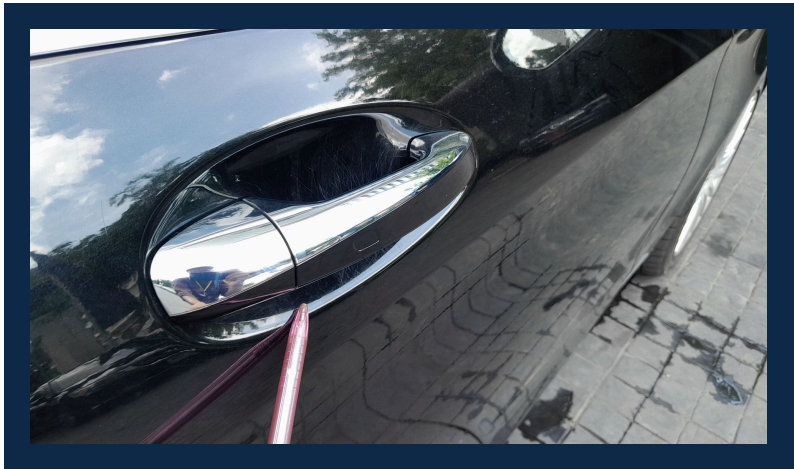
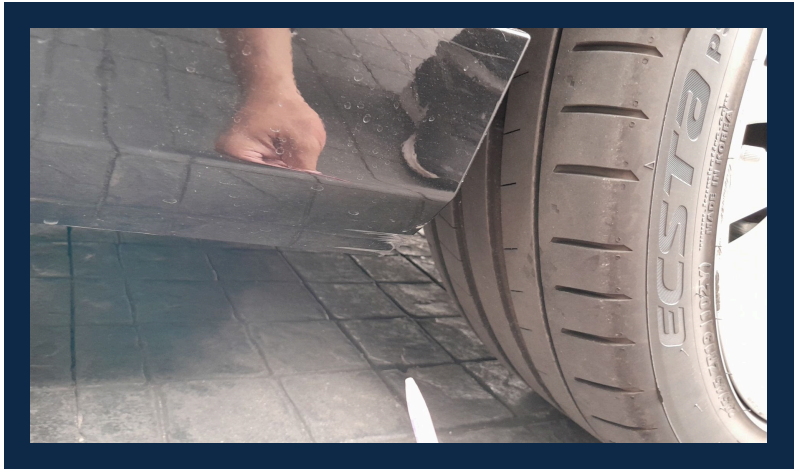
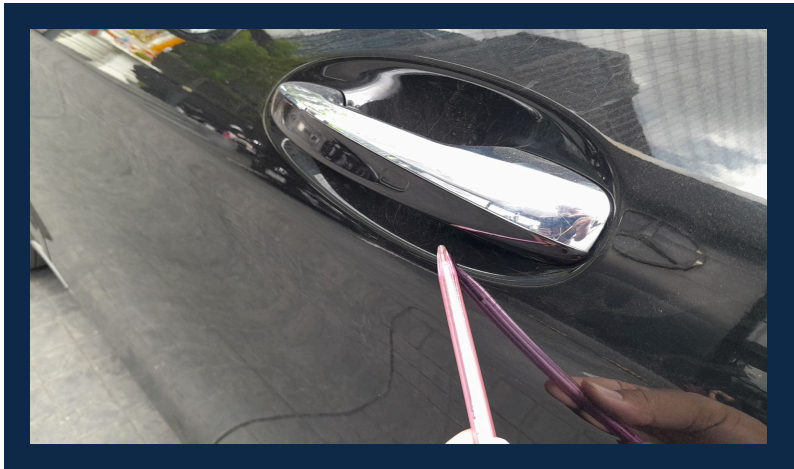
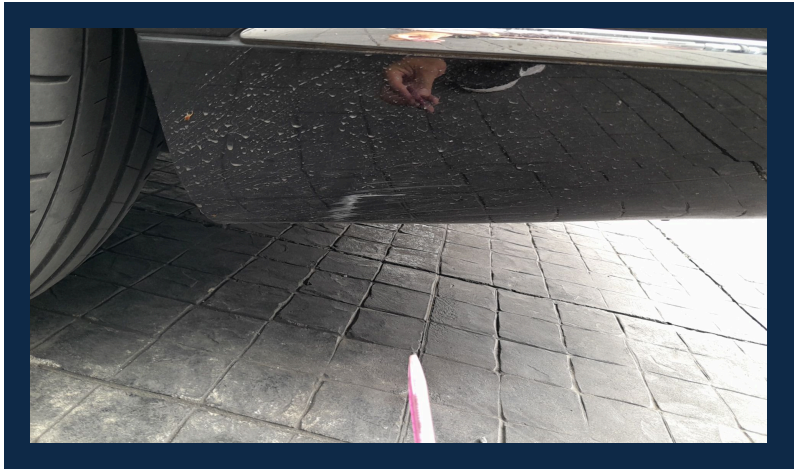
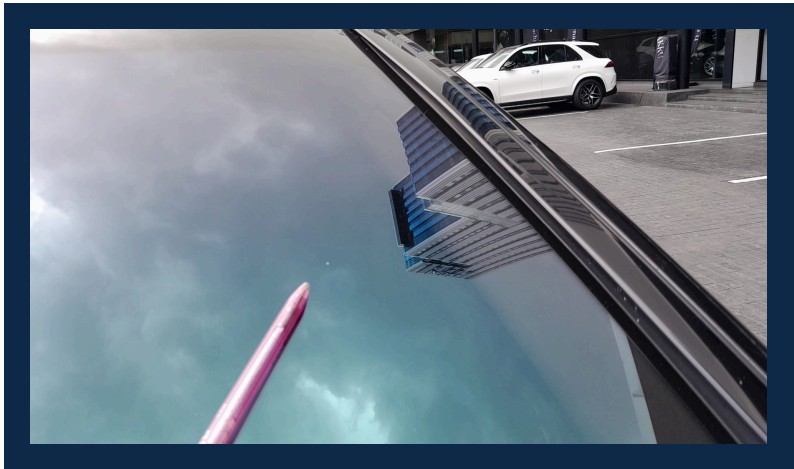
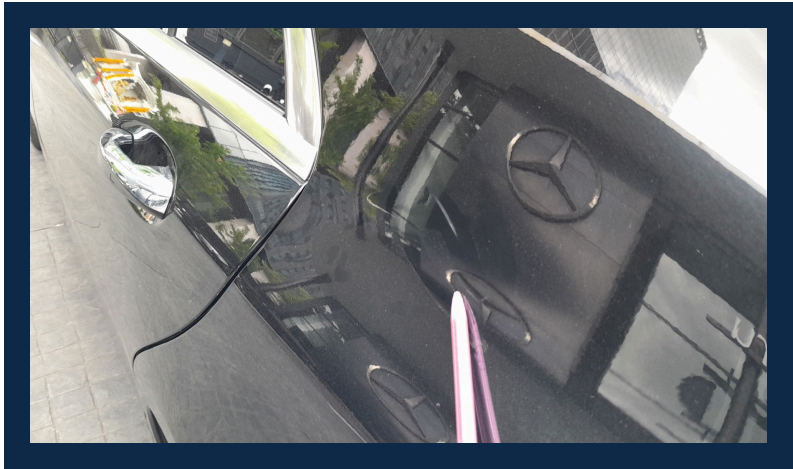
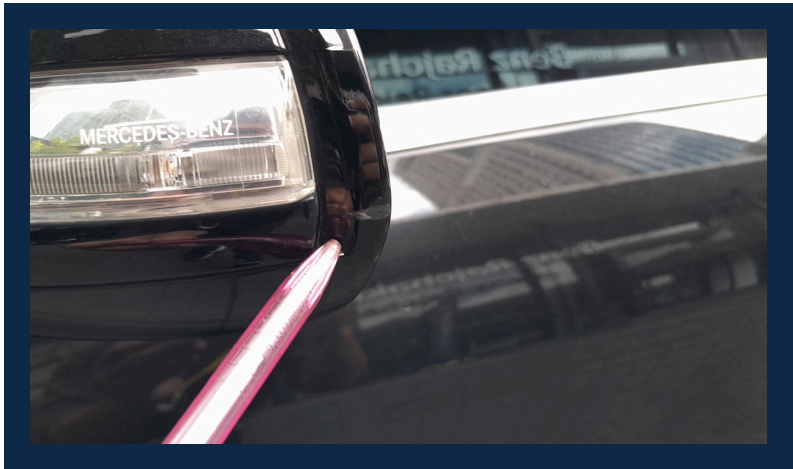
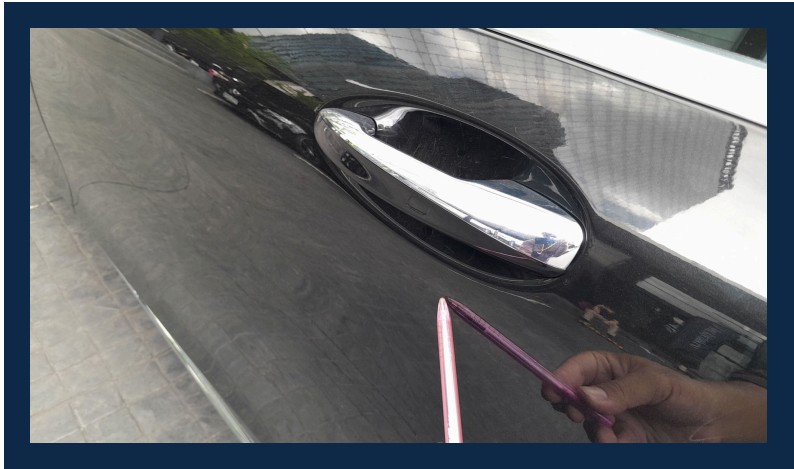
Vehicle Defect Notices

1. Front Skirt	O (S1)	14. Left skirt	O (S1)
2. Front Bumper	O	15. Left wing mirror	O (S1)
3. Front Right Fender	O (S1)	16. Front windshield	N (G1)
4. Front Right Wheel	O (S1)	17. Roof	O
5. Front Left Fender	O (S1)	18. Rear right fender	O (S2)
6. Front Left Wheel	O (S2)	19. Rear Bonnet	O (S1)
7. Front bonnet	O (S1)	20. Back right wheel	O (S1)
8. Right Wing Mirror	O	21. Rear Bumper	O
9. Front right door	O (S1)	22. Rear skirt	O (S2)
10. Rear right door	O (S1)	23. Rear left fender	O (S1)
11. Right Skirt	O	24. Back left wheel	O (S1)
12. Rear Left door	O (S1)	25. Back Windshield	O
13. Front left door	O (S1)
