Preowned Vehicle Inspection Report

Premium Inspection Analysis

Customer Name	: MERCEDES-BENZ MOBILITY (THAILAND) CO., LTD.	Inspection Date	: 2024-06-25
Tel.	:	Lemon Inspection ID	: LEMON24060262
Inspector	: สุวัฒน์ วัฒน ทองพิมพ์	Approved By	: Chaimongkol C

Brand	MERCEDES BENZ	Model year	2021
Model	CLA45	Engine Code - No.	13998060022018
Sub-model	S 4MATIC+ AMG	Registration year	2021-10-12
Registration No.		Chassis No.	W1K1183542N235927
Current Mileage(km.)	34135	Engine Capacity(cc.)	2000

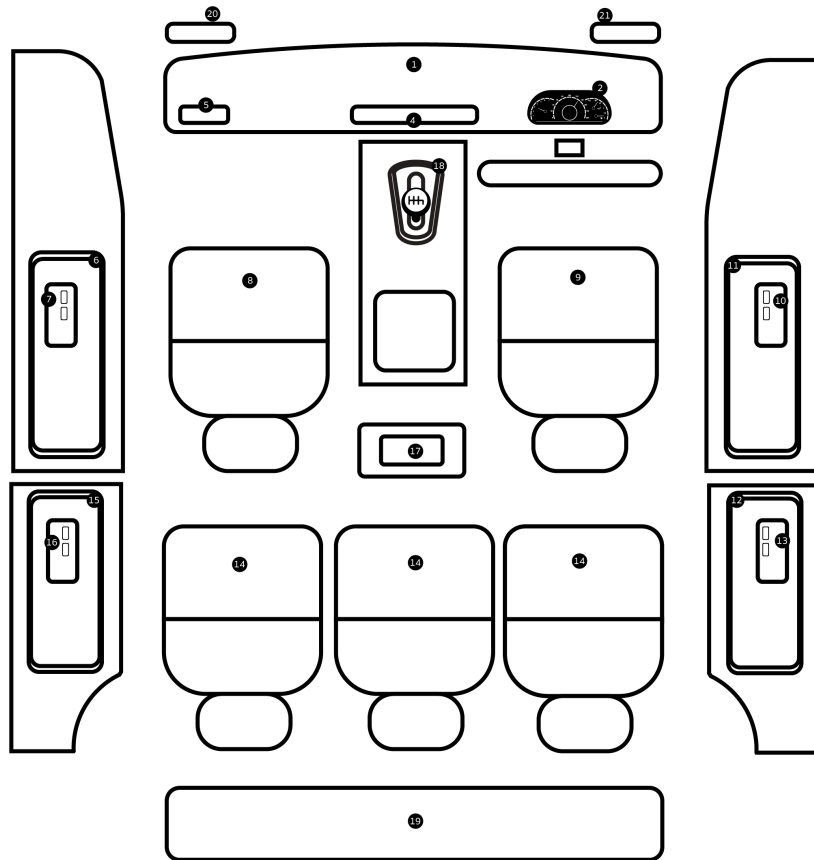
Interior Inspection Points

Scratched/Faded items	S
Sunken/Sagging car seats	D
Tear/Cracks	Y
Failed Electrical Equipment	E
