Premium Inspection Analysis

Customer Name	: MERCEDES-BENZ MOBILITY (THAILAND) CO., LTD.	Inspection Date	: 2024-06-25
Tel.	:	Lemon Inspection ID	: LEMON24060257
Inspector	: แทนรัก ทอย ทิพย์อินทร์	Approved By	: Chaimongkol C

Brand	MERCEDES BENZ	Model year	2018
Model	C200	Engine Code - No.	26491530043511
Sub-model	COUPE AMG DYNAMIC	Registration year	2019-10-28
Registration No.		Chassis No.	WDD2053776L043159
Current Mileage(km.)	131872	Engine Capacity(cc.)	1500

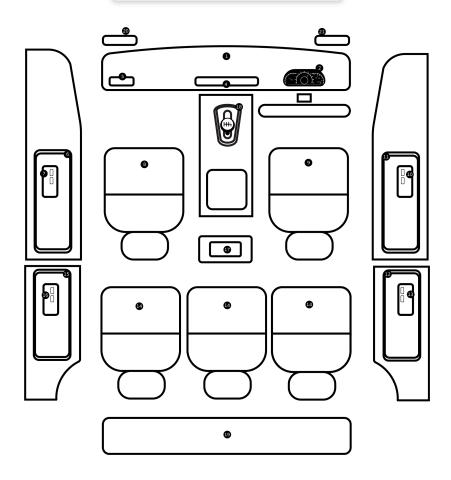
## Interior Inspection Points

Scratched/Faded items	S
Sunken/Sagging car seats	D
Tear/Cracks	Y
Failed Electrical Equipment	E

1. Console	
2. Dashboard	
3. Steering wheel and control panel	
4. Sound system and monitor	
5. Air conditioning system	
6. Front left door panel	
7. Left power window master	
8. Front left seat	
9. Front right seat	
10. Window control switch, front right door	
11. Front right door panel	
12. Right rear door panel	
13. Right rear power window master switch	
14. Rear Seat 1	
15. Rear Seat 2	
16. Rear Seat 3
