Vehicle : MERCEDES BENZ GLC250

Chassis number : WDC2539096L016417

Inspection date : 2024-07-15

Vehicle Certification : Pass the inspection standard of SCHIC INSPECTION BY LEMON-AIDE

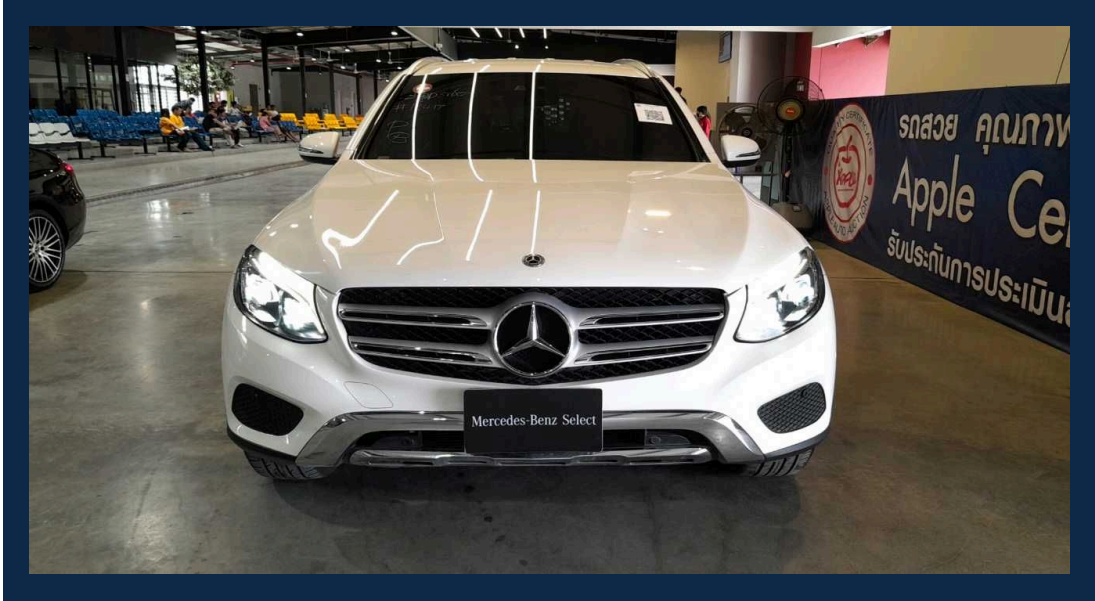
Vehicle Front Image

| 2. Front Bumper | O (S1) | 15. Left Wing Mirror | O |
| 7. Front bonnet | O (S1) | 20. Back Right Wheel | O |

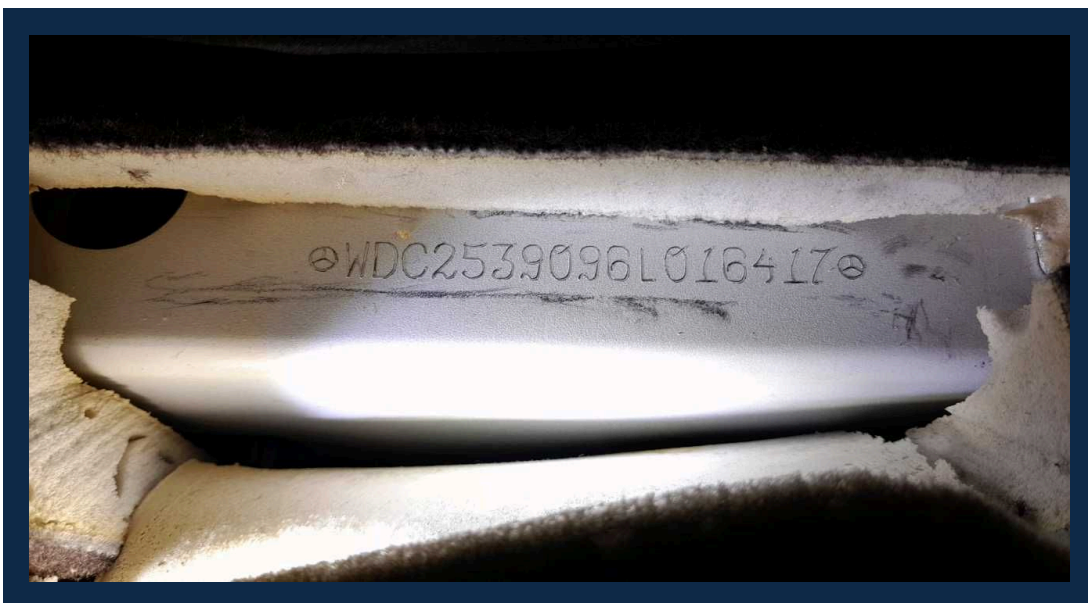
Vehicle Chassis Image

| No dent in the under carriage (th) | PASS |
| No deform chassis or chassis frame (th) | PASS |
| No visible corrosion on the chassis or chassis frame (th) | PASS |
| No missing part on the chassis frame (th) | PASS |
| Half cut Analysis (th) | PASS |

| Chassis Damage Level | No Damage |
