Preowned Vehicle Inspection Report

Premium Inspection Analysis

Customer Name : MERCEDES-BENZ MOBILITY (THAILAND) CO., LTD. Inspection Date : 2024-07-16
Tel. : Lemon Inspection ID : LEMON24070267
Inspector : แทนรัก ทิพย์อินทร์ Approved By : ไซยมงคล ไพริสัยง

Table with 4 columns: Brand, Model, Sub-model, Registration No., Current Mileage(km.), MERCEDES BENZ, GLE300, d 4MATIC AMG Dynamic, 1กย6996, 71689, Model year, Engine Code - No., Registration year, Chassis No., Engine Capacity(cc.), 2020, 65492080777076, 2022-11-08, W1N671196M001690, 2000

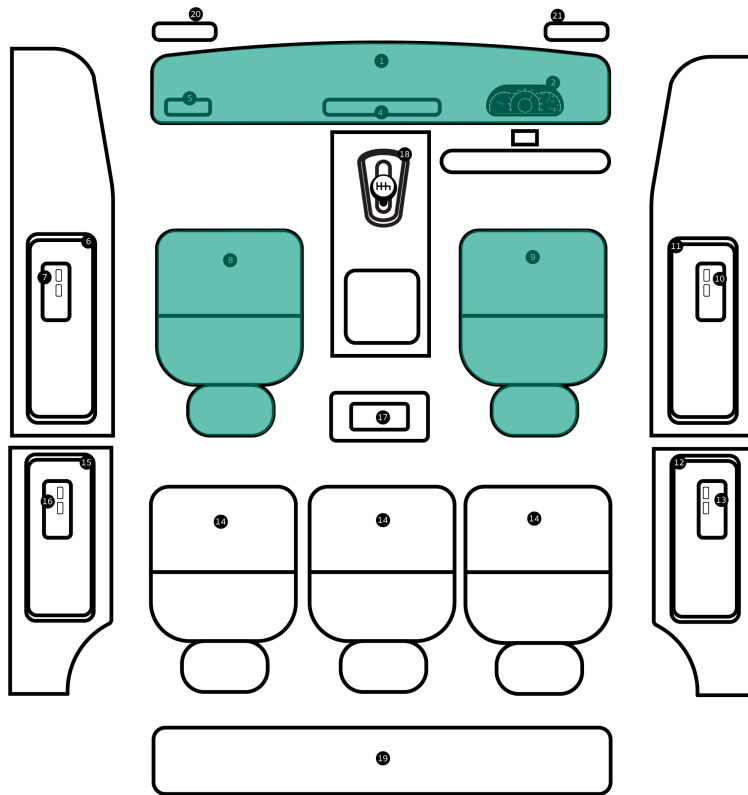
Interior Inspection Points

Scratched/Faded items	S
Sunken/Sagging car seats	D
Tear/Cracks	Y
Failed Electrical Equipment	E
