# Preowned Vehicle Inspection Report

Premium Inspection Analysis

**Vehicle :** MERCEDES BENZ CLS220

**Chassis number :** W1K2573146L004378

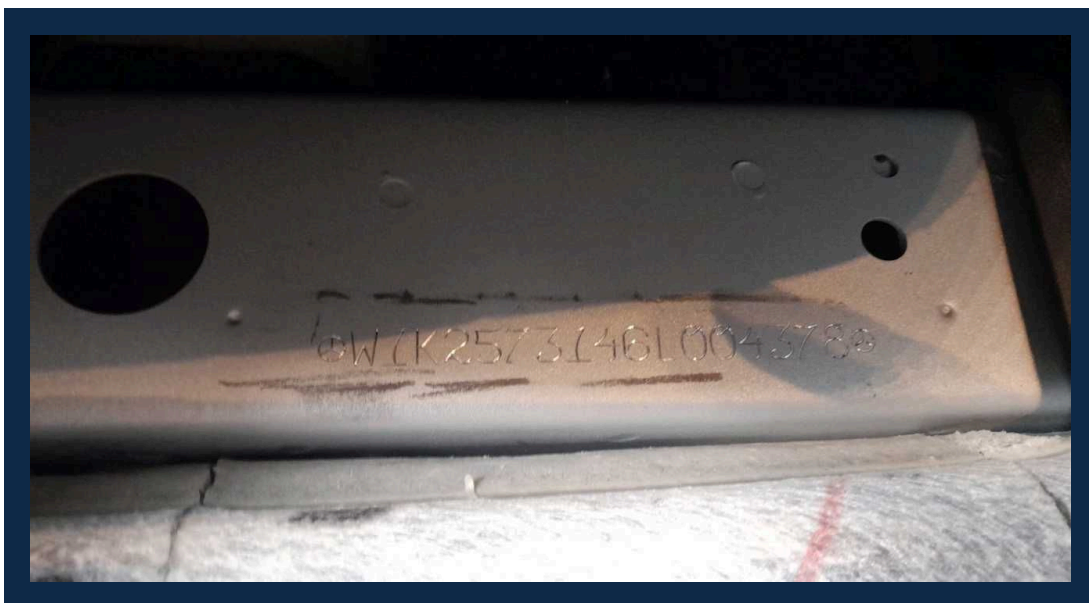
**Vehicle Chassis Image**

No dent in the under carriage (th)	PASS
No deform chassis or chassis frame (th)	PASS
No visible corrosion on the chassis or chassis frame (th)	PASS
No missing part on the chassis frame (th)	PASS
Half cut Analysis (th)	PASS
